**COMANDO DA AERONÁUTICA**  
**CENTRO DE INVESTIGAÇÃO E PREVENÇÃO DE**  
**ACIDENTES AERONÁUTICOS**

**FINAL REPORT**  
**A-147/CENIPA/2022**

<b>OCCURRENCE:</b>	<b>ACCIDENT</b>
<b>AIRCRAFT:</b>	<b>PP-IRC</b>
<b>MODEL:</b>	<b>AT 502A</b>
<b>DATE:</b>	<b>22DEZ2022</b>

This is the Final Report of the 22 December 2022 accident involving the model AT-502A aircraft of registration marks PP-IRC. The occurrence was typified as “[UIMC] Unintentional IMC” and “[LOC-I] Loss of Control in Flight.”

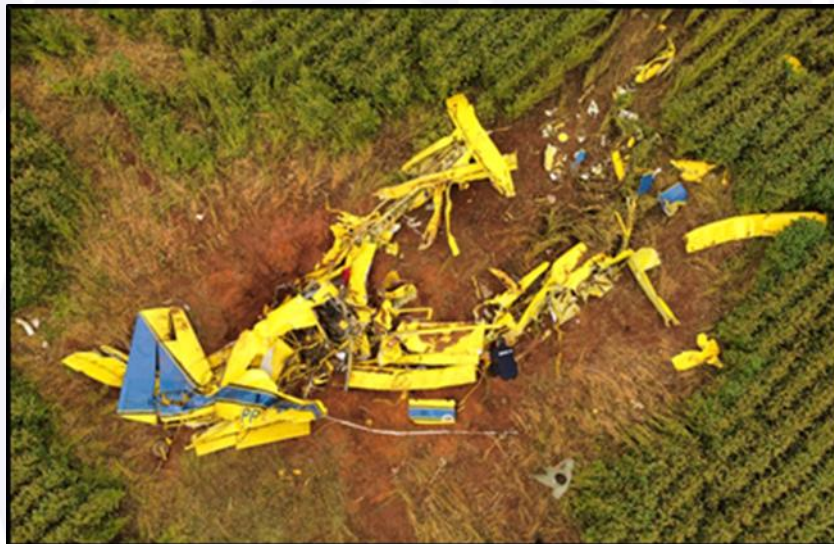
During the climb, the aircraft encountered adverse weather conditions, with subsequent loss of control and collision with the ground.

Figure 1 - Top view of the wreckage site of the aircraft PP-IRC.

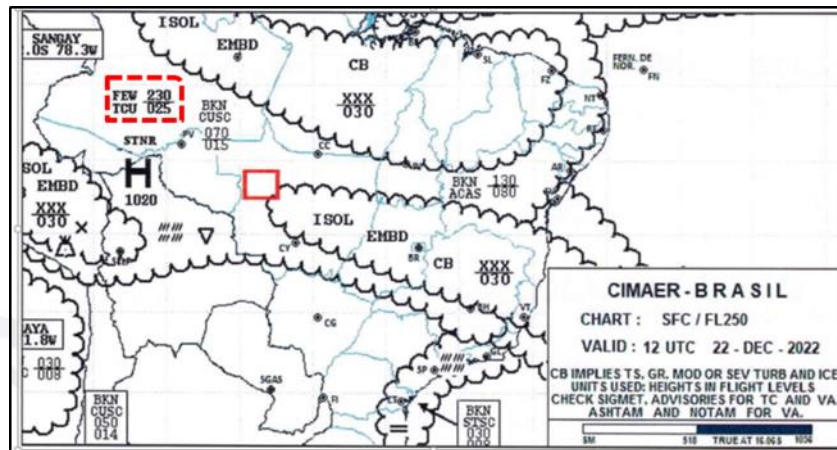
For Significant Weather (SIGWX), from the surface to FL250, there were forecasted Towering Cumulus (TCU) clouds with bases at 2,500 ft., tops at 23,000 ft., and a coverage of 1 to 2 oktas, as shown in Figure 2.

Figure 2 - SIGWX chart valid until 12:00 UTC on the day of the occurrence. Red dashed lines highlight the information on TCU clouds in the region; the solid red square indicates the accident location. Source: REDEMET.

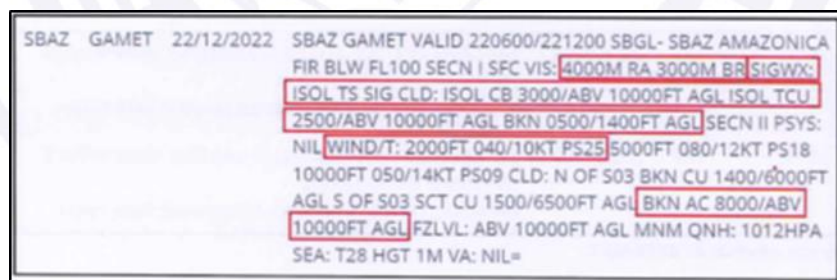
The Department of Airspace Control (DECEA) provided the GAMET (area meteorological forecast in abbreviated clear language for low-level flights). The FIR AMAZÔNICA GAMET (valid until 12:00 UTC on December 22, 2022) had the following forecast: Moderate rain, reducing visibility to 4,000 meters; Mist, reducing visibility to 3,000 meters; Isolated cumulonimbus clouds (CB) with base at 3,000 ft.; Isolated thunderstorms (ISOL TS) at 2,500 ft.; Low cloud coverage with base at 500 ft. and ceiling at 1,400 ft.; Wind at 2,000 ft. 040° at 10 knots; Altocumulus clouds (AC) with base at 8,000 ft. (Figure 3).

Figure 3 - GAMET valid from 06:00 to 12:00 UTC on the day of the occurrence. The main pieces of information are highlighted in red. Source: REDEMET.

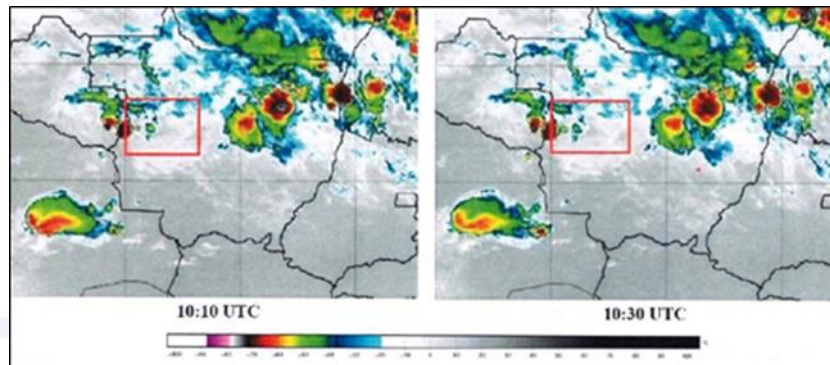
Satellite images showed low and medium cloud coverage across the accident region, with clouds west of the area, indicating the presence of CB/TCU.

Figure 4 - Satellite imagery from December 22, 2022.  
Source: Weather Forecast and Climate Studies Center.

The presence of low and medium cloud coverage, combined with convective clouds (CB/TCU), had the potential to cause light to moderate rainfall, as well as restrict horizontal and vertical visibility.

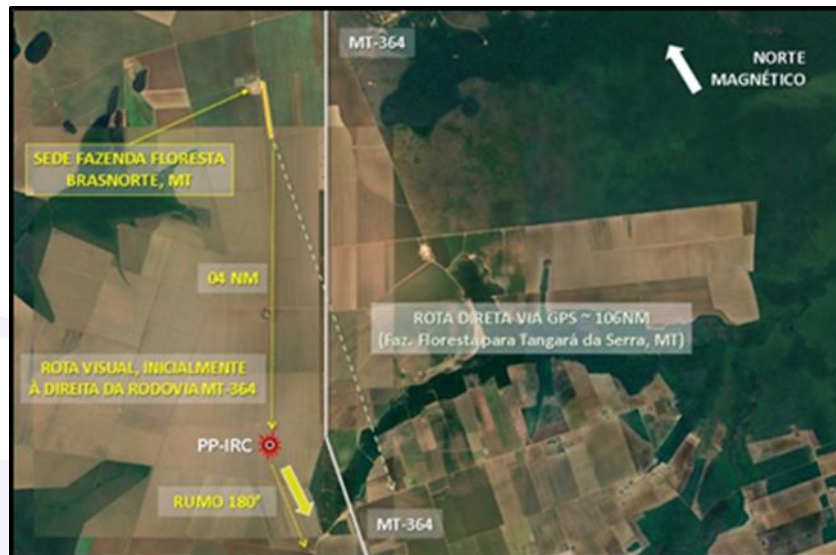
The wreckage was located at a distance of 4 NM south of the point of departure, in the direction of the intended destination, consistent with the planned route. The site was flat and located at a distance of approximately 1.5 km from the highway MT-364, as shown in Figure 5.

Figure 5 - Overview of the area where the crash occurred.

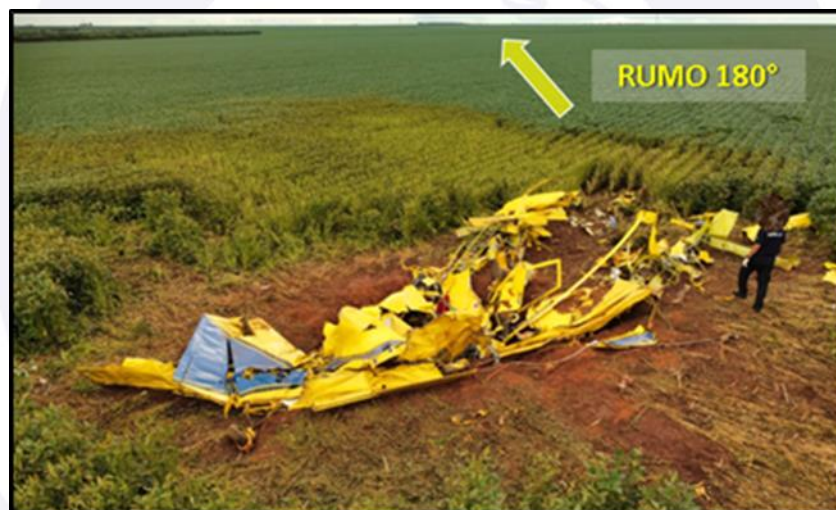
The concentrated disposition of the wreckage indicated that the aircraft collided with the ground at a high vertical speed with a steep angle (greater than 45°). The engine was found buried at a depth of 4 meters in a rural area of *Brasnorte*, MT.

There were no signs of horizontal movement of the aircraft on the ground. The discoloration of vegetation near the wreckage suggested fuel dispersion following the impact, indicating that the final heading of the flight was 180° (Figure 6).

Figure 6 - Overview of the aircraft wreckage.
