FINAL REPORT
A-105/CENIPA/2021

OCCURRENCE:	ACCIDENT
AIRCRAFT:	PP-JCS
MODEL:	210L
DATE:	16SET2021

This is the Final Report of the 16SEPT2021 accident with the Cessna 210L aircraft, registration marks PP-JCS. The accident was typified as “[SCF-PP] Engine failure or malfunction | Engine failure in flight.”

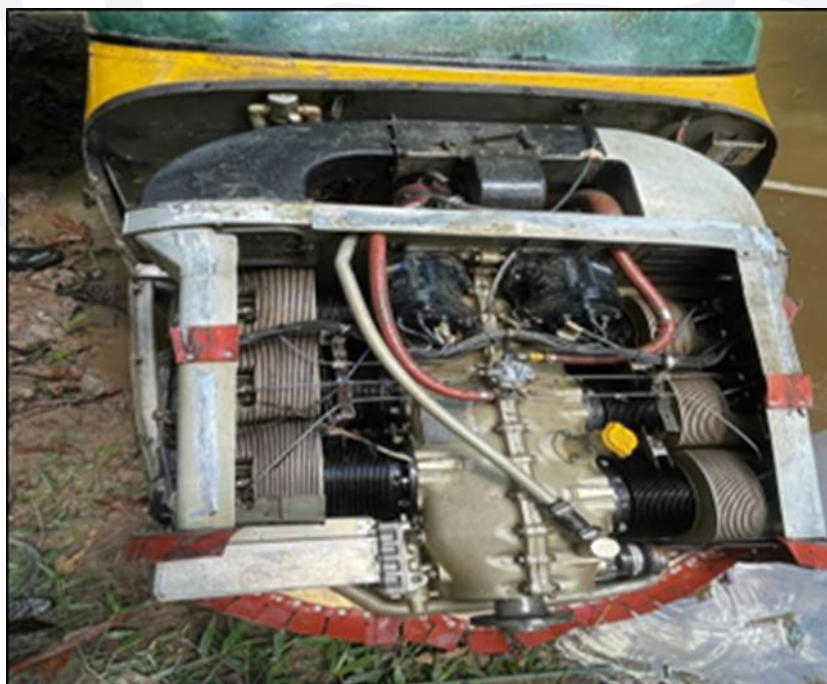
The aircraft sustained substantial damage to the engine, engine housing and windshield. There was slight damage to the fuselage and propeller (Figure 1).

Figure 1 - Front view of the aircraft engine, after removal from the river.

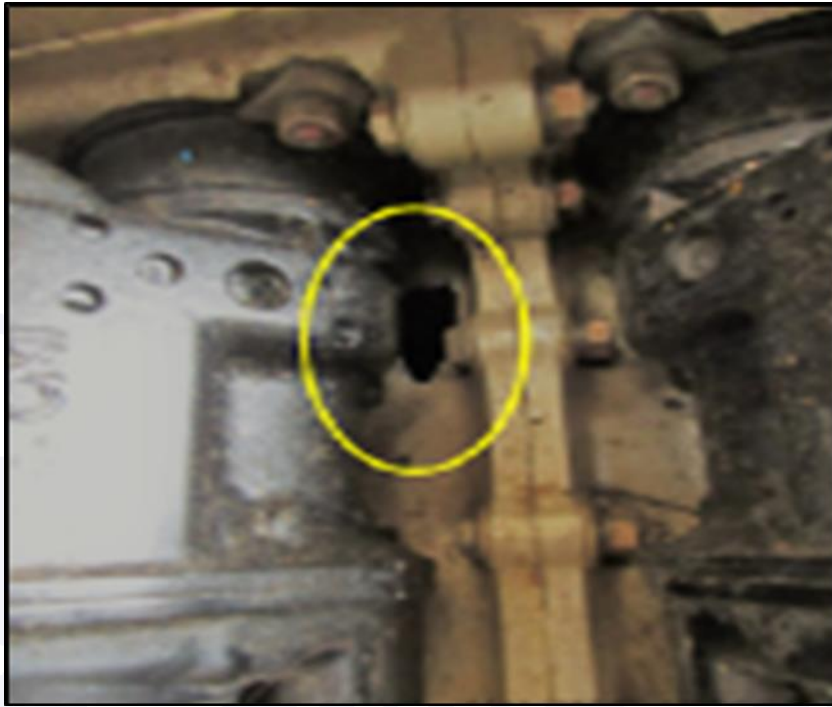
At the time, one verified that there was a hole in the upper part of the engine block, on the right-hand side, in an area adjacent to the cylinder nº 1 (Figure 2).

Figure 2 - Hole in the engine block housing close to the cylinder nº 1.

The SN 553,849 model IO-520L Continental engine which equipped the PP-JCS was disassembled and analyzed. Internal damage was observed in the block of the engine, including a hole on the upper part of the right-hand side. Several parts and fragments of the piston as well as internal parts of the block were spread inside the engine.

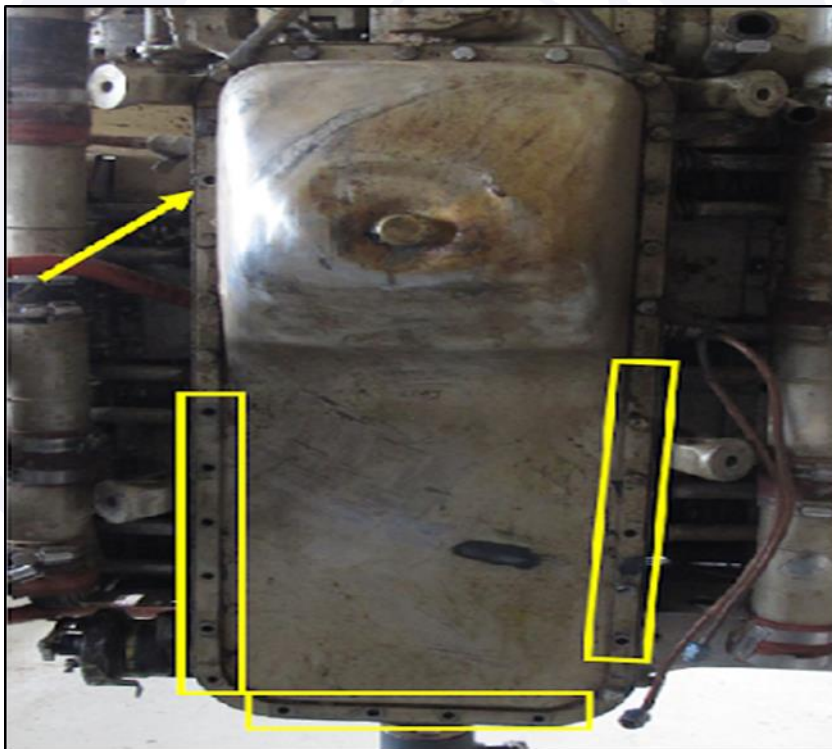
The crankcase was drained, that is, without oil, and many of its screws had been removed during the process of sending the engine to the workshop where the examinations were to be carried out.

Figure 3 - Bottom view of the engine crankcase without some of the screws.

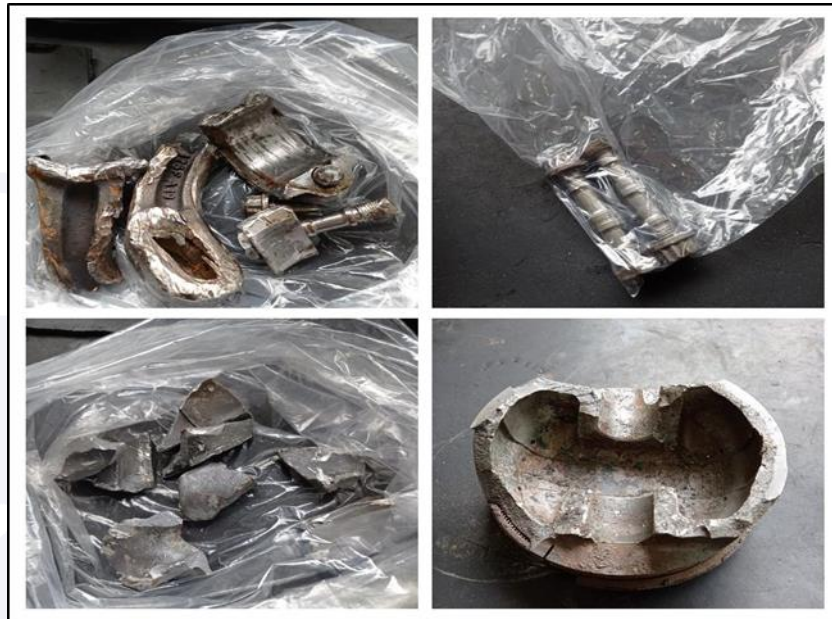
Fragments of the piston nº 1 were found inside the engine block, as well as parts of the respective connecting rod.

The analyses conducted at the DCTA revealed that the “connecting rod cap” (part of the connecting rod attached to the crankshaft) of the cylinder number nº 1 failed due to a

fatigue mechanism. However, it was not possible to identify the beginning of the pre-crack process, on account of the damage sustained after the failure, when the component was in operation.

Figure 4 - Material collected for analysis at the DCTA.

As a consequence, during the motion, there was interference of the piston and piston rings with the inner wall of the cylinder. The sequence of piston movements under those conditions resulted in the rupture, due to overload, of the other interconnected components, such as connecting rod, piston body, piston pin and piston rings, generating the fragments found as illustrated in Figures 4 and 5.

Work with *Voare Táxi Aéreo Ltda.* (COM No. 1506-61/ANAC), so that the referred operator demonstrates that its Technical Maintenance Control (CTM) mechanisms are appropriately implemented and functioning, especially with regard to the activities related to controlling the utilization of aircraft and equipment operated by the company.

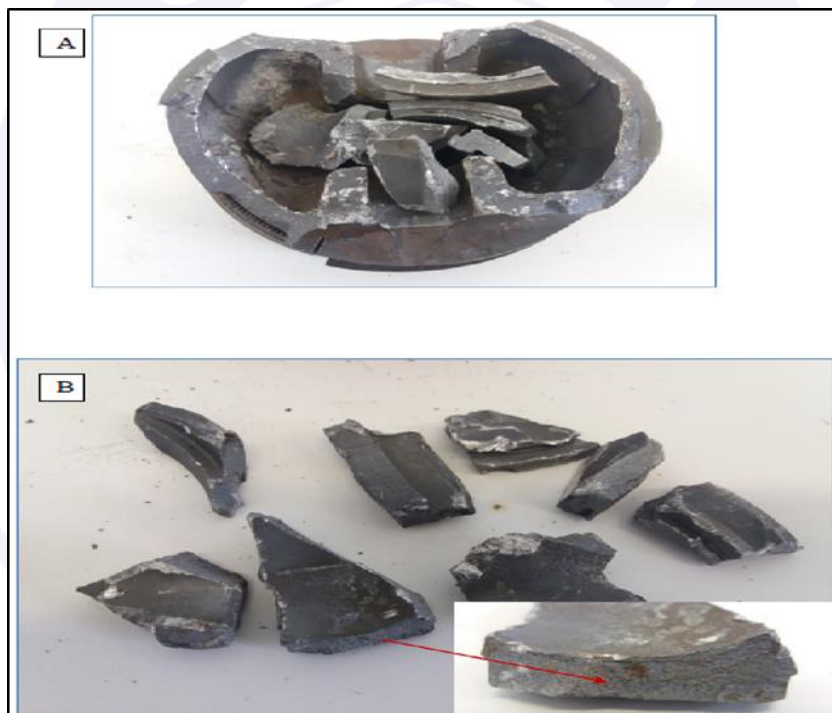
Figure 5 - General view of the piston and fragments. The red arrow indicates fractures attributed to an overload mechanism.

Due to the failure, the piston misaligned inside the cylinder, altering its upward and downward path, between the Top Dead Center (*PMS*) and the Bottom Dead Center (*PMI*).

One found the cap of the connecting rod corresponding to the piston nº 1 which had broken due to fatigue, and the piston which had broken due to stress as a result of the probable misalignment caused by the breaking of the connecting rod.
