COMANDO DA AERONÁUTICA
CENTRO DE INVESTIGAÇÃO E PREVENÇÃO DE
ACIDENTES AERONÁUTICOS

FINAL REPORT
A-105/CENIPA/2021

OCCURRENCE:	ACCIDENT
AIRCRAFT:	PP-JCS
MODEL:	210L
DATE:	16SET2021

This is the Final Report of the 16SEPT2021 accident with the Cessna 210L aircraft, registration marks PP-JCS. The accident was typified as “[SCF-PP] Engine failure or malfunction | Engine failure in flight.”

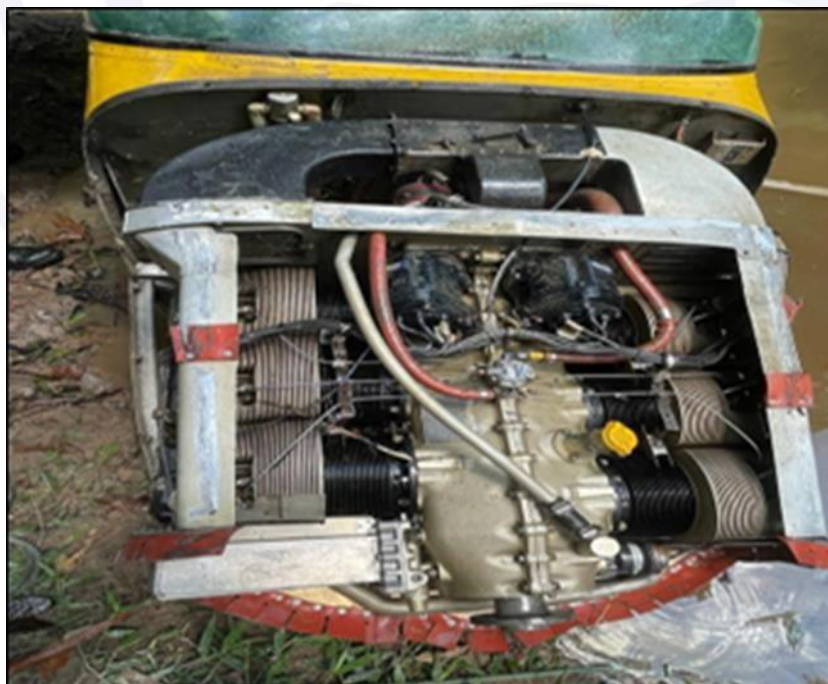
The aircraft sustained substantial damage to the engine, engine housing and windshield. There was slight damage to the fuselage and propeller (Figure 1).

Figure 1 - Front view of the aircraft engine, after removal from the river.

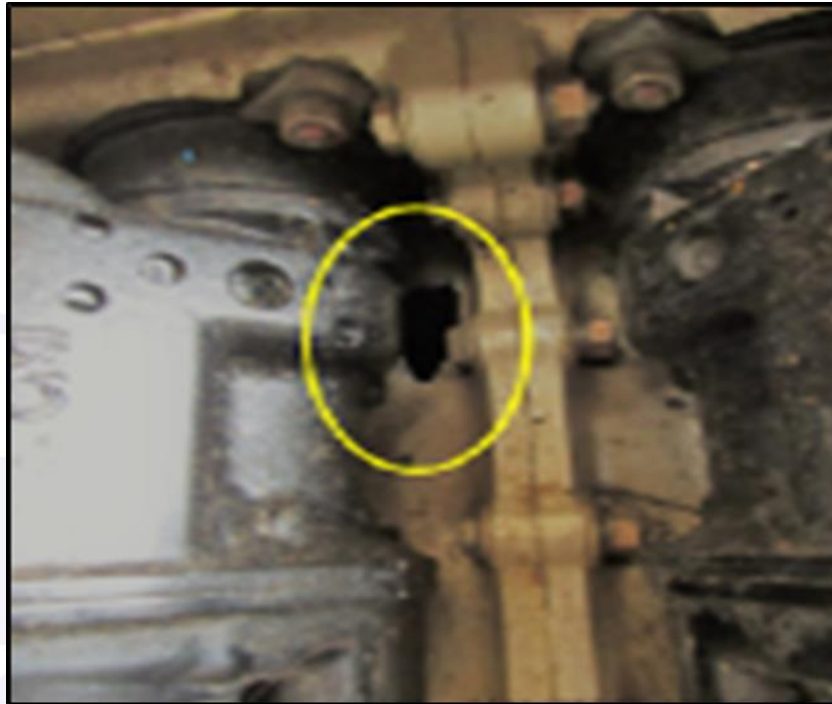
At the time, one verified that there was a hole in the upper part of the engine block, on the right-hand side, in an area adjacent to the cylinder nº 1 (Figure 2).

Figure 2 - Hole in the engine block housing close to the cylinder nº 1.

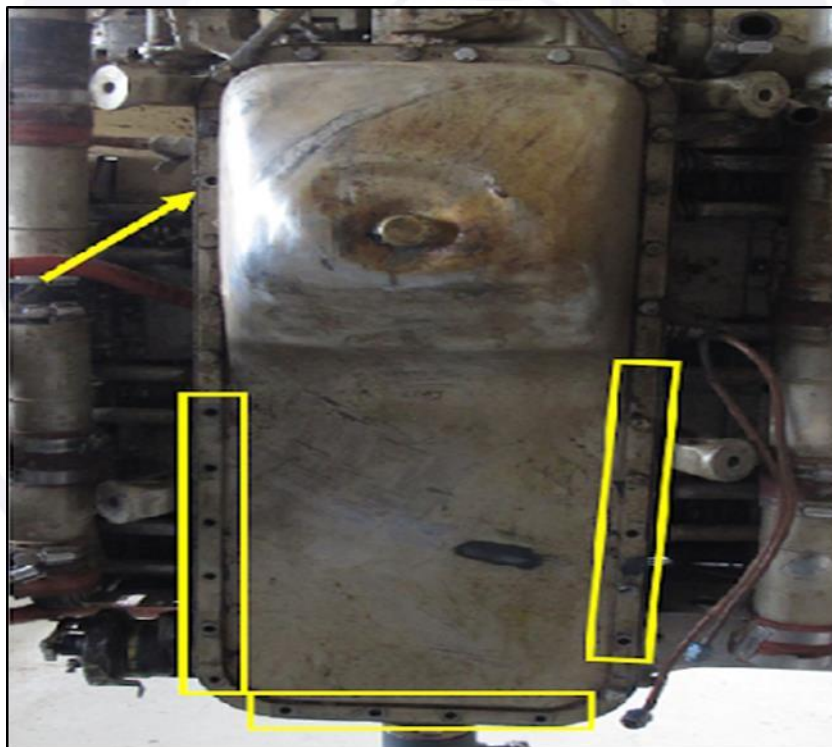
The crankcase was drained, that is, without oil, and many of its screws had been removed during the process of sending the engine to the workshop where the examinations were to be carried out.

Figure 3 - Bottom view of the engine crankcase without some of the screws.

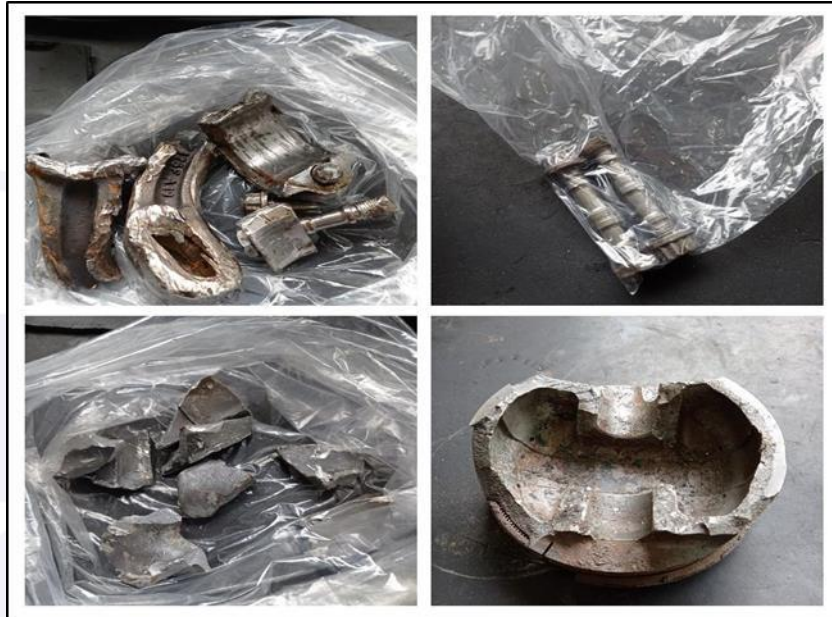
The analyses conducted at the DCTA revealed that the “connecting rod cap” (part of the connecting rod attached to the crankshaft) of the cylinder number nº 1 failed due to a

fatigue mechanism. However, it was not possible to identify the beginning of the pre-crack process, on account of the damage sustained after the failure, when the component was in operation.

Figure 4 - Material collected for analysis at the DCTA.

As a consequence, during the motion, there was interference of the piston and piston rings with the inner wall of the cylinder. The sequence of piston movements under those conditions resulted in the rupture, due to overload, of the other interconnected components, such as connecting rod, piston body, piston pin and piston rings, generating the fragments found as illustrated in Figures 4 and 5.

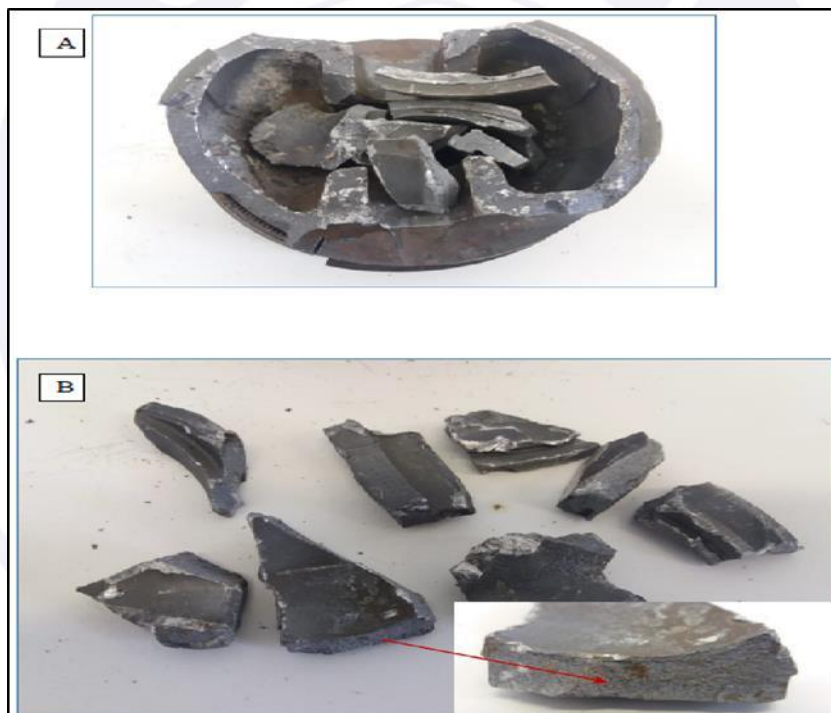
Figure 5 - General view of the piston and fragments. The red arrow indicates fractures attributed to an overload mechanism.

Due to the failure, the piston misaligned inside the cylinder, altering its upward and downward path, between the Top Dead Center (*PMS*) and the Bottom Dead Center (*PMI*).

One found the cap of the connecting rod corresponding to the piston nº 1 which had broken due to fatigue, and the piston which had broken due to stress as a result of the probable misalignment caused by the breaking of the connecting rod.
