COMANDO DA AERONÁUTICA
CENTRO DE INVESTIGAÇÃO E PREVENÇÃO DE
ACIDENTES AERONÁUTICOS

FINAL REPORT
A - 512/CENIPA/2021

OCCURRENCE:	ACCIDENT
AIRCRAFT:	PP-LOS
MODEL:	AW109SP
DATE:	31AUG2012

This is the Final Report of the 31AUG2012 accident with the AW109SP aircraft model, registration PP-LOS. The accident was classified as “[RAMP] Ground Handling”.

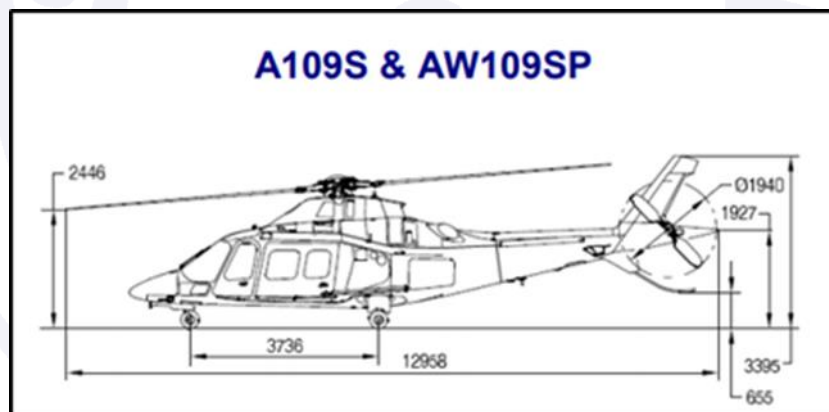
The model was a light twin-engine turbine helicopter, having a four-blade main rotor and a two-blade tail rotor. The main rotor had a diameter of 10.83m and a height of 2.446m from the tip of the blade to the ground, at the front of the aircraft (Figure 1).

Figure 1 - Dimensions of the AW109SP, in millimeters.

The height of the static main rotor blade tip to the ground was 2,446 m and the terrain was flat, with a gentle downward slope in the tail-to-nose direction of the aircraft.

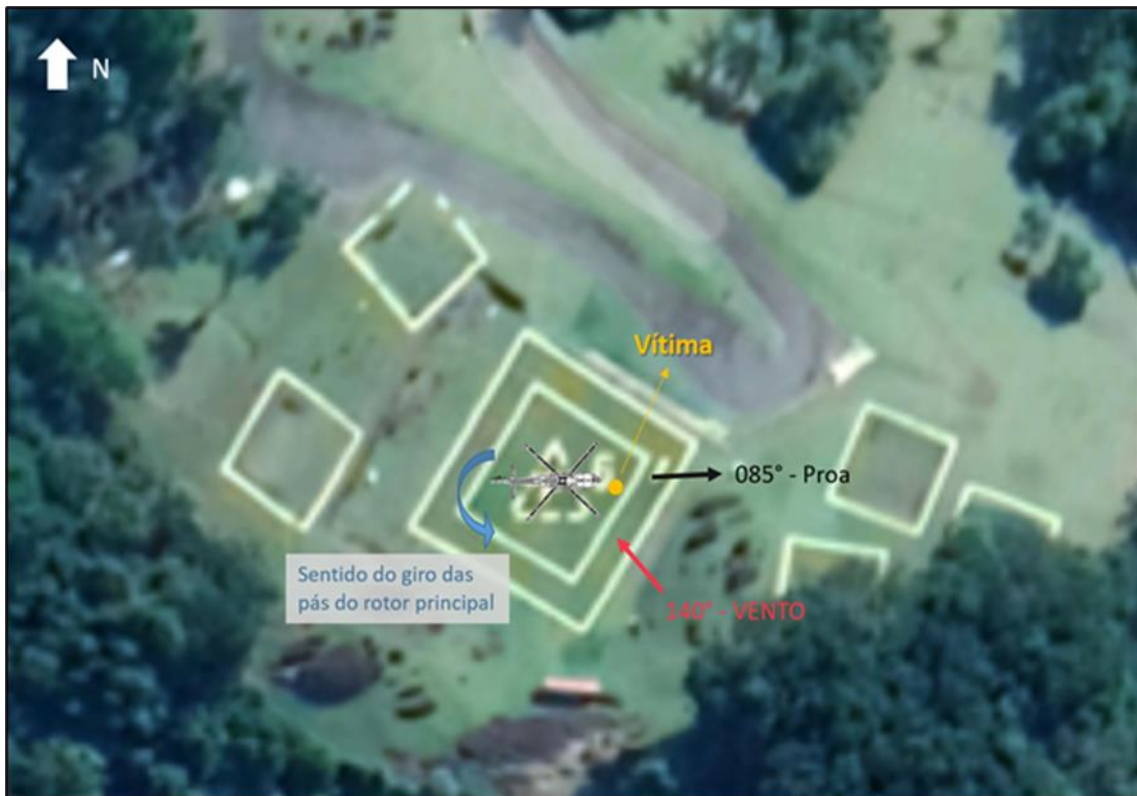
According to observers, the passengers were disembarking from the side of the aircraft, when the helipad support employee approached from the front of the aircraft and was hit by the main rotor blades.

Figure 2 - Position of the aircraft and the employee in relation to the helipad.

Thus, considering the position of the aircraft at the time of the occurrence, whose heading was approximately 085°, the wind would have hit the aircraft from the heading, on the right side, forming an angle of approximately 55° with the nose of the helicopter.

In this way, it is possible to verify that, since the rotation of the main rotor occurred in a counterclockwise direction, the blades, due to the wind direction, would tend to be above the height of the stabilized rotation, in the region around the helicopter where the employee was (Figure 2).

At the time of the occurrence, a prevention activity was carried out with the support staff of the Santos late Clube Helipad (SJCG) advising them on safety aspects when approaching and leaving the parking area, with the aircraft's engines running.
