**COMANDO DA AERONÁUTICA**  
**CENTRO DE INVESTIGAÇÃO E PREVENÇÃO DE**  
**ACIDENTES AERONÁUTICOS**

**FINAL REPORT**  
**A-069/CENIPA/2022**

<b>OCCURRENCE:</b>	<b>ACCIDENT</b>
<b>AIRCRAFT:</b>	<b>PP-MCJ</b>
<b>MODEL:</b>	<b>206B</b>
<b>DATE:</b>	<b>05JUN2022</b>

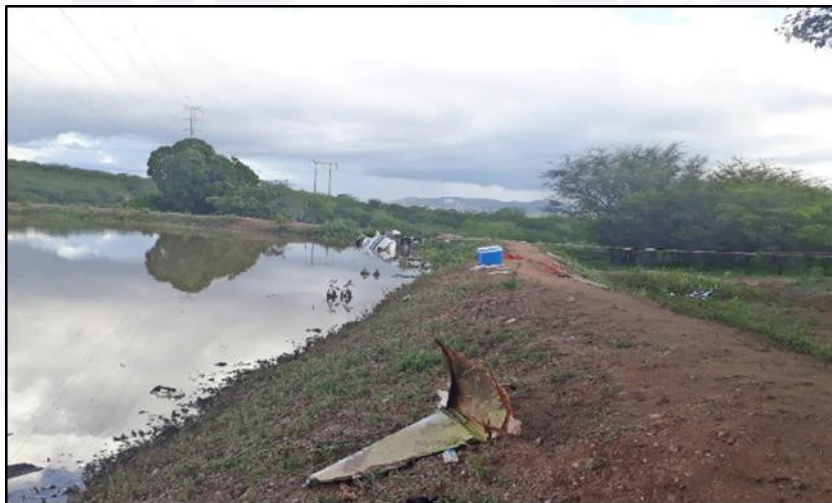
During the flight, the aircraft collided with a transmission line of TAESA (*Transmissora Aliança de Energia Elétrica S.A*) near the town of *Currais Novos*. Subsequently, the aircraft fell into a dam and sank (partially).

Figure 1 – View of the PP-MCJ at the accident site.

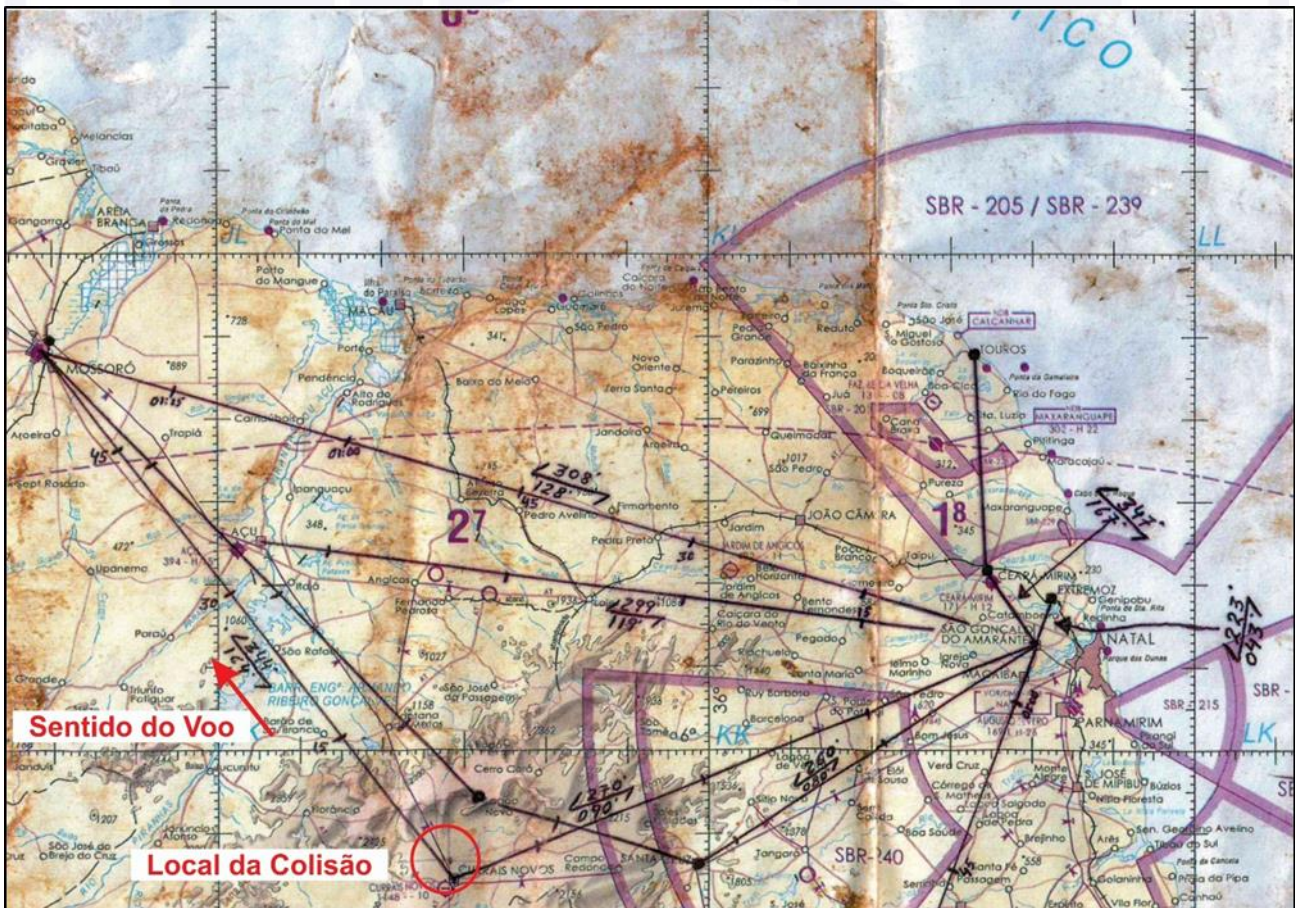
Next to the wreckage, one found the chart WAC 3018, 4th edition, from July 2004, in which the CHESF LTs were marked for purposes of flight planning. The Investigation Committee found, however, that the WAC was out of date and did not contain the mapping of the 230-kV LT that crossed with the 138-kV LT chosen for inspection.

Additionally, one verified that the chart did not have the other LT intersections marked in the planning of flights (Figure 8).

Figure 8 – Chart WAC 3018 - 4th Edition, 2004, found at the accident site.

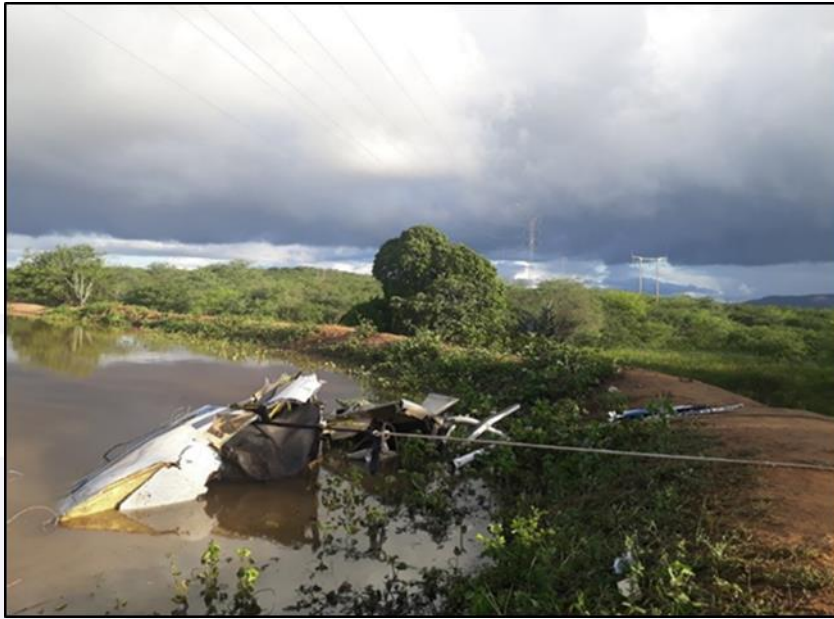
The wreckage was relatively concentrated, and was found partially submerged in the dam, and with the intermediate segment of the lightning rod attached to the aircraft (Figure 16).

Figure 16 - Aspect of the partially submerged wreckage.

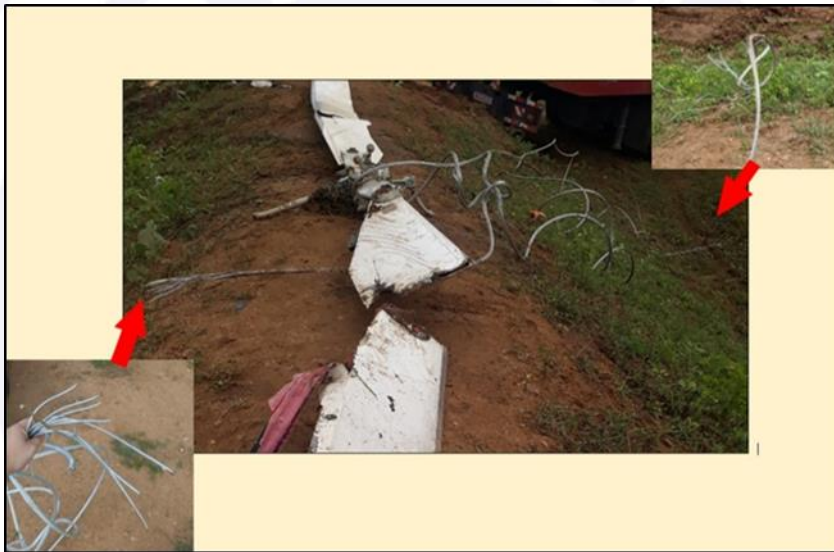
One found a broken segment of the lightning rod entangled in the main rotor (Figure 17).

Figure 17 – Lightning-rod cable segment broken in two places (highlighted ends).

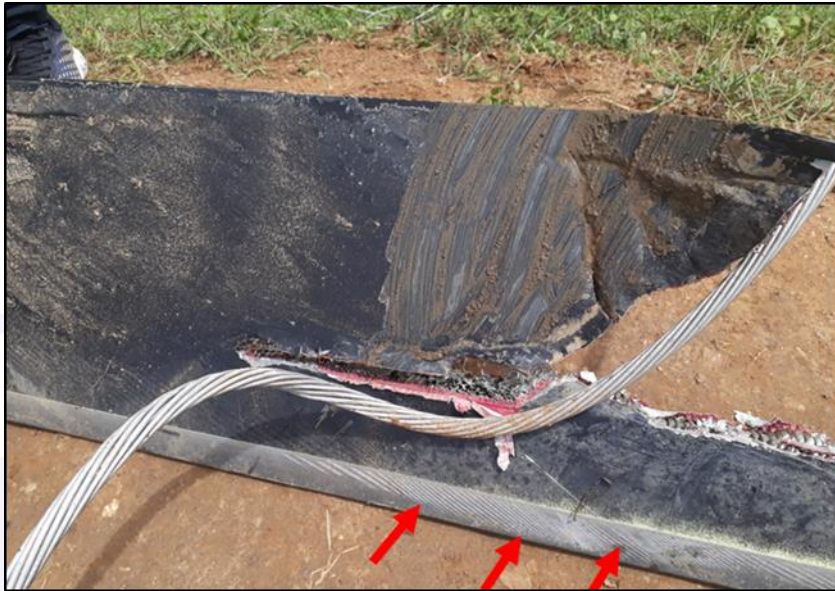
The main rotor blades showed damage and marks compatible with contact with the lightning-rod cable (Figure 18).

Figure 18 – Contact marks (grooves) between the lightning-rod cable and the leading edge of one of the main rotor blades.

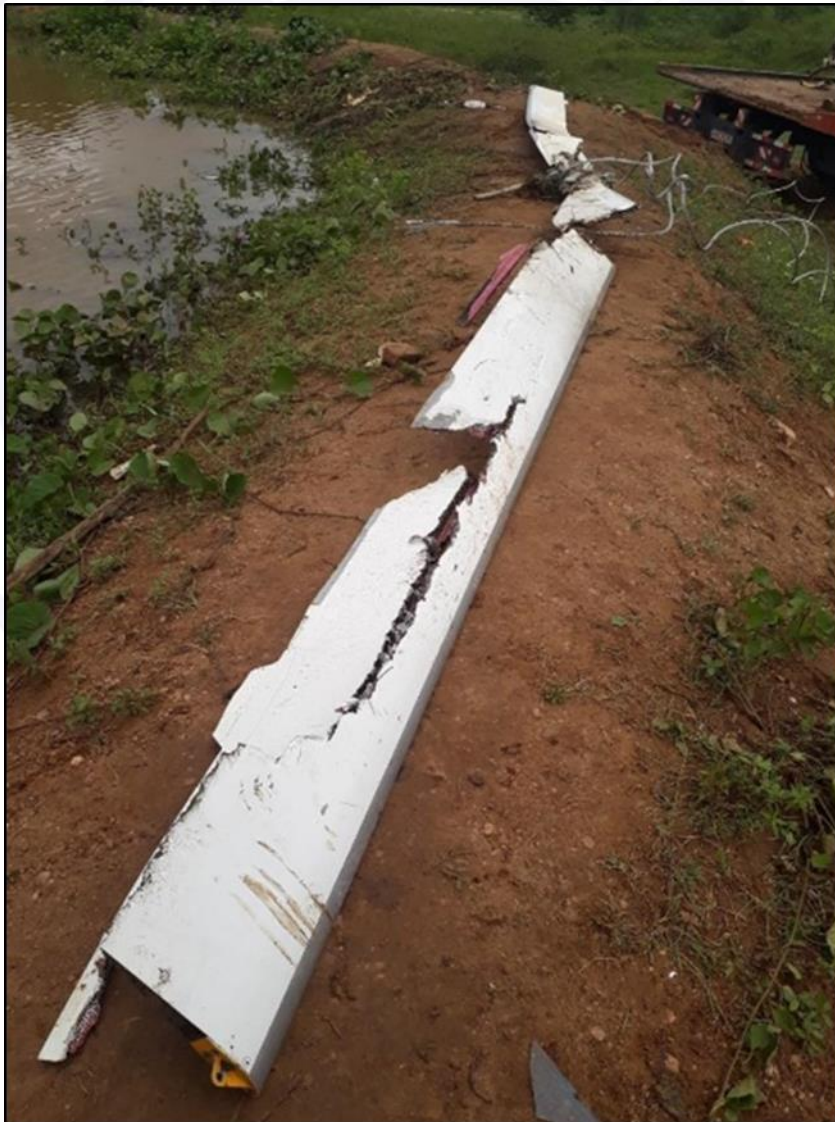
Figure 19 shows the two blades of the main rotor, with the lightning-rod cable wrapped close to the root of one of them.

Figure 19 - View of the two main rotor blades.

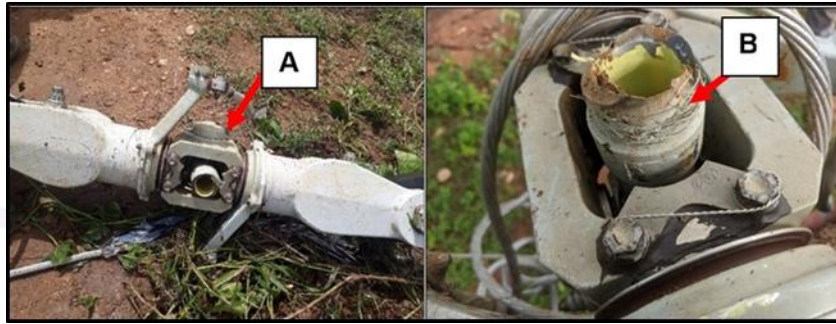
The main rotor mast was sectioned near the main rotor hub, and showed signs of rubbing against the lightning-rod cable (Figure 20).

Figure 20 - Upper segment of the sectioned main-rotor mast (A) and detail of the rubbing marks against the lightning-rod cable (B).

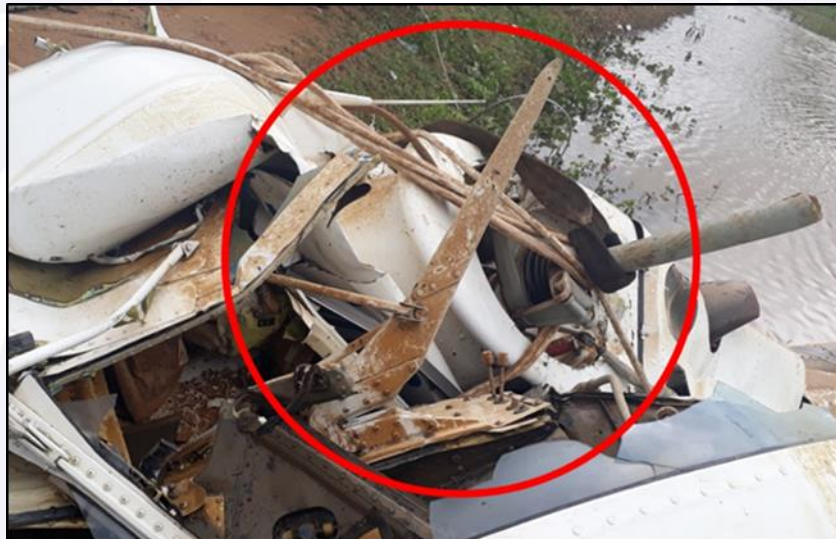
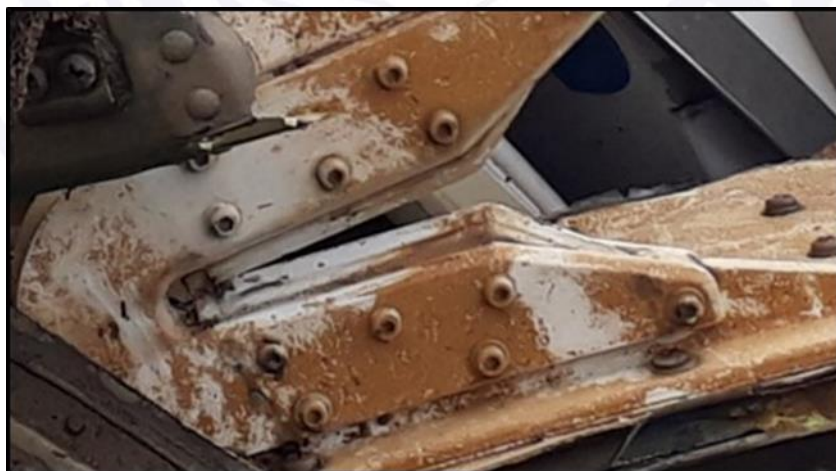
Figures 21 and 22 show that the lower wire-cutter device had no traces of contact with the cable.

Figure 21 - Detail of the aircraft's lower wire-cutter with no traces of contact with the lightning-rod cable.

Figure 22 - Enlarged image of the aircraft's lower wire-cutter.

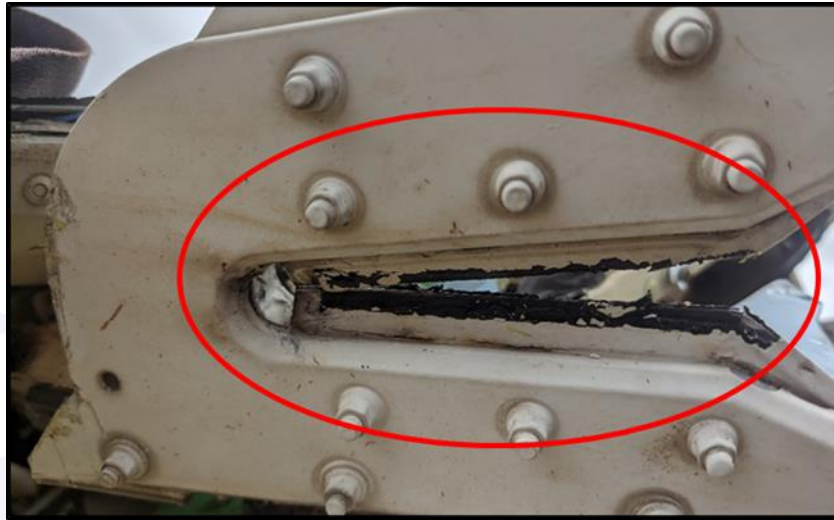
The helicopter's upper wire-cutter showed evidence of contact with the LT lightning-rod cable (Figure 23).

Figure 23 - Upper wire-cutter with evidence of contact with the lightning-rod cable.

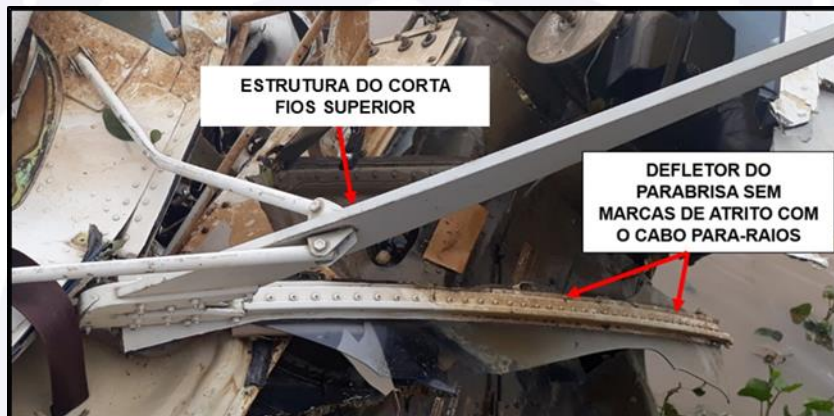
The central deflector on the aircraft's windshield did not show any marks of contact with the lightning-rod cable (Figure 24).

Figure 24 - General view of the upper wire-cutter with the central deflector of the windshield.

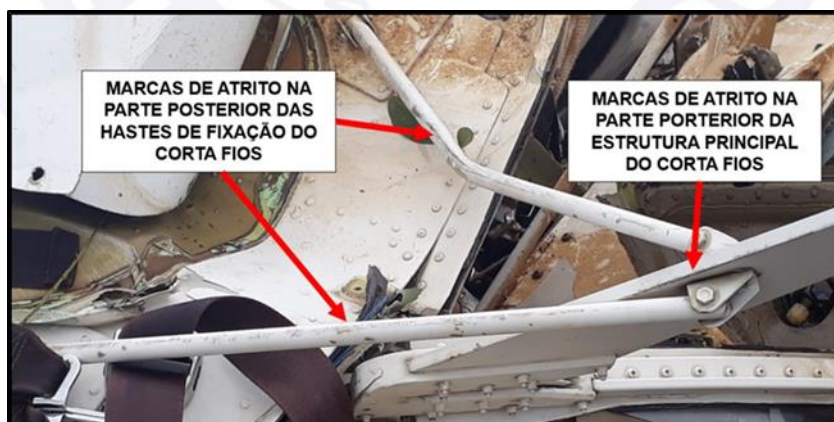
The rear part of the central structure, as well as the attachment rods of the upper wire-cutter, showed signs of contact with the lightning-rod cable (Figure 25).

Figure 25 - General condition of the upper wire-cutter.

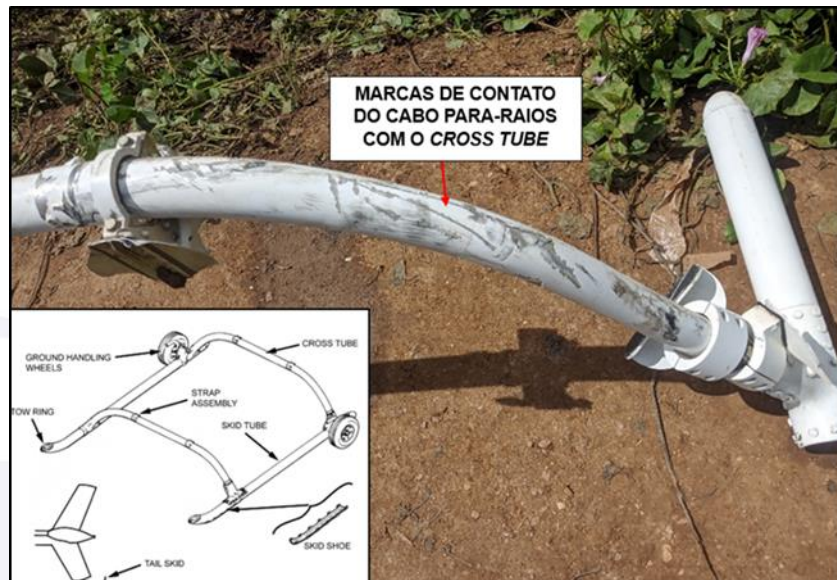
The left side of the rear skid cross tube showed signs of friction with the lightning-rod cable (Figure 26).

Figure 26 – Lightning-rod cable markings on the rear cross tube.

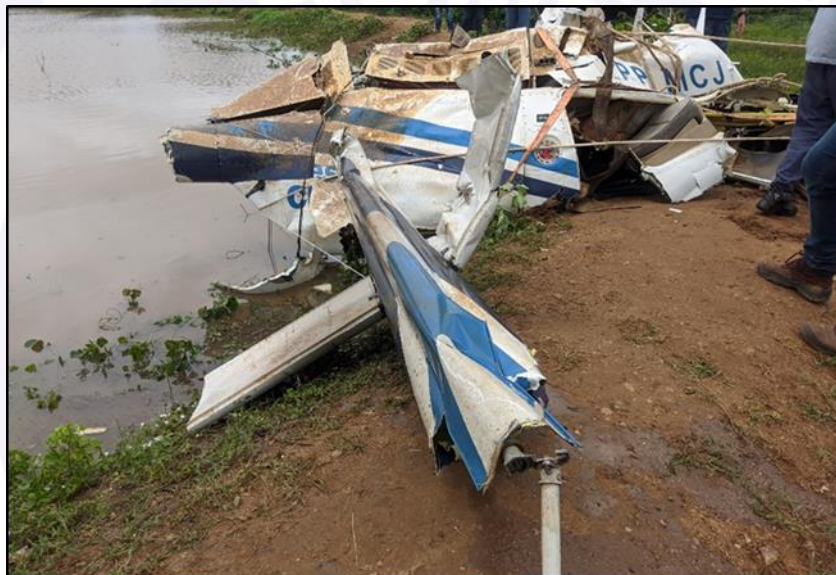
There was substantial damage to the left-hand horizontal stabilizer, with sectioning of the tail cone and tail rotor transmission shaft (Figure 27).

Figure 27 - Damage to the left-hand horizontal stabilizer, with sectioning of the tail boom and tail-rotor transmission shaft.

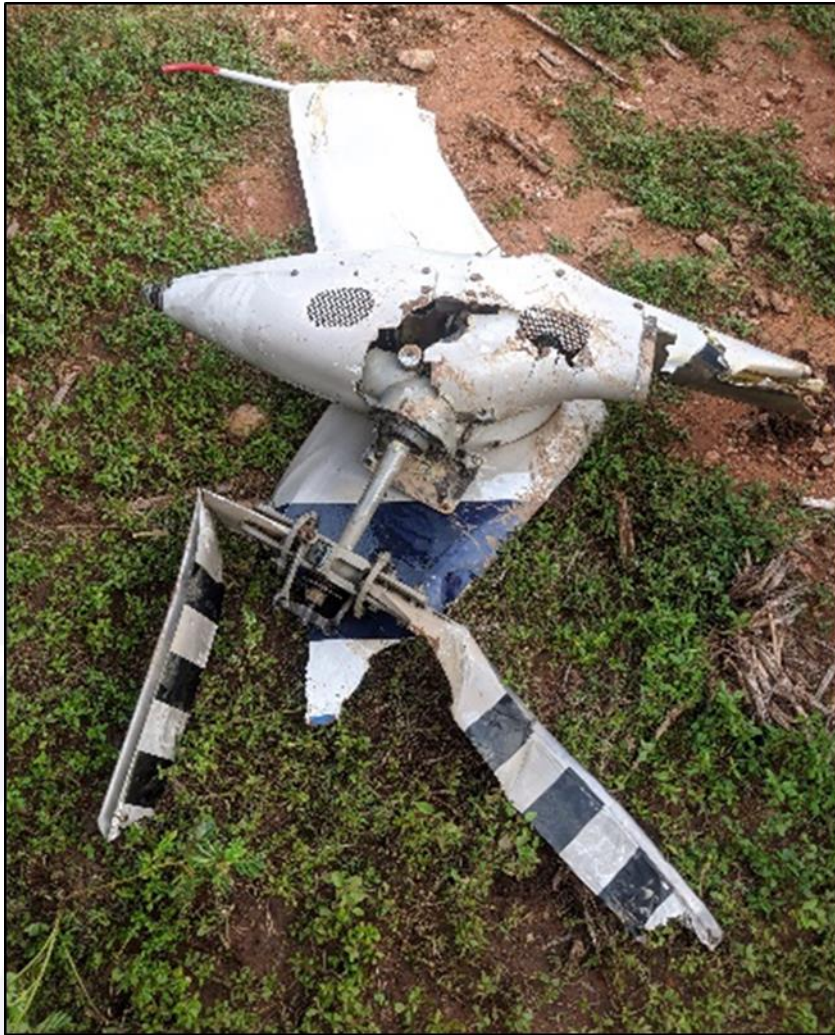
Figure 28 shows the damage to the tail rotor and the separation of the transmission box.

Figure 28 - View of the tail rotor and transmission box.

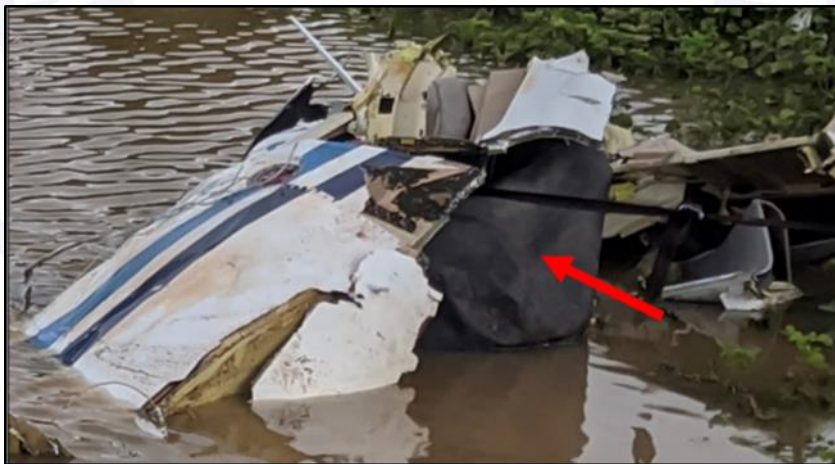
The aircraft's fuel tank sustained rupture (Figure 29).

Figure 29 – Aircraft debris, with the fuel tank in highlight.

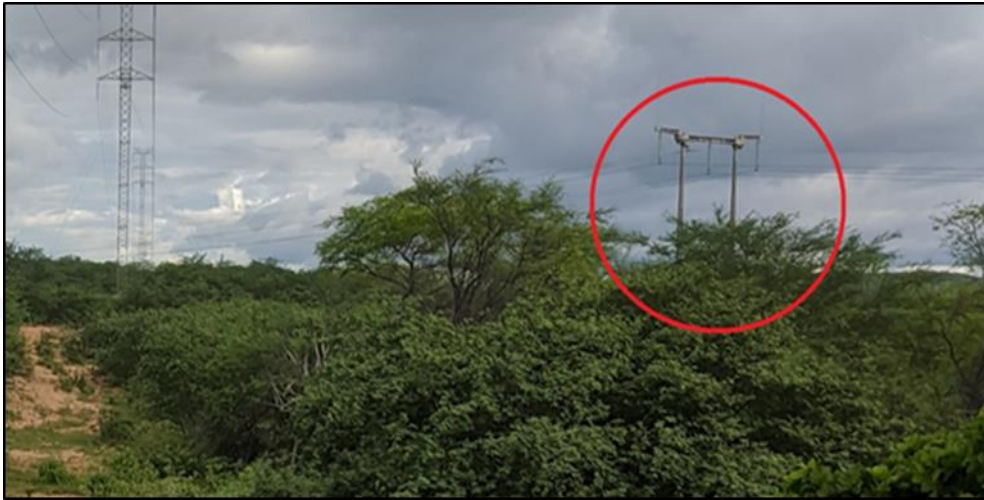
The Investigation Committee verified that, in the vicinity of the intersection of the transmission lines where the accident occurred, the 138-kV LT towers were not signalized by painting in accordance with the criteria of the ABNT NBR 6535:2005 (Figure 32).

Figure 32 – Vicinity of the intersection of the 138-kV with the 230-kV transmission lines, highlighting the lack of signage on the tower (support) of the 138-kV LT.

With respect to the painting of the unmarked towers close to the intersection, the Investigation Committee was informed by a DOSPA representative that, on account of an agreement signed by the companies, the operator of the 230-kV LT would be responsible for signaling (painting) the towers (supports) of the 138-kV LT existing on the location, based on the criteria of the ABNT NBR 6535:2005.

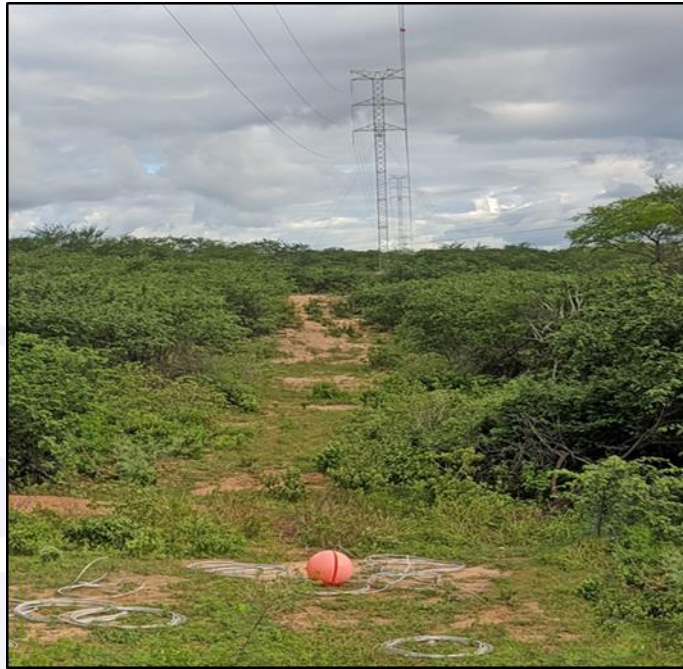
At the collision with the transmission line, the 230-kV TL warning sphere number 1 fell to the ground due to breakage of the lightning-rod cable (Figure 35).

Figure 35 – Aircraft warning sphere nº 1 on the ground, due to breakage of the lightning-rod cable of the 230-kV LT.

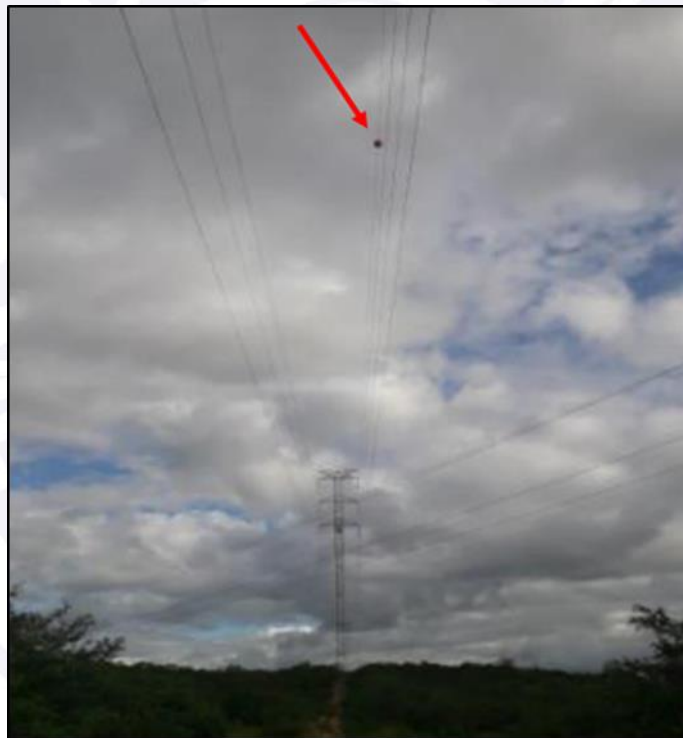
In turn, the warning sphere nº 2 remained in its position at the intersection (Figure 36).

Figure 36 - Warning sphere nº 2 of the 230-kV LT

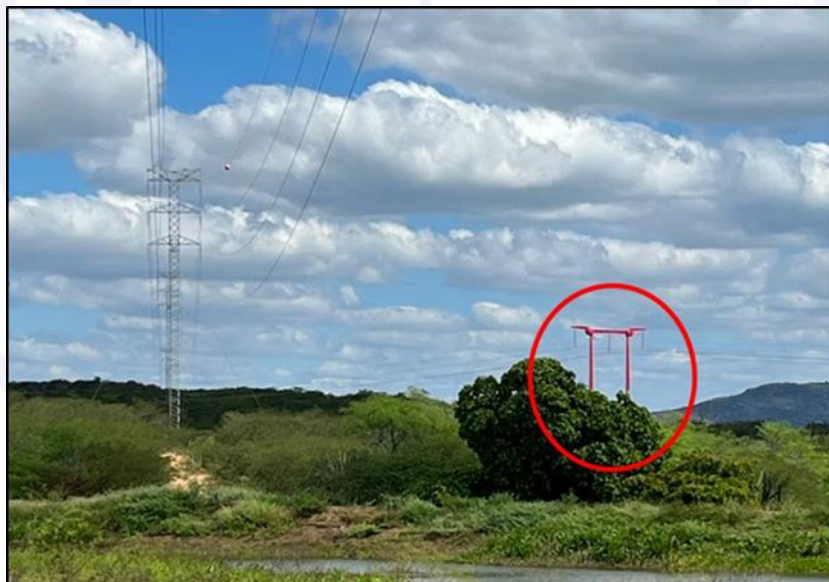
Figure 39 - Painting of 138-kV LT supports (towers), after the accident.

After the accident, the towers of the 138-kV LT were signaled by means of painting near the intersection with the 230-kV LT, as recommended in the ABNT NBR 6535:2005 (Figure 39).
