**FINAL REPORT**  
**IG - 145/CENIPA/2016**

<b>OCCURRENCE:</b>	<b>SERIOUS INCIDENT</b>
<b>AIRCRAFT:</b>	<b>PP-MHJ</b>
<b>MODEL:</b>	<b>PZL-SW4</b>
<b>DATE:</b>	<b>08NOV2016</b>

This is the Final Report of the 08NOV2016 serious incident with the PZL-SW4 aircraft, registration PP-MHJ. The serious incident was classified as “[SCF-NP] System/Component Failure or Malfunction Non-Powerplant – with windshield / window / door”.

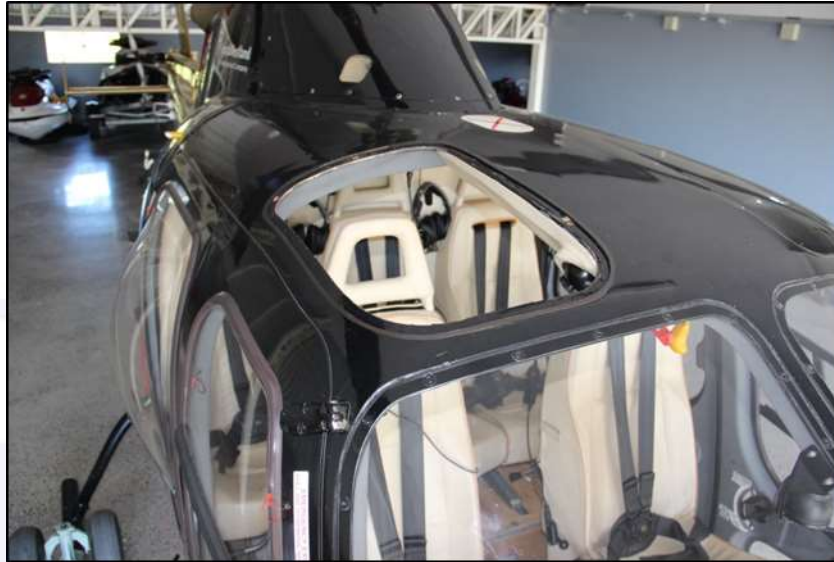
Figure 1 - View of the aircraft damage.

The aircraft had minor damage. The damages were limited to the loss of the upward vision window right.

Upward vision window right was not found.

The aircraft was not damaged, apart from the loss of the upward vision window right.

When checking the opening in which the upward vision window was installed, it was found that the residue from the glue used for the fixture had remained in place.

The upper right window had been replaced on the last inspection of the aircraft following the procedure described in the maintenance manual, except for the replacement of the adhesive element, using the Essex U-438RF instead of the Betaseal 1407.

This way there is the possibility that the detachment of the upper right window would be associated with the use of a sealant not prevised in the maintenance manual of the aircraft manufacturer, together with a possible non-compliance with the exchange of the upper right window procedure.

Act with the Agusta Westland do Brasil Ltd. shop (COM N ° 0001-02 / ANAC), in order to demonstrate that it possesses and applies all the necessary resources for the adequate provision of maintenance services on PZL-SW4 aircraft manufactured by PZL-SWIDNIK, as recommended by regulations, the manufacturer's technical manuals, and the company's Capabilities List, which accompanies the Maintenance Organization Certificate.
