**COMANDO DA AERONÁUTICA**  
**CENTRO DE INVESTIGAÇÃO E PREVENÇÃO DE**  
**ACIDENTES AERONÁUTICOS**

**FINAL REPORT**  
**A - 065/CENIPA/2019**

<b>OCCURRENCE:</b>	<b>ACCIDENT</b>
<b>AIRCRAFT:</b>	<b>PP-MMG</b>
<b>MODEL:</b>	<b>AS 350 B3</b>
<b>DATE:</b>	<b>24APR2019</b>

This is the Final Report of the 24APR2019 accident with the AS 350 B3 aircraft model, registration PP-MMG. The accident was classified as “[LOC-I] Loss of Control in Flight”.

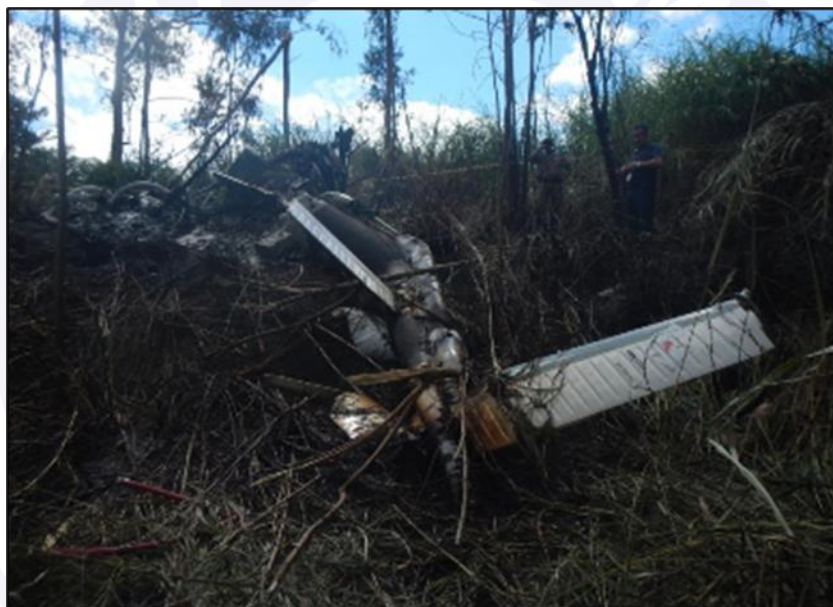
The aircraft was destroyed by fire.

Figure 1 - View of the PP-MMG destroyed by fire after the accident.

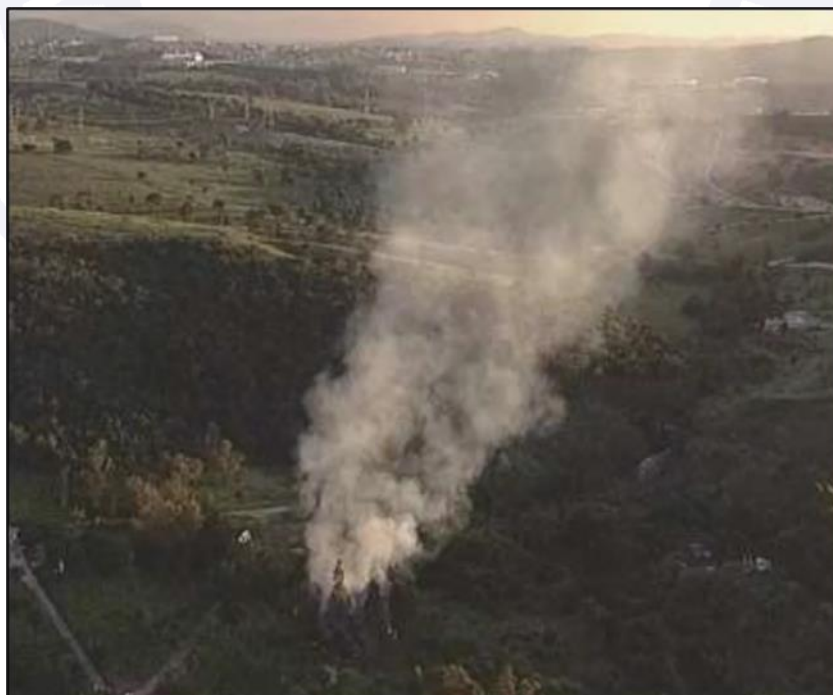
The fire broke out after the total stop. The fire was not controlled, and the aircraft had a large part of its structure and components consumed by the fire (Figure 4).

Figure 4 - Aerial view of the accident site, with the presence of fire.

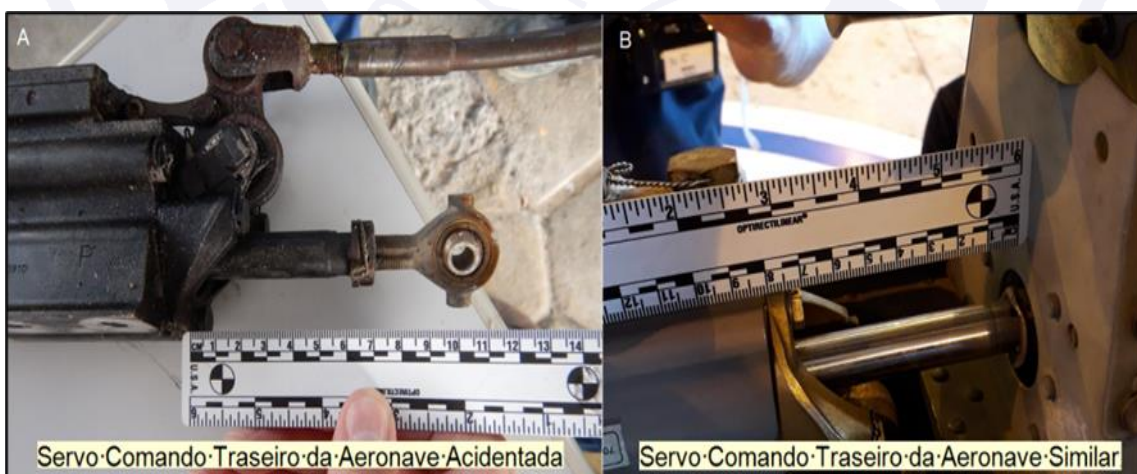
After disassembling the tail rotor, relevant marks were observed on the stops, which showed the command to the right. Additionally, the rear servo control was analyzed, and it was locked due to the action of the fire, with its rod extended 10 cm.

For comparison, the right pedal command was performed on a similar aircraft. After measuring the aircraft's rear servo control rod, it was observed that it also had an extension of 10 cm (Figures 5 A and B).

Figure 5 A and B - Position of the command servos.

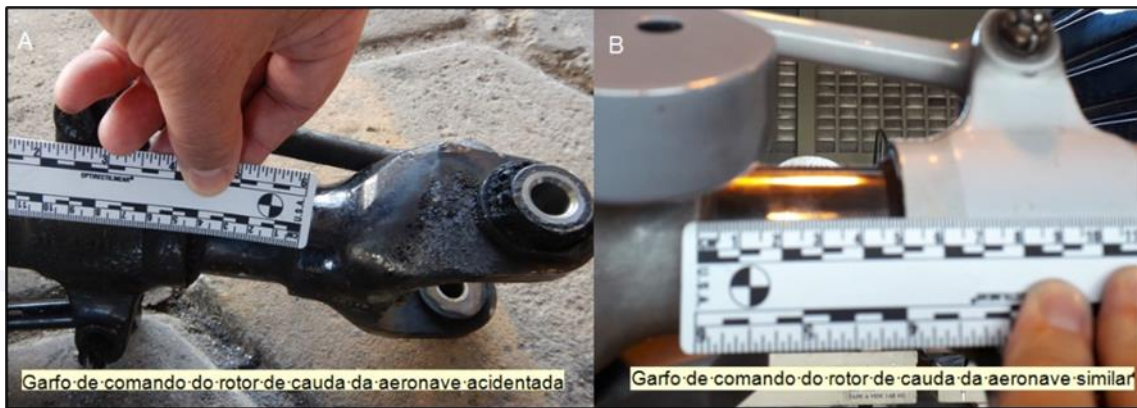
In addition to this measurement, the tail rotor drive forks were locked with the same measurements (Figures 6 A and B).

Figure 6 A and B - Tail rotor control fork.

After disassembling the tail rotor fixing fork, it was found that its alignment stop was marked with an impact. This fact allowed us to conclude that the tail rotor was working at the moment of impact.

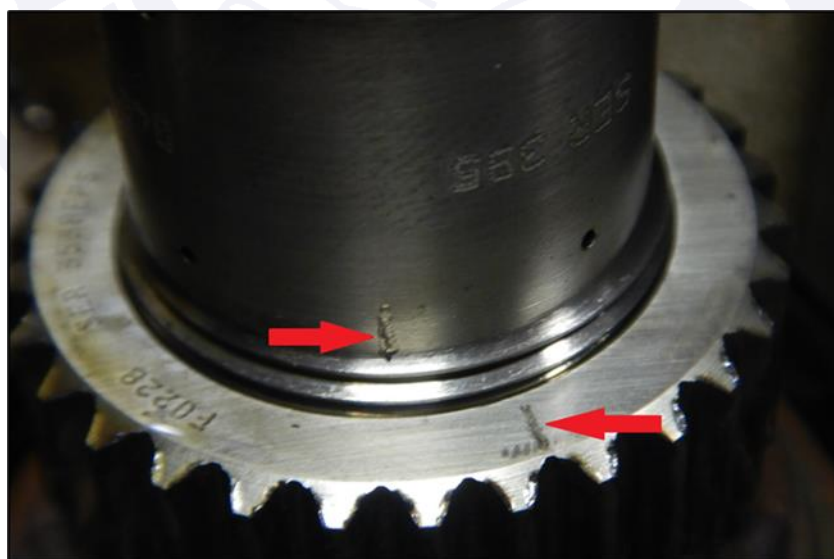
For this analysis, the module 05 was opened, and the alignment mark that existed on the drive gear and the fixing nut was verified. A misalignment of the marks was observed (Figure 7) which indicates that the engine was delivering power at the time of the impact with the ground.

Figure 7 - Misalignment marks overview.

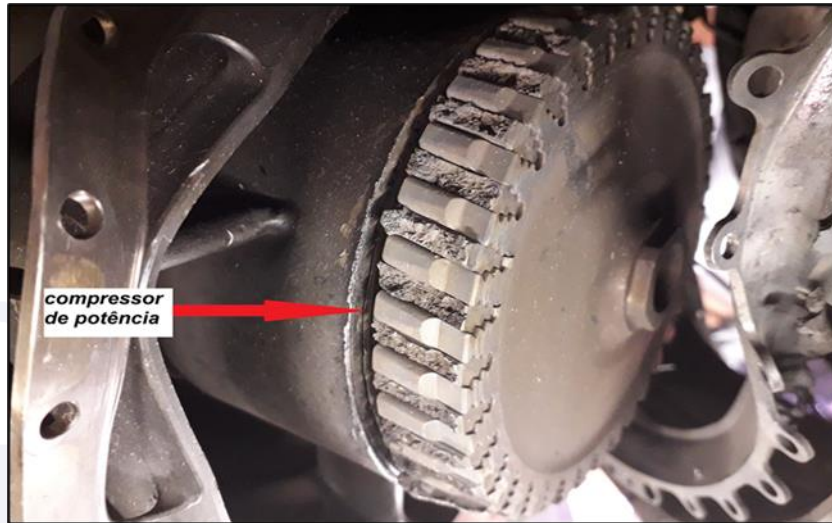
It was found that all the power turbine blades profiles were lost following blade shedding (Figure 8).

Figure 8 - Power turbine overview with loss of all the blades.

Probably, all engine damage happened due to the ground impact and the fire.

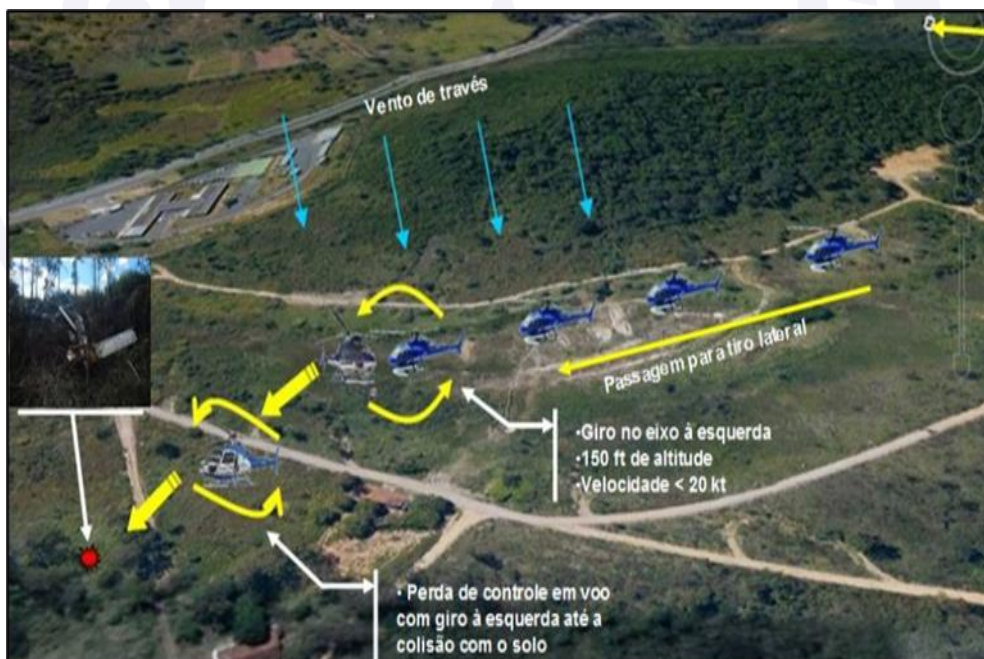
Despite this action, it was not possible to stabilize the helicopter. Also, according to the PIC, the device experienced an uncontrolled turn to the left, with a loss of height, before impacting the ground (Figure 9).

Figure 9 - Sketch of the accident. Source: adapted from Google Maps.
