**FINAL REPORT**  
**IG - 111/CENIPA/2020**

<b>OCCURRENCE:</b>	<b>SERIOUS INCIDENT</b>
<b>AIRCRAFT:</b>	<b>PP-MRA</b>
<b>MODEL:</b>	<b>AS 350 B3</b>
<b>DATE:</b>	<b>13SEPT2020</b>

This is the Final Report of the 13SEPT202 serious incident with the AS 350 B3 aircraft model, registration PP-MRA. The serious incident was classified as “[LOC-I] Loss of Control in Flight”.

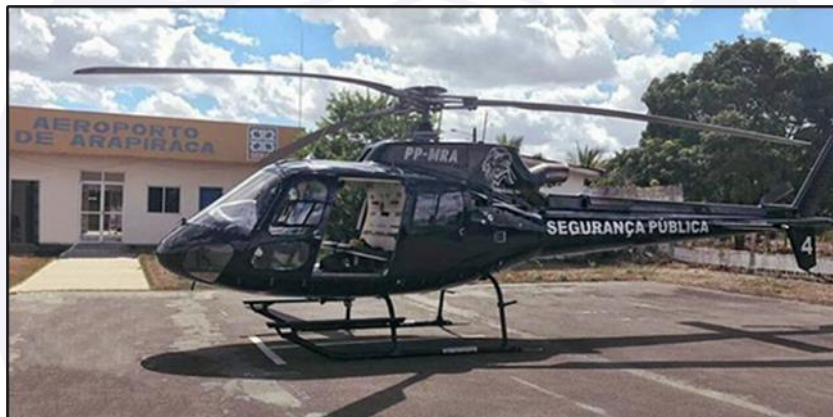
Figure 1 – The PP-MRA helicopter at the SNAL maneuvering apron.

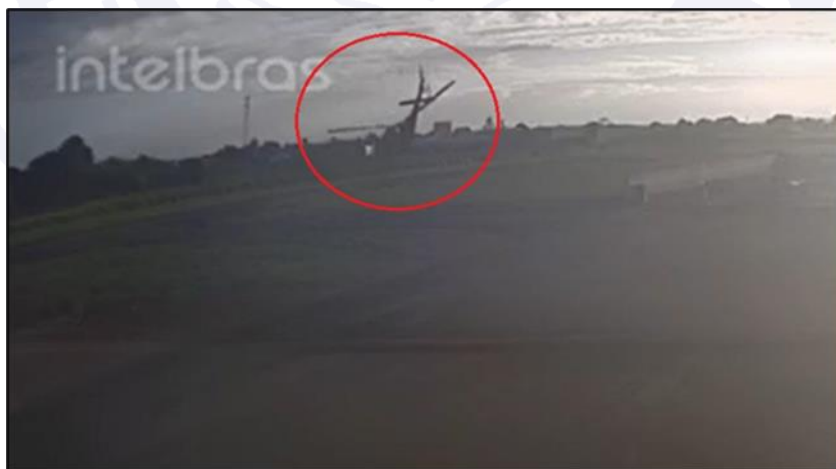
The loss of control occurred at the end of the 90° turn to the left when entering the taxiway that gave access to the apron (Figures 5 and 6).

Figure 6 - Point 4, beginning of the loss of control.

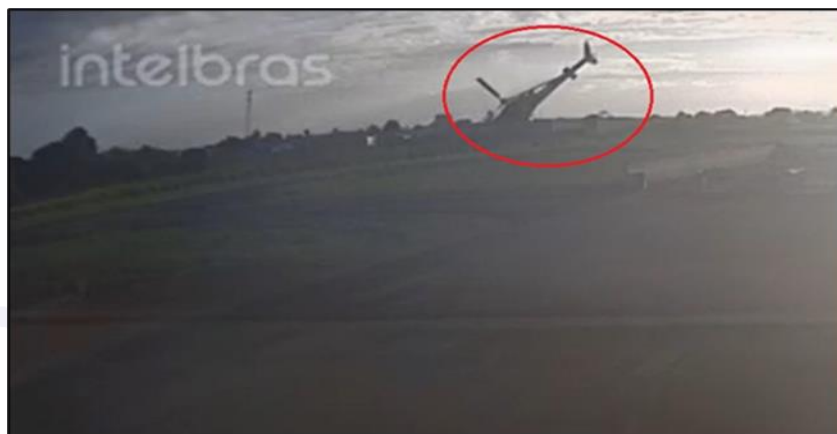
Figure 7 - Point 5, another record of the loss of control of the aircraft.

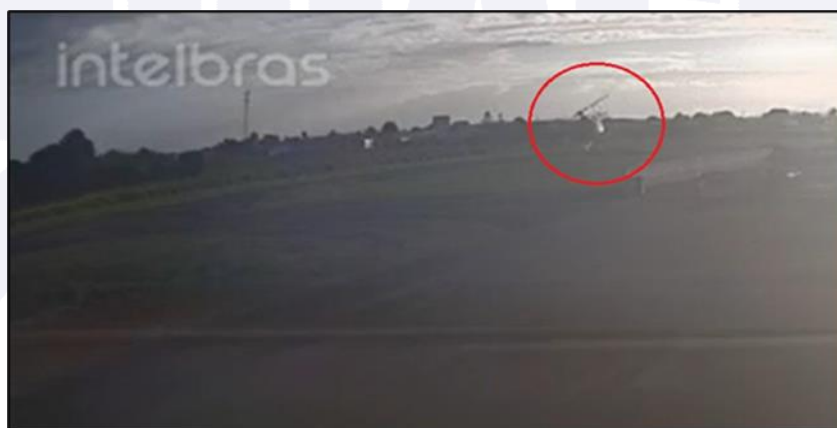
Figure 8 - Point 6, final moments of the loss of control of the aircraft.

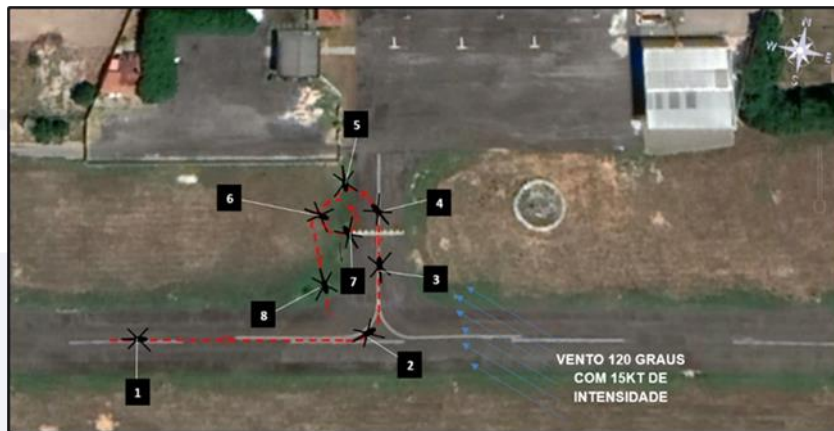
Figure 11 - Sketch of the serious incident.

- Point 1: air taxiing over the runway aiming at landing;
  - Point 2: start turning left, to enter the taxiway;
  - Point 3: air taxiing over the taxiway;
  - Point 4: the beginning of the loss of control;
  - Points 5 and 6: sequence of loss of control in-flight;
  - Point 7: Restoration of aircraft control; and
  - Point 8: aircraft returning to the runway, controlled.
- The CAESP-AL PTO, section C, page 09, of 09APR2020, Revision 02, contemplated procedures for the prevention of Loss of Tail Rotor Effectiveness (LTE).

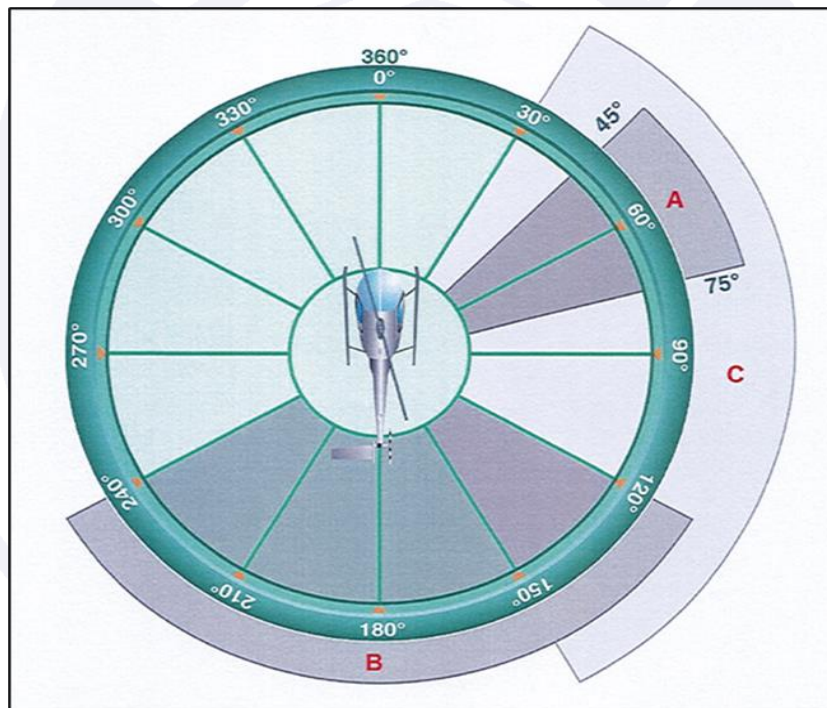
Figure 12 - LTE for helicopter with clockwise Main Rotor.

Tailwinds of  $120^\circ$  to  $240^\circ$  typically cause an increase in pilot workload (Figure 12, letter B). Given the influence of relative wind on the fuselage and vertical drift, tailwinds act as an accelerator on the yaw rate, requiring corrective pedal action to counter the aircraft's tendency to align with the wind. A delay in this correction or in controlling the desired yaw rate can initiate an accelerated turn on the vertical axis.

Relative winds of  $30^\circ$  to  $150^\circ$  (right sector) can cause the tail rotor vortex ring state to develop (Figure 12, letter B). Since the tail rotor drives the airflow from left to right (aircraft upper view), right-sector crosswinds oppose this air mass movement imposed by the tail rotor. Thus, conditions can develop for the formation of the state of vortex rings, causing a non-uniform and unstable flow in the tail rotor, with consequent oscillation of the traction of this rotor and deviations in the yaw of the helicopter.

Some conditions present contributed to the unexpected yaw, such as tailspin from the right to enter the taxiway, with right and tailwinds (Figure 12), and high gross weight with a speed ahead of less than 30 kt.

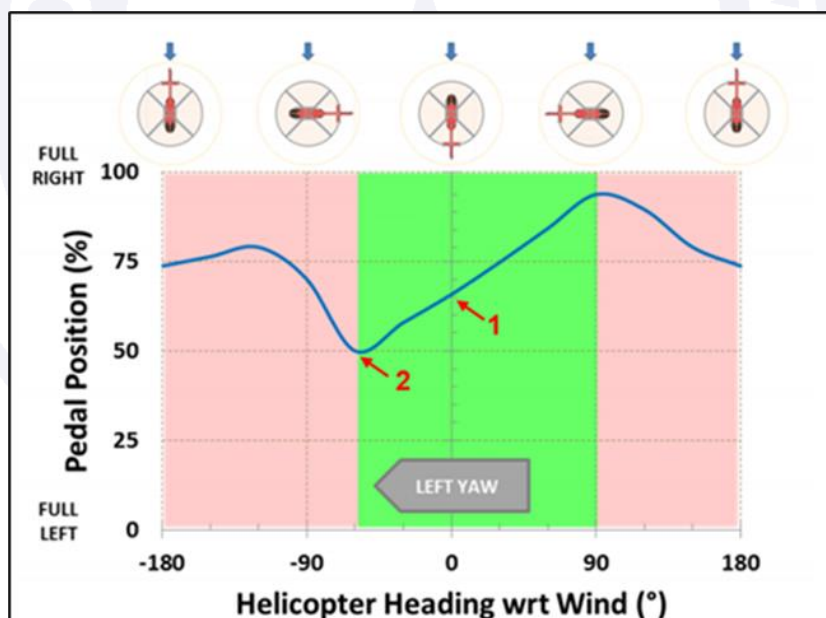
Figure 13 - Stabilized pedal position as a function of the relative wind.  
Source: Airbus Helicopters.

Regarding a helicopter with clockwise rotation of the main rotor, maintaining a hover with a relative wind of 0° (number 1 in Figure 13, wind aligned with the helicopter's heading) requires the application of about 65% pedal, i.e., with pedal a little closer to the right pedal stop (upper part of the graph) than to the left pedal stop (lower part of the graph).
