**FINAL REPORT**  
**A - 176/CENIPA/2018**

| <b>AIRCRAFT:</b> | <b>PP-MRT</b> |
| <b>MODEL:</b> | <b>PZL-106BT-601</b> |
| <b>DATE:</b> | <b>27NOV2018</b> |

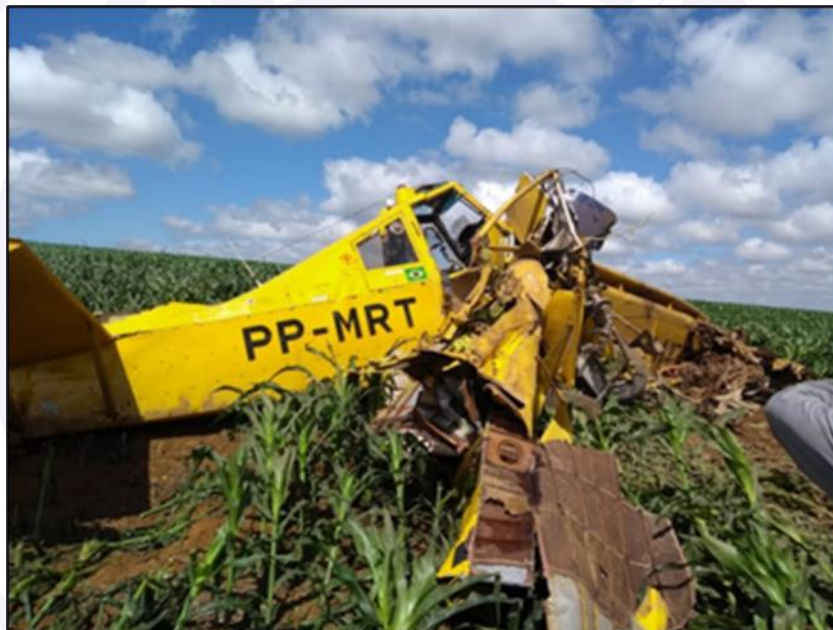
The aircraft had substantial damage, and the pilot left unharmed.

Figure 1 - Image of the aircraft after coming to a complete stop.

The aircraft had substantial damage to its entire structure.

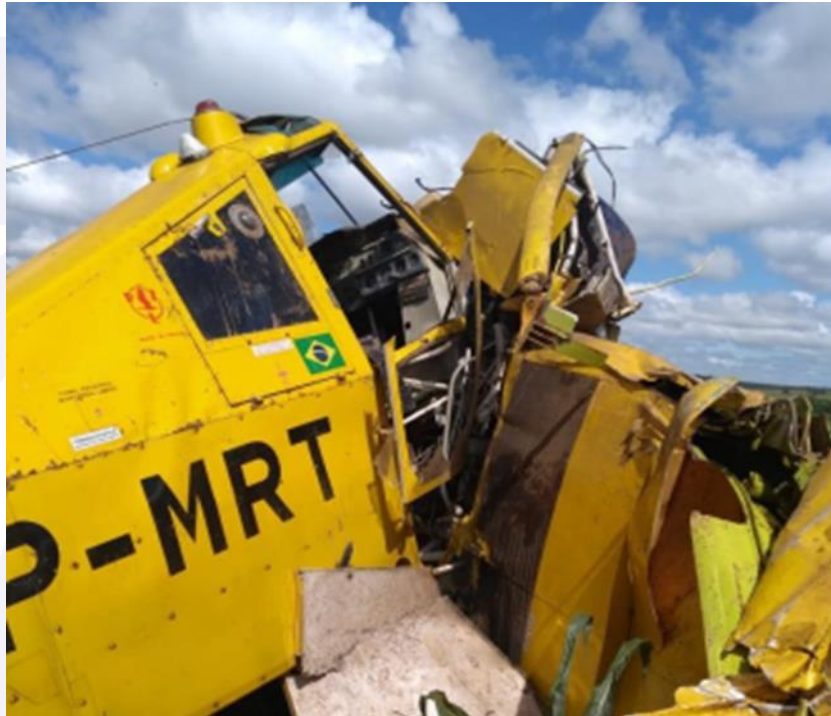
Despite the extensive damage to the aircraft fuselage, the cabin remained relatively undamaged.

The pilot abandoned the aircraft from the right side (Figure 2).

Figure 2 - Detail of the fuselage and cabin damage.

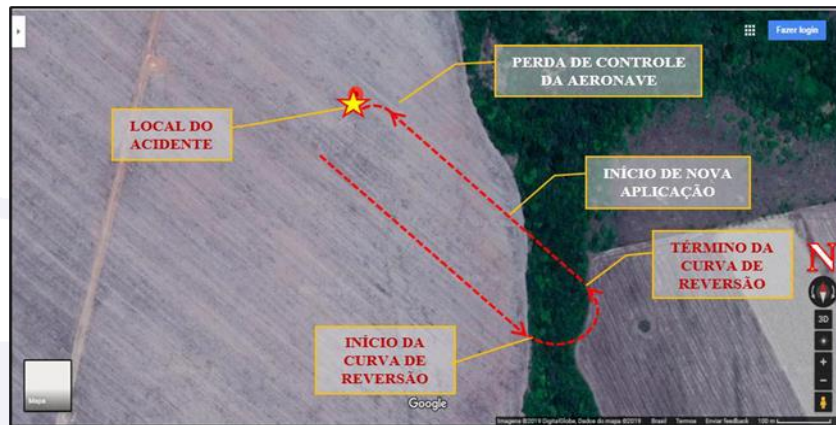
From the observation of the area and the reports collected, the investigators prepared a sketch of the occurrence. The information gathered indicated that, at the moment of loss

of control, the airplane should have been in stable flight over the plantation with a magnetic heading of 330° (Figure 3).

Figure 3 - Sketch of the occurrence.

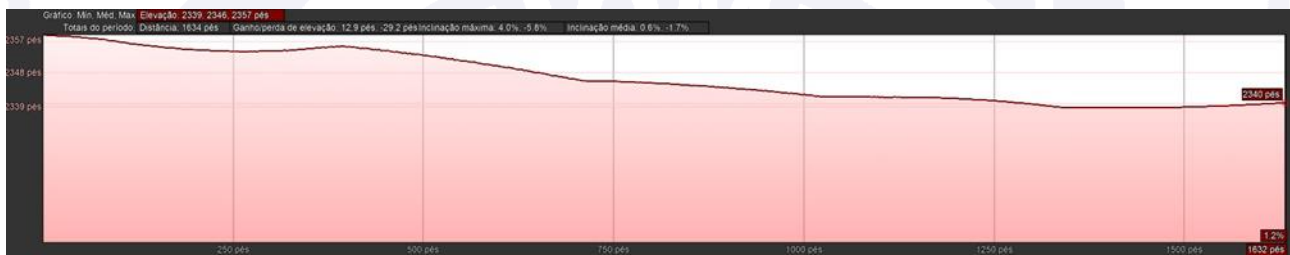
In the application axis, the terrain profile was uphill with a maximum slope of 5.8% at about 210 m from the point of impact.

Figure 4 - Vertical section of the terrain on the application axis. Source: Google Earth.

Another factor to be considered concerns the application axis, whose terrain profile was steep, with a maximum slope of 5.8% at about 210 m from the point of impact. This terrain condition, although not considered critical, could require an action on the controls to correct the height in relation to the plantation and maintain the aircraft's speed.
