FINAL REPORT
A-149/CENIPA/2020

OCCURRENCE:	ACCIDENT
AIRCRAFT:	PP-MSA
MODEL:	206B
DATE:	11DEZ2020

This is the Final Report of the accident involving the 206B aircraft, registration PP-MSA, on 11 December 2020. The accident was typified as “[CTOL] Collision with an obstacle during takeoff and landing.”

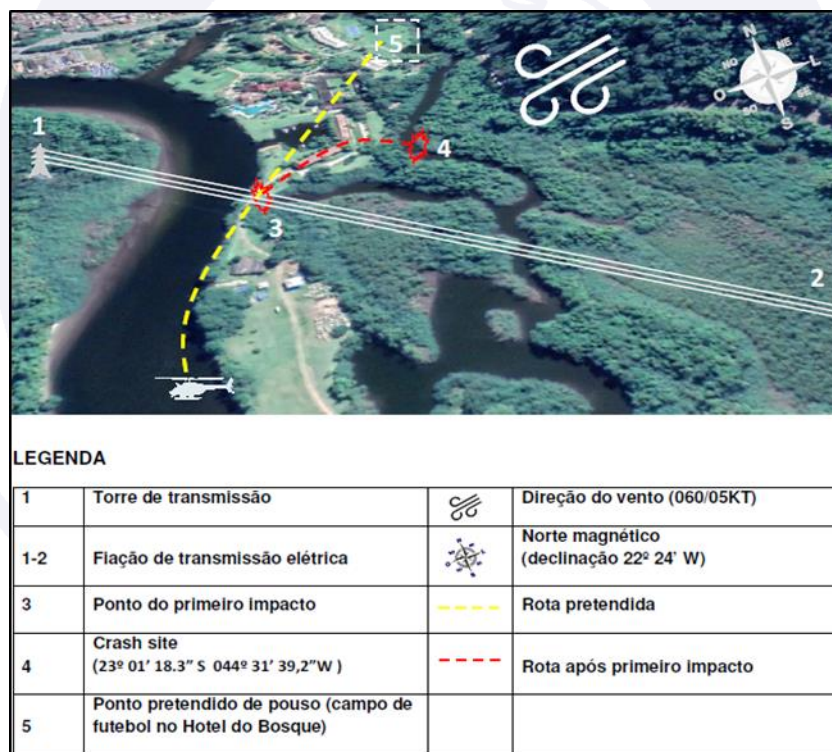
The impact between the aircraft and the high voltage transmission line occurred at 21:43 UTC, at a distance of approximately 380 m from the planned landing position at *Hotel do Bosque* (Figure 1).

Figure 1 - Croquis of the occurrence.

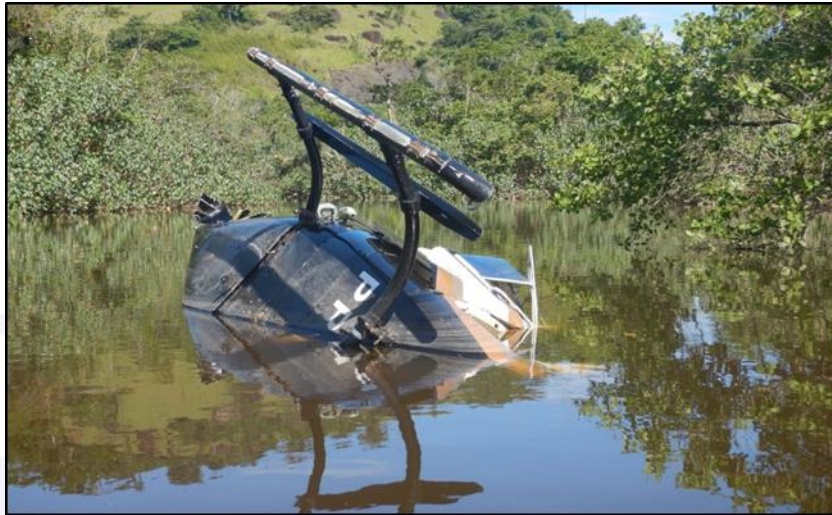
After colliding with the cables of the power transmission line, the aircraft crashed into a river and submerged (Figures 2 and 3).

Figure 2 - Final position of the PP-MSA in the river.

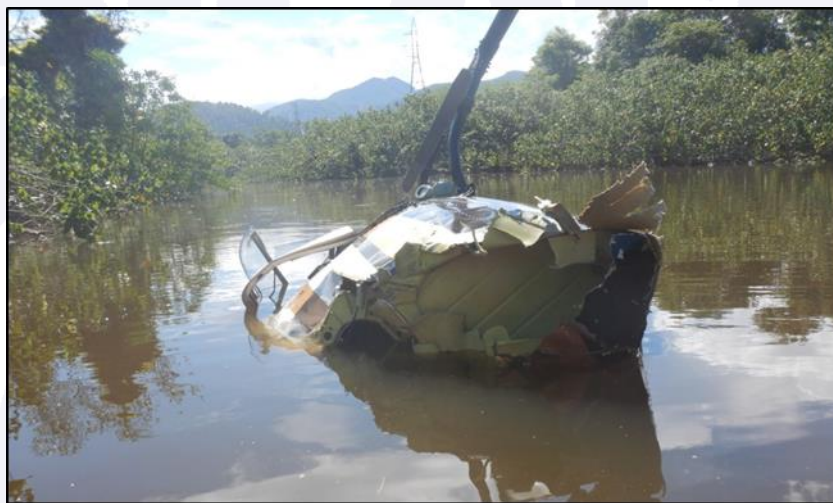
Figure 3 - Overview of the damage sustained by the helicopter (detail of the transmission line towers in the background).

The aircraft's main rotor and engine separated at the impact with the riverbed, and remained close to the airframe in the crash site.

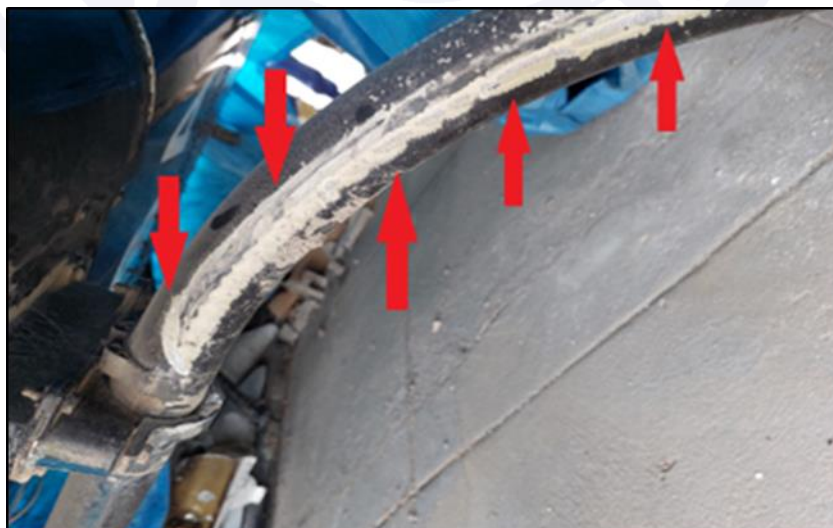
On the aircraft skids, it was possible to observe points of impact with the cables of the power transmission line (Figure 4).

Figure 4 - Marks of the impact against the transmission line cables.

Near that location, the wreckage of the PP-MSA was located. The helicopter had marks on the skids resulting from the impact against the cables of the transmission line. The aircraft was at a distance of about 200 m from the intended landing site (*Hotel do Bosque*).
