COMANDO DA AERONÁUTICA <u>CENTRO DE INVESTIGAÇÃO E PREVENÇÃO DE</u> <u>ACIDENTES AERONÁUTICOS</u>

FINAL REPORT A - 165/CENIPA/2018

OCCURRENCE: AIRCRAFT: MODEL: DATE: ACCIDENT PP-MTX A109E 03NOV2018

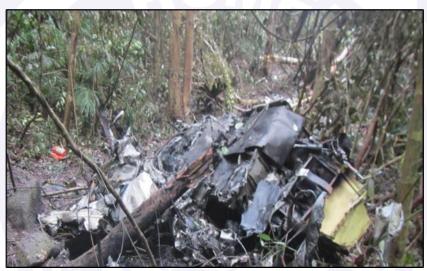
During the en-route flight, in a region under adverse weather conditions, the aircraft collided in a forest area, near the district of Quatinga, located in the municipality of Mogi das Cruzes - SP.

Figure 1- View of the PP-MTX wreckage.

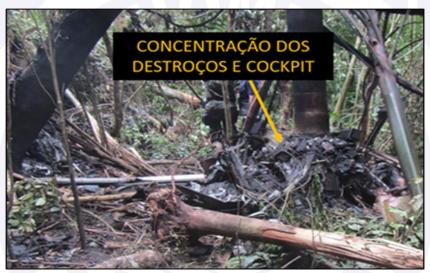
There were some trees whose trunks had greater mass, which partially broke, preventing the rest of the aircraft structure from moving across the terrain. Figure 14 shows the position of the wreckage core.

Figure 14 - Wreckage concentration.

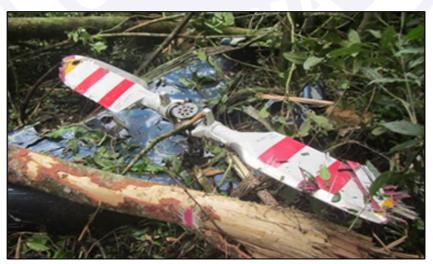
The tail rotor section was found near the first points of impact against the tallest trees and showed no marks of fire or soot (Figure 15).

Figure 15 - View of the rotor and part of the tail cone.

It was observed that the tail rotor section showed no signs of fire, soot, or smoke.

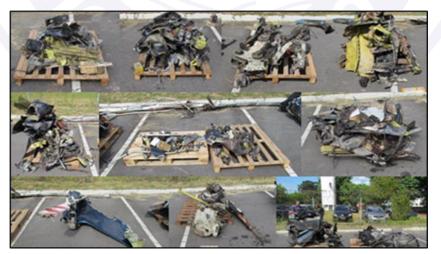
Figure 17 - Wreckage distribution.

From the analyses, it was observed that the landing gear actuation lever was in the "down" position, with no evidence of activation and use of the emergency system.

The main landing gears were found with one actuator extended and the other retracted, and the one that was retracted had damage and dents from the impact. It was not possible to identify which side (left or right) the actuators belonged to. The nose gear actuator was in the extended position.

Thus, given the degree of destruction of the aircraft caused by the impact, it was not possible to determine whether there was an attempt to lower the landing gear.

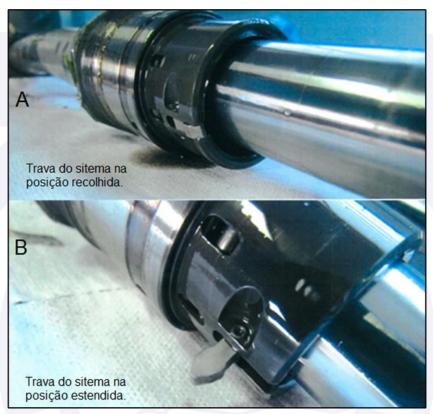
However, macroscopic examinations conducted by the Materials Division of the IAE indicated that the landing gear locking device in the extended position showed no signs of failure and that no fractures were observed in the lock (Figures 18 A and B).

Figures 18A and B - Landing gear locking system.

Thus, it was concluded that the landing gear locking system did not suffer failure or fracture.

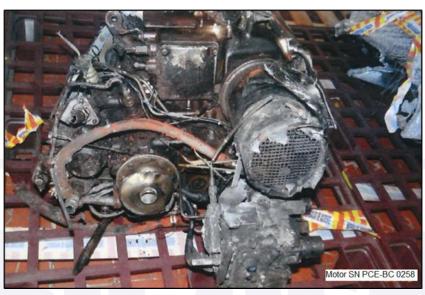
Figures 19 and 20 show that the engines were subjected to deformations and fires resulting from the impact of the aircraft on the ground.

Figure 19 - Front view of the SN PCE BC 0258 engine.

During the analysis, it was observed that the engines had damage by denting.

The severe action of the fire that followed the collision of the aircraft with the ground made it impossible to analyze the components of the engines that were exposed.

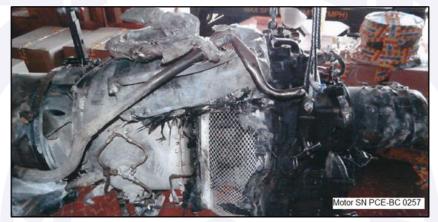
Figure 20 - Right side view of the SN PCE BC 0257 engine.

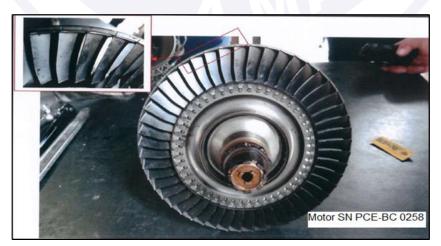
The hot sections were the ones that provided the greatest evidence of normal engine operation at the time the aircraft was involved in the accident. Rubbing marks were observed at the ends of the blades of the compressor's rotors and the power turbines, which made it possible to verify that both engines were operating normally. (Figure 21).

Figure 21 - Rear view of the power turbine rotor, highlighting the rubbing marks.
