COMANDO DA AERONÁUTICA
CENTRO DE INVESTIGAÇÃO E PREVENÇÃO DE
ACIDENTES AERONÁUTICOS

FINAL REPORT
A-133/CENIPA/2022

OCCURRENCE:	ACCIDENT
AIRCRAFT:	PP-OBL
MODEL:	AT-502A
DATE:	18NOV2022

This is the Final Report on the accident that occurred on November 18th, 2022, involving the AT-502A aircraft with registration marks PP-OBL. The occurrence was classified as “[LOC-I] Loss of control in flight and [LALT] Low altitude operation”.

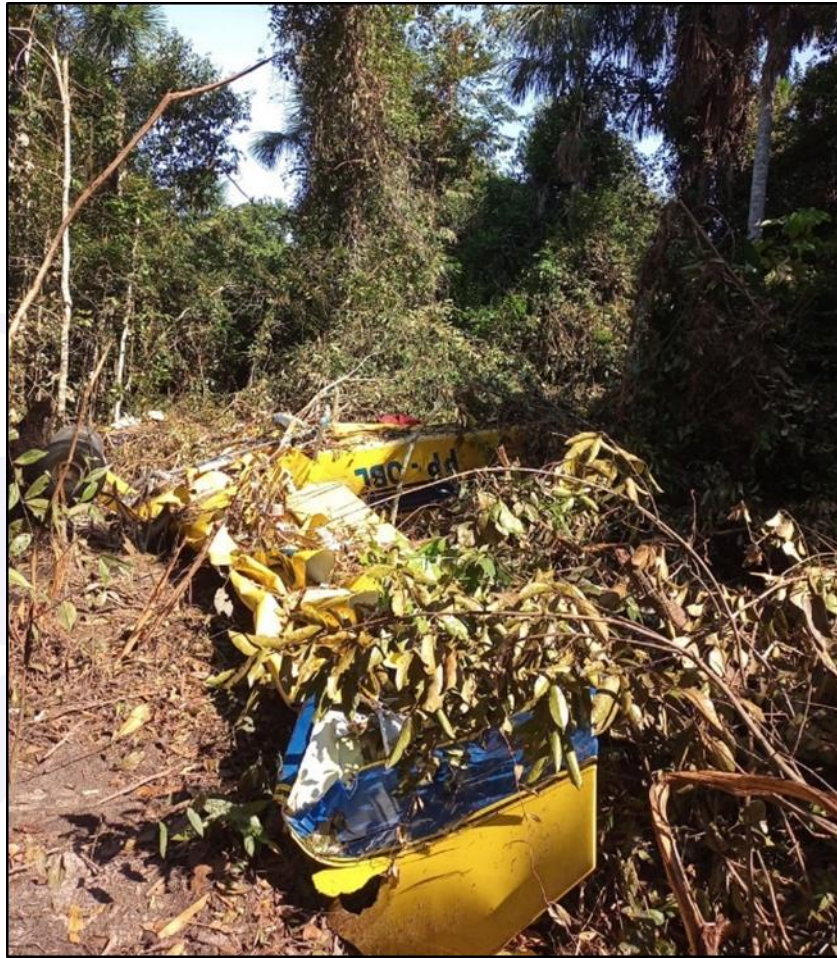
According to physical evidence, the aircraft collided with the treetops and then with the ground at a very steep angle (Figure 1).

Figure 1 – Lateral view of the aircraft wreckage and of the vegetation.

The front section of the fuselage sustained severe damage and the powerplant ended up buried in the ground.

There was wrinkling of the leading edges of the wings and significant denting in the upper part of the cockpit.

The rear section of the aircraft was relatively preserved, showing deformations resulting from deceleration and impact with the vegetation.

The longitudinal axis of the aircraft was aligned with the 260° magnetic heading and the fuselage on the ground came to rest in an upside-down position.

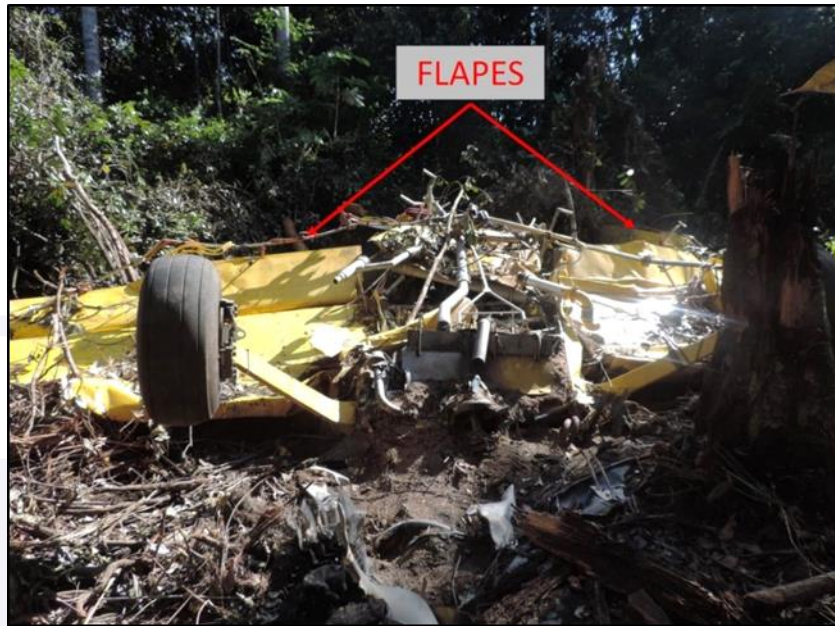
Figure 2 - Front section of the aircraft buried in the ground, and position of the flaps.

The aircraft had its flaps extended close to the 10° position, as evidenced by the visualization of a black rectangle on its extrados, as shown in Figures 2 and 3.

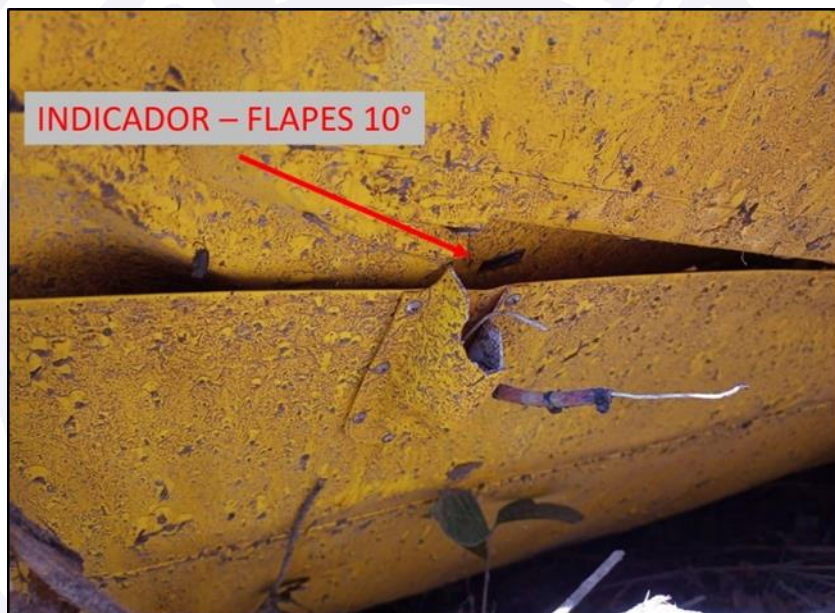
Figure 3 – Rectangular mark indicating flaps at 10° .

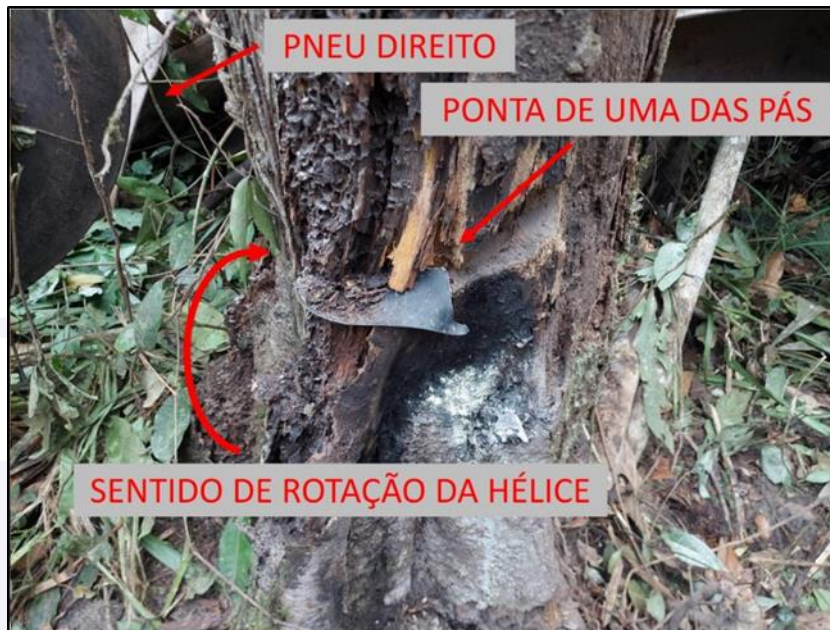
The propeller hit the trunk of a tree moments before the collision with the terrain. The tip of one of the blades was embedded in the tree trunk, and detached from the rest of the component, as shown in Figure 4.

Figure 4 - Tip of the blade of one of the propellers embedded in a tree trunk.

The level of deformation of the blade observed, the tip of which was found embedded in the tree trunk, was consistent with a rotating propeller. Its fracture, of the fragile type due to the impact, is characteristic of the imposition of high stress over a short period of time, possibly due to the conversion of the torque existing in the propeller shaft at the moment of the collision. These observations corroborated the hypothesis of the existence of power in the shaft of the propeller assembly at the moment of impact.

The physical evidence found in the accident site (linear marks on the bark of a tree juxtaposed with the tip of a propeller blade tip embedded in the tree trunk) indicated that the aircraft was developing power at the time of impact.

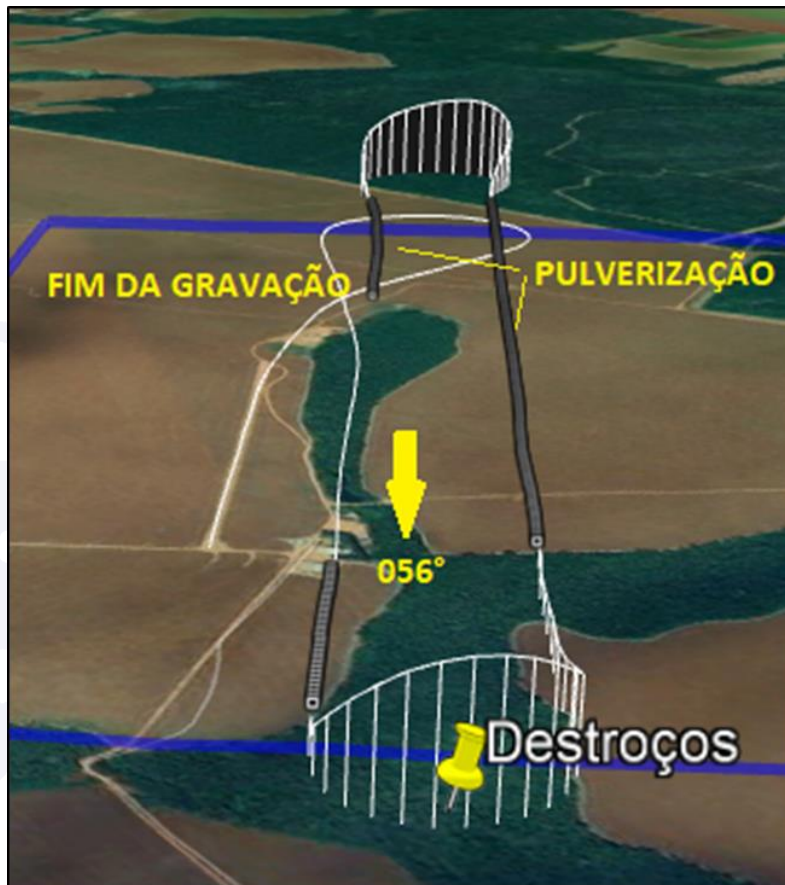
Another aspect observed during the analysis was that the moments prior to the impact were not recorded in the equipment's memory.

Figure 5 - Recorded trajectory of the accident flight.

One found that the axes of the spraying runs were generally oriented on the 056° and 236° magnetic headings, with two reversal turns made in the northeastern and southwestern sectors of the application circuit, respectively.

The circuit flown by the aircraft had a counterclockwise rotation, that is, with turns made to the left. Analysis of the flight prior to the accident showed a similar flight pattern.

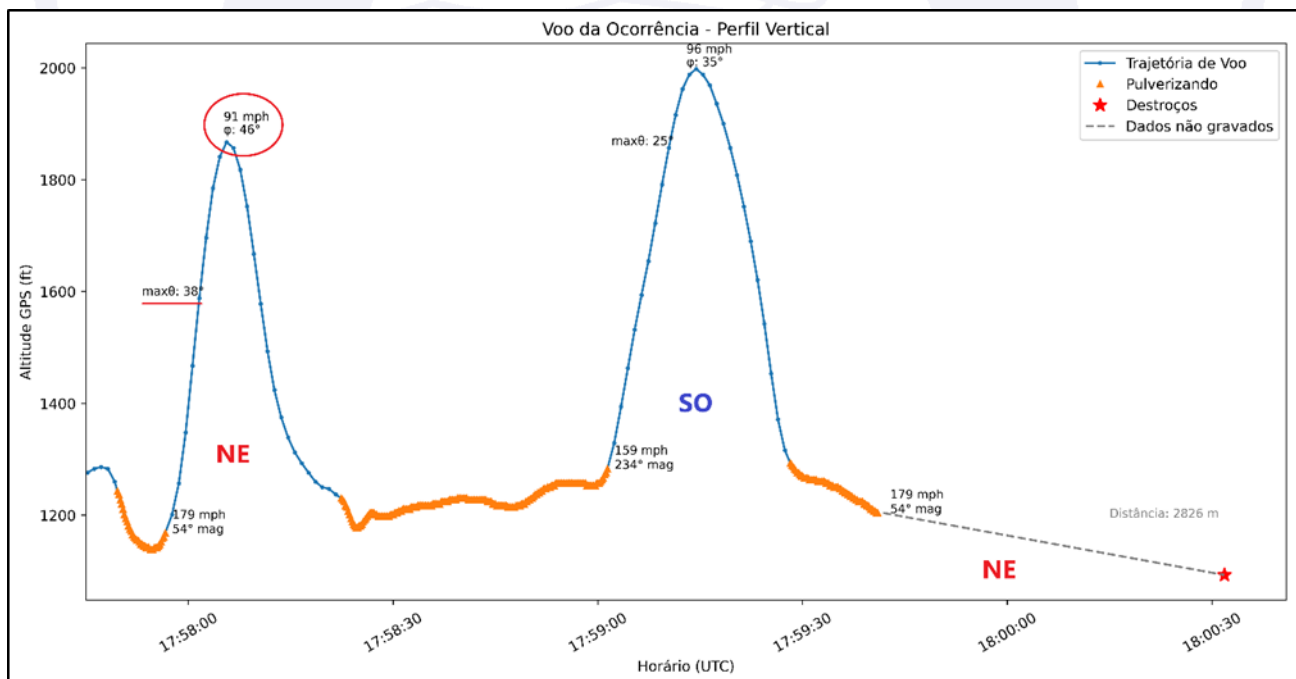
Figure 7 - Vertical profile of the accident flight.

The figure shows the speeds in miles/hour (mph), magnetic headings, and the banking of the aircraft’s wings (φ) at the beginning and at the top of the reversal curves. The maximum climb attitudes reached in each of these maneuvers ($\max\theta$) were also represented.

It was also observed that the initial speed of the first reversal turn was 20 mph higher than the second one, however, the speed reached at the top was 7 mph lower. Thus, it was considered that the use of a very steep attitude contributed to the observed decrease in speed.

Still regarding the flight performance at the top of the northeastern turn, it was observed that the recorded speed was 91 mph and that the estimated wing banking was 46° .

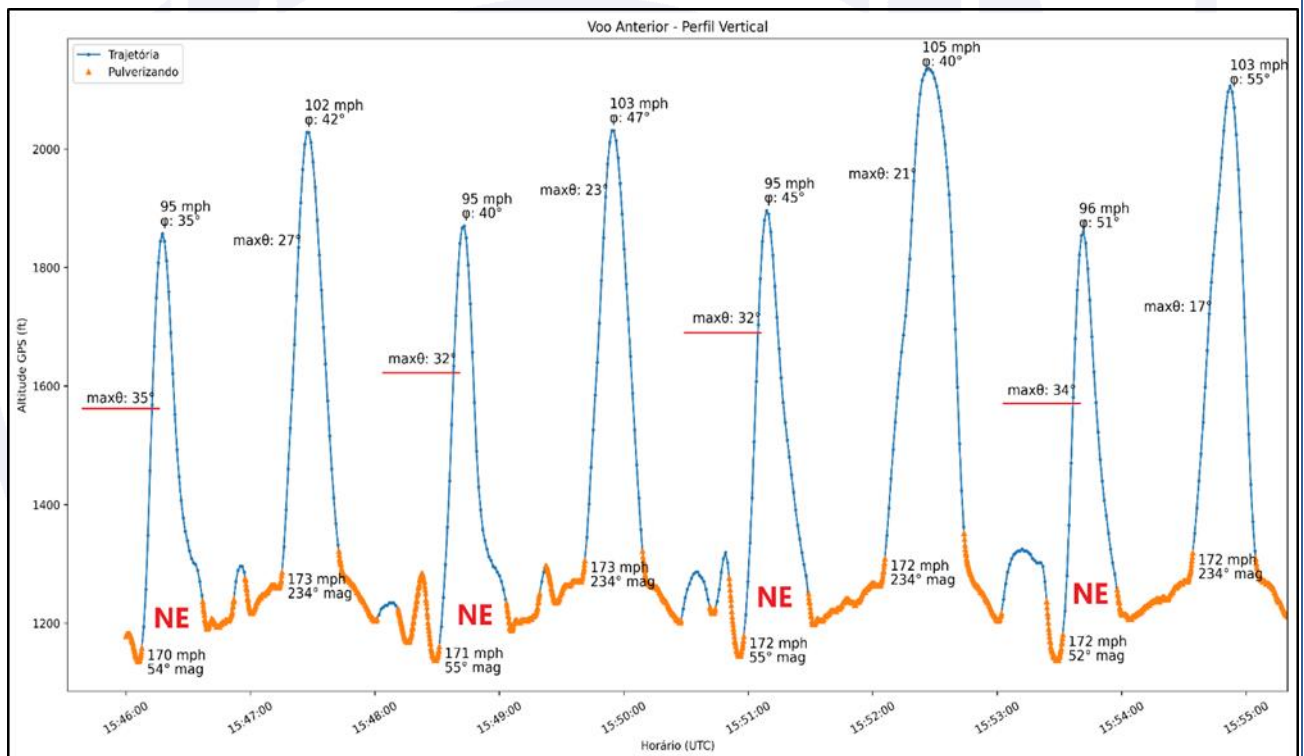
The analysis of the previous flight showed that in the last four reversal turns in the northeastern (NE) sector, climb attitudes greater than 30° were also used and that the speeds at the top of these maneuvers were significantly lower than those in the southwestern sector of the circuit (Figure 8).

Figure 8 - Vertical profile of the flight before the accident flight.

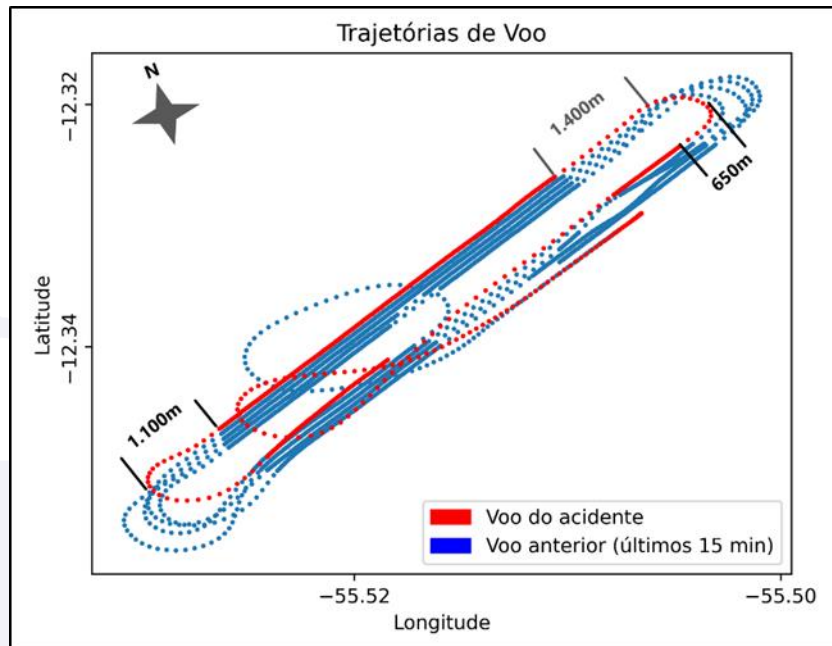
Observing the projection of the flight path on the terrain (horizontal profile), it was noted that the last five “runs” in the southwesterly direction were initiated approximately 1,400 meters ahead of an imaginary perpendicular line connecting to the spot at which the runs in the opposite direction had ended. This was due to the fact that the strip of land in question consisted of an area of thick forest and, thus, there was no need for spraying (Figure 9).

Figure 9 - Horizontal profile of the flights' trajectory.

It was also observed that, in the region of the accident, the turns to the northeast covered a shorter distance than those to the southwest. During the occurrence, for example, the distances between the start and end of the turns were 650 meters in the northeast and 1,100 meters in the southwest.

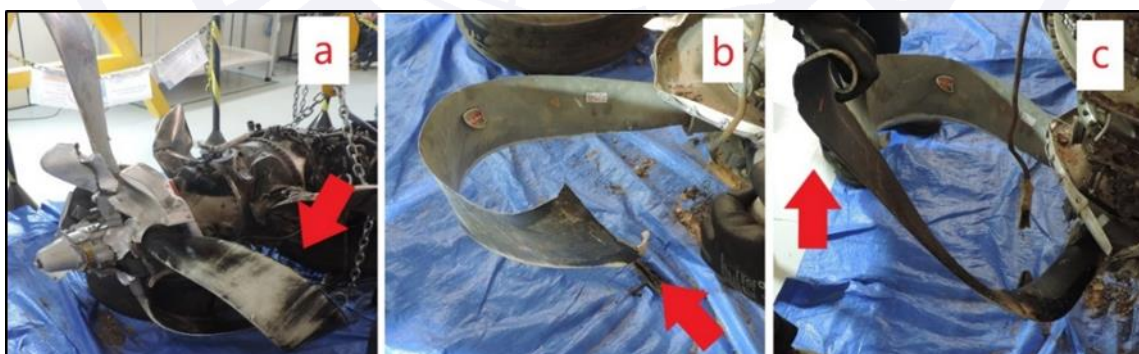
The four propeller blades had bends at their tips, as well as marks and scratches perpendicular to their longitudinal axis. Two of the blades had fractures near their tips, with part of the material having been sectioned (Figure 10).

Figure 10 - (a) propeller, general appearance and perpendicular marks; (b) blade tip severed by impact with a tree; and (c) bent blade tip.

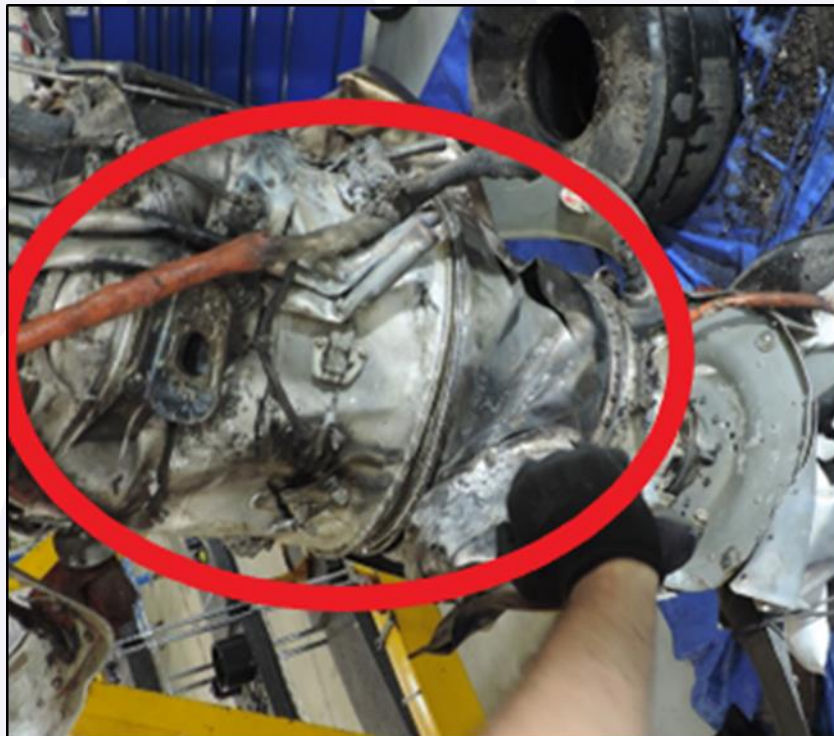
Analysis of the engine revealed severe buckling damage to the engine case, especially to the exhaust duct. This type of failure occurs in thin-walled structural elements due to the application of compression stress, possibly resulting from impact at a high angle (Figure 11).

Figure 11 - Buckling damage.

The other examinations of the engine were inconclusive from the perspective of power development due to the high level of post-impact destruction.

From the evidence found in the analysis of the powerplant, the aircraft was considered likely to have developed power until the collision with obstacles, although it was not possible to quantify either the amount of engine power or the RPM of the propeller.

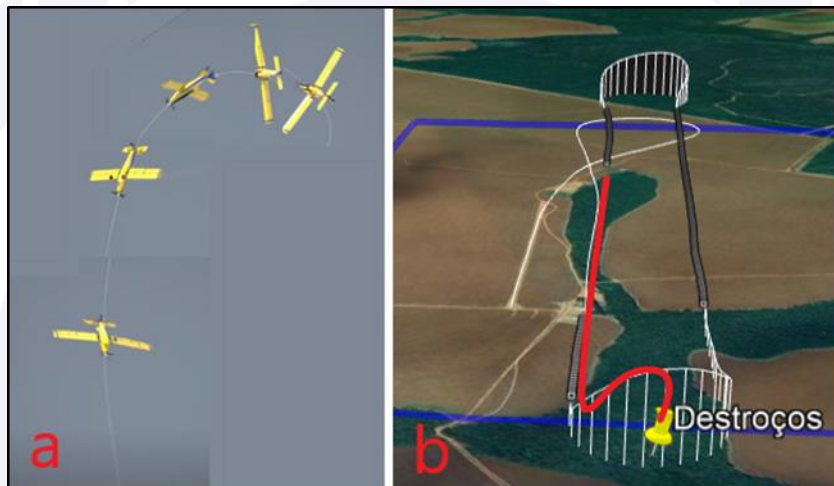
Figure 14a represents the spin condition during a left turn. Figure 14b represents the estimated final trajectory of the accident flight.

Figure 14 - spin image (a); and image of the estimated final flight trajectory (b) in red.

The hypothesis of development of a spin condition was further supported by the angle of impact of the aircraft's nose against the ground and the orientation of the aircraft on the terrain (260°). The fuselage possibly assumed the upside-down position due to the inertia of the impact with a pitch-down attitude at an angle greater than 90°.
