**FINAL REPORT
A - 174/CENIPA/2018**

OCCURRENCE:	ACCIDENT
AIRCRAFT:	PP-OEG
MODEL:	C525
DATE:	26NOV2018

This is the Final Report of the 26NOV2018 accident with the C525 aircraft model, registration PP-OEG. The accident was classified as “[CTOL] Collision with obstacle during take-off or landing”.

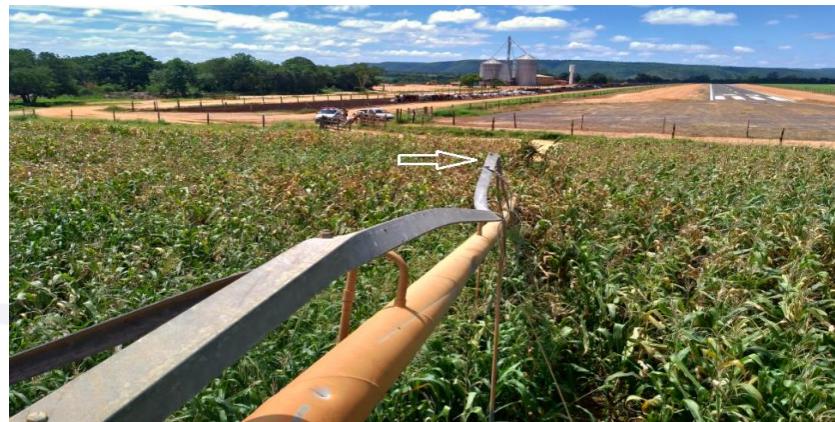
The aircraft collided with an irrigation pivot (440m long metallic structure, which revolves around a point in the center of the cultivated area), cutting the steel cables that supported the last "arm" of the referred equipment, which fell on the plantation after the impact (Figures 1 and 2).

Figure 1 - View of the last "arm" of the pivot, fallen over the plantation.

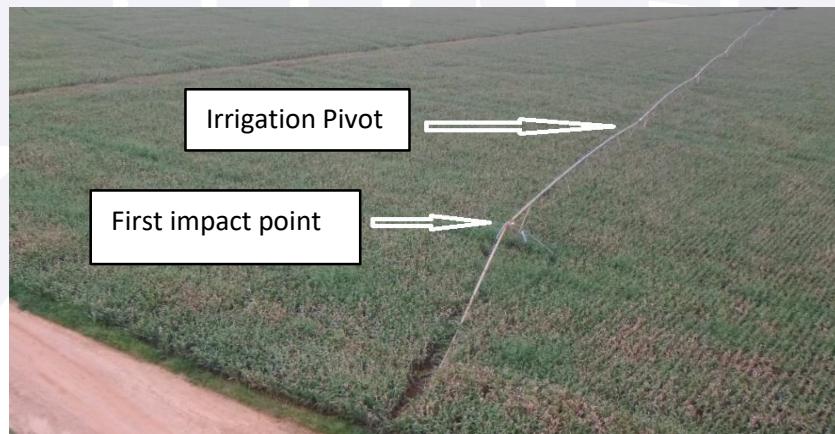
Figure 2 - Aerial view of the irrigation pivot and the first impact point.

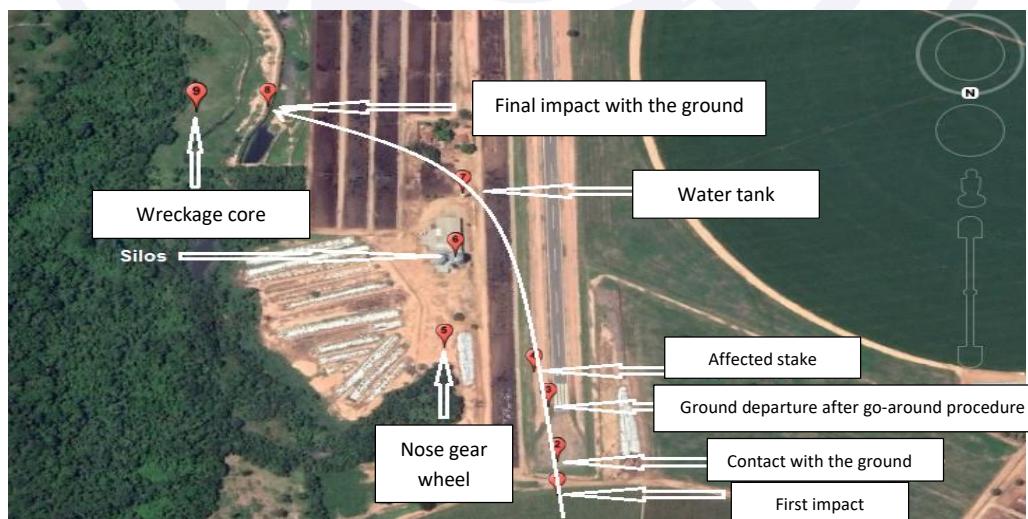
The wreckage was distributed linearly along 75 m, with its core about 600m away from the site of the first impact with the ground (Figure 3).

Figure 3 - Sketch of the aircraft trajectory, from the first impact to the final impact with the ground. Source: adapted from Google Earth.

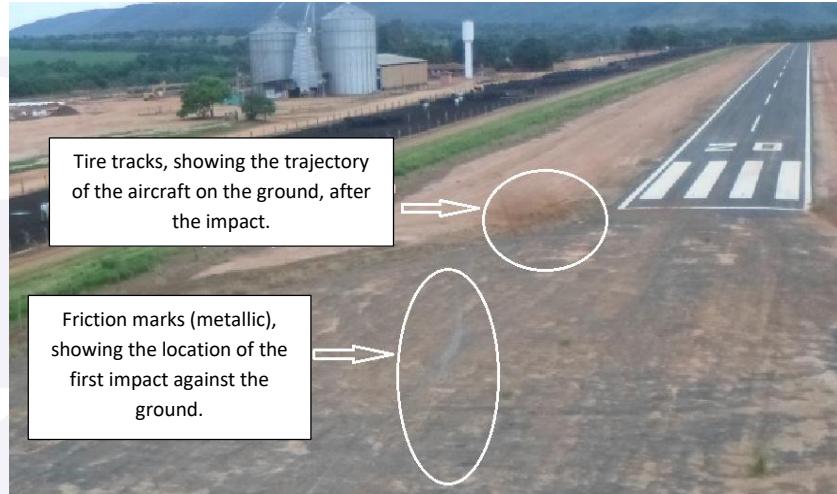
The first contact with the ground took place 67m before the threshold 20. This condition was evidenced by marks produced on the pavement, indicative of a dragging with a metallic aspect and, subsequently, by tire marks, produced by the aircraft wheels, both on the paved part and on the unpaved part on the side of the road. This evidence can be identified in the image shown in Figure 4.

Figure 4 - View of the site of the first impact against the ground.

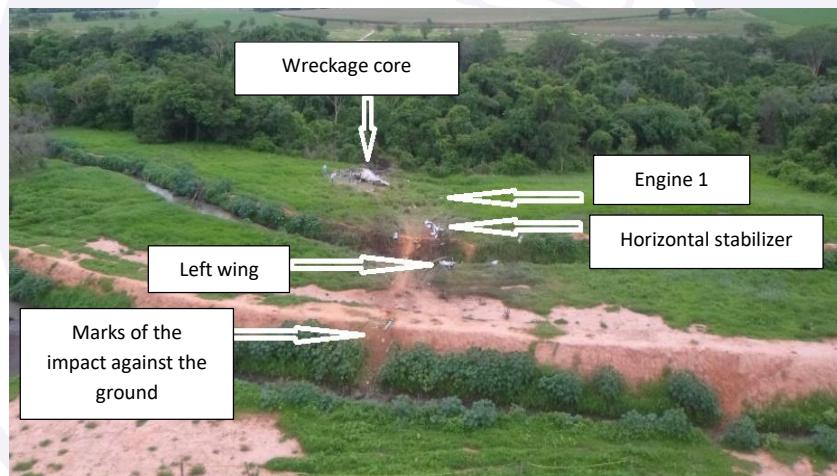
After the go-around procedure, the aircraft flew about 500m until it hit the ground again, separating into many parts, in a predominantly linear arrangement, as can be seen in Figure 5.

Figure 5 - Aerial view of the wreckage, where the final collision with the ground occurred.

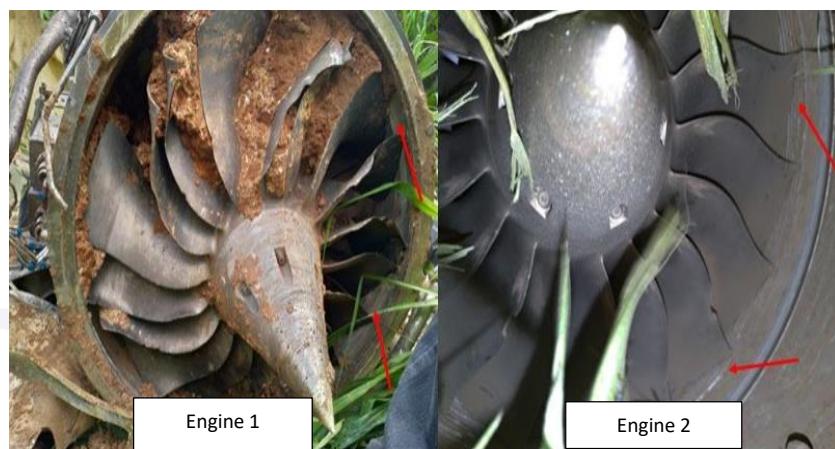
In both engines, marks of friction (rubbing) of the blades against the internal walls of the air intake were identified, and these blades presented predominantly uniform deformations, indicating that the two engines were developing power when they collided, as can be seen in Figure 6.

Figure 6 - View of the air inlet of the engines, with an indication of the friction areas of the blades on the walls of the compressor.

No evidence of engine failure or loss of power was found in flight. After the final impact with the ground, engine 1 detached itself from the aircraft and engine 2 remained attached to the fuselage.

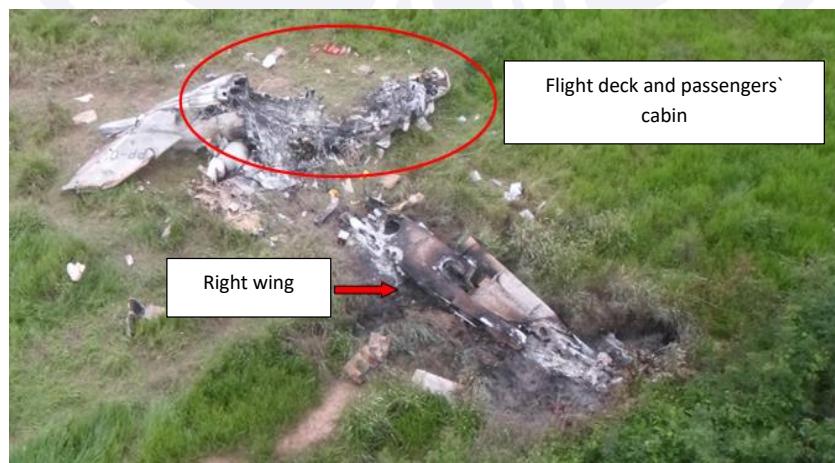
There was fire, apparently of long duration, in the core of the wreckage that hit many parts of the aircraft, especially the flight deck, the right wing and the passengers' cabin, as can be seen in Figure 7.

Figure 7 - View of the wreckage, showing the areas most affected by the fire.

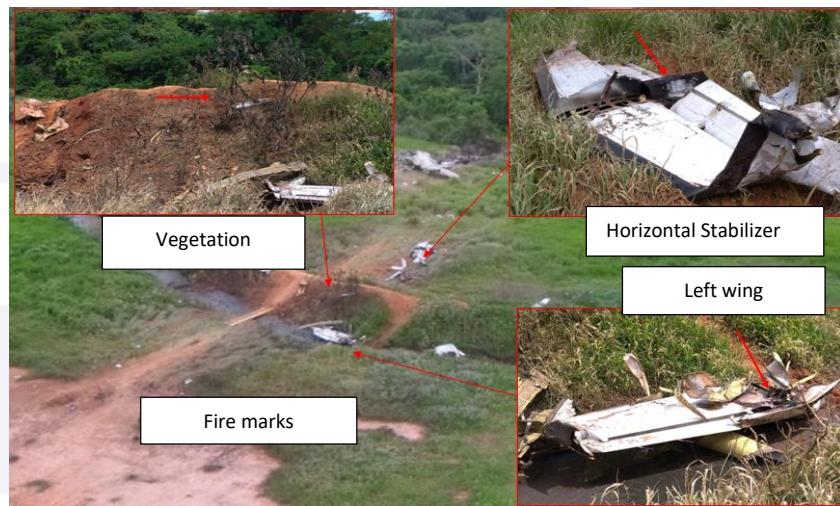
Fire signs were also identified in other parts of the aircraft, apparently of short duration, whose main focuses were observed in the left wing, in the horizontal stabilizer and in the trajectory described by the aircraft wreckage after impact with the ground (Figure 8).

Figure 8 - Fire marks on vegetation and other parts of the aircraft.

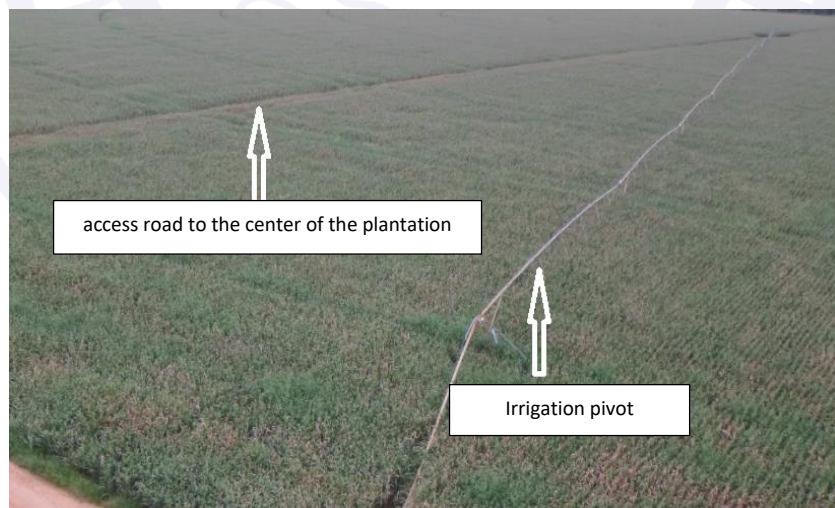
However, due to problems with one of the engines used to pull this structure, it was left in a different position (Figure 9), in the approach sector of runway 20, almost aligned with the direction of the runway, as can be seen in Figure 10.

Figure 9 - View of the access road to the center of the plantation and the irrigation pivot.

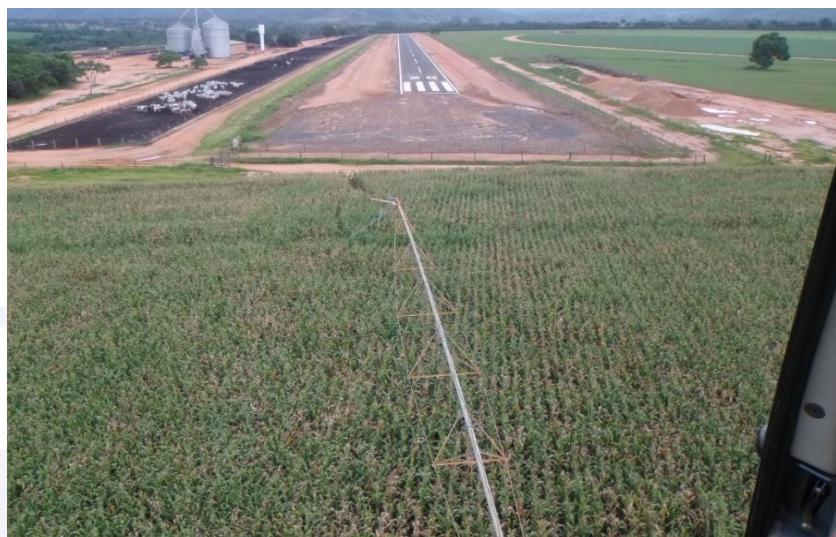
Figure 10 - Image of the irrigation pivot direction in relation to runway 20.

Another aspect observed in the course of the investigation refers to the irrigation pivot. In the position it was in, the pivot impaired the gauge of the Aerodrome approach surface by 4.36 m.

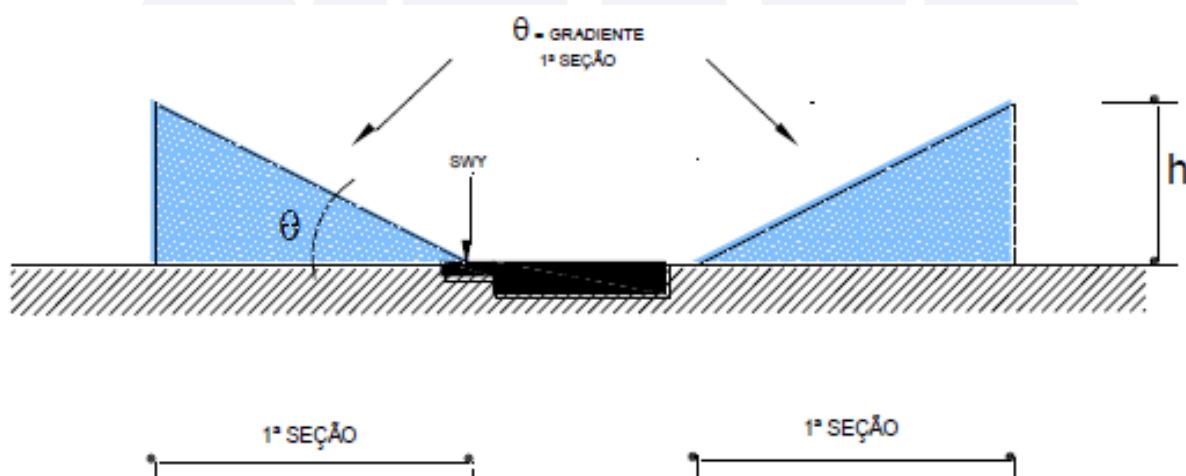
Figure 12 - First Section of the PBZPA Approach Surface.

Thus, observing the runway data highlighted in Figure 11, that is, the runway (classified as code 2 - from 800 to 1,200m), the distance of 6 m from the obstacle to the beginning of the runway strip (60m from the threshold) and the gradient of 4%, a value of 2.64 m of height of the PBZPA approach surface at that point is reached, considering the threshold of the runway and the obstacle with the same altitude.

It was found that the irrigation pivot, at the point where the collision took place, was impairing the gauge of the approach surface as described in Ordinance 957/GC3, of 09JUL2015, which provided for restrictions on objects projected into the airspace that could adversely affect the safety or regularity of air operations.
