COMANDO DA AERONÁUTICA
CENTRO DE INVESTIGAÇÃO E PREVENÇÃO DE
ACIDENTES AERONÁUTICOS

FINAL REPORT
A - 062/CENIPA/2021

OCCURRENCE:	ACCIDENT
AIRCRAFT:	PP-PIT
MODEL:	AS 350 B2
DATE:	06MAY2021

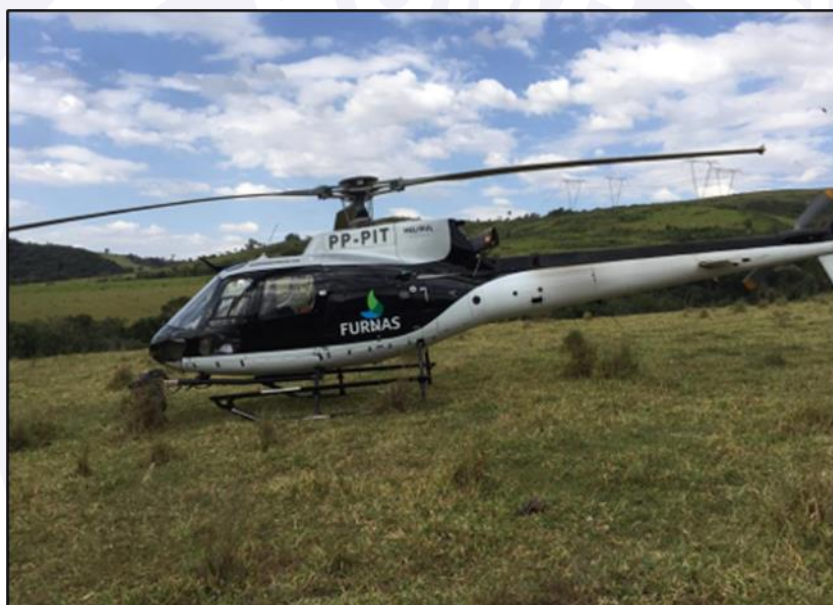
After about twenty-five minutes of flight, the main rotor blades collided with a string of insulators on one of the towers. Subsequently, the crewmembers noticed a strong vibration in the controls and performed an emergency landing in an open area.

Figure 1 - View of the PP-PIT at the emergency landing site.

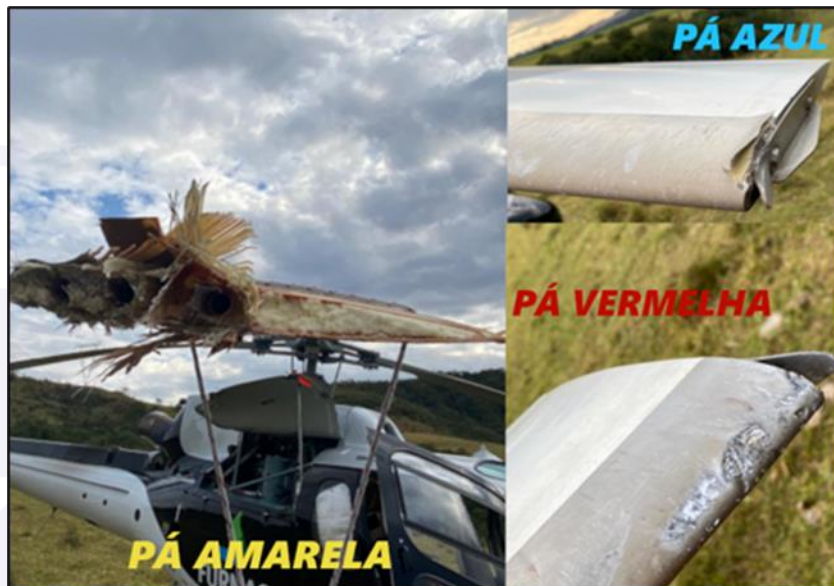
The impact occurred between the main rotor blades and the insulator chain of the power grid.

There was severe damage to all three main rotor blades.

Figure 2 - Damage to the main rotor blades.

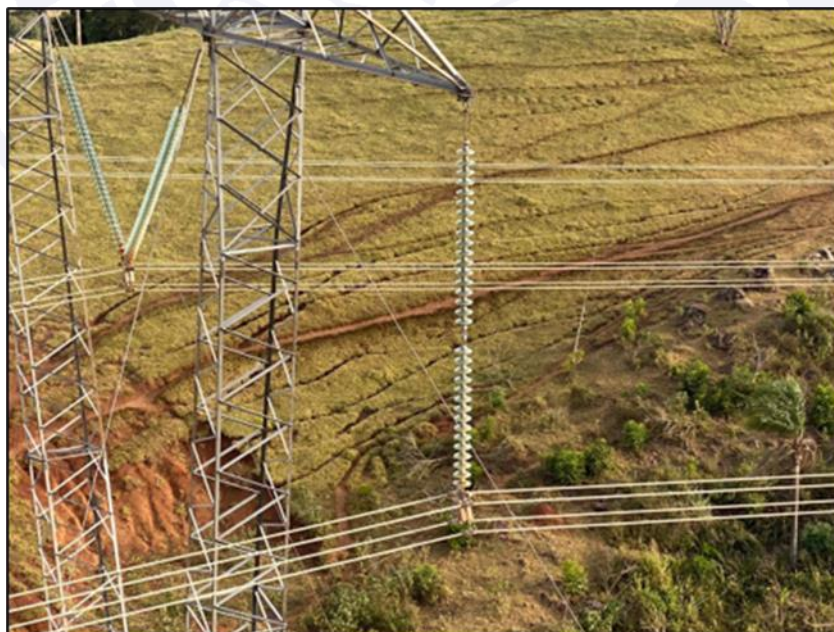
According to the PIC, during the inspection flight, in a displacement parallel to the transmission lines using a speed of 30 kt, at a distance of 10 meters from the power tower, he was surprised by a gust of wind. It made the helicopter move towards the power cables. This report was corroborated by the passengers.

Subsequently, the blades collided with the insulator chain (Figure 3).

Figure 3 - Location of the collision between the PP-PIT and the insulator chain of the power transmission grid.

This approach increased the risk of a collision by reducing the safety margin of the operation. Likewise, there was a decrease in the response time required for the PIC to avoid the impact, as it was found that, when hit by a gust of wind, the pilot was not able to avoid the collision with a chain of insulators.

Disclose to Helisul Air Taxi Ltd. the lessons learned in this investigation so that the operator, in coordination with the company Furnas Centrais Elétricas, seeks to update the Technical Field Manual for Aerial Inspection of Transmission Lines Using Helicopters, especially concerning the use of technologies that can contribute to operational safety, and also carry out internal activities to promote operational safety, using the EHST publication Techniques for Helicopter Operations in Steep and Mountainous Terrains.

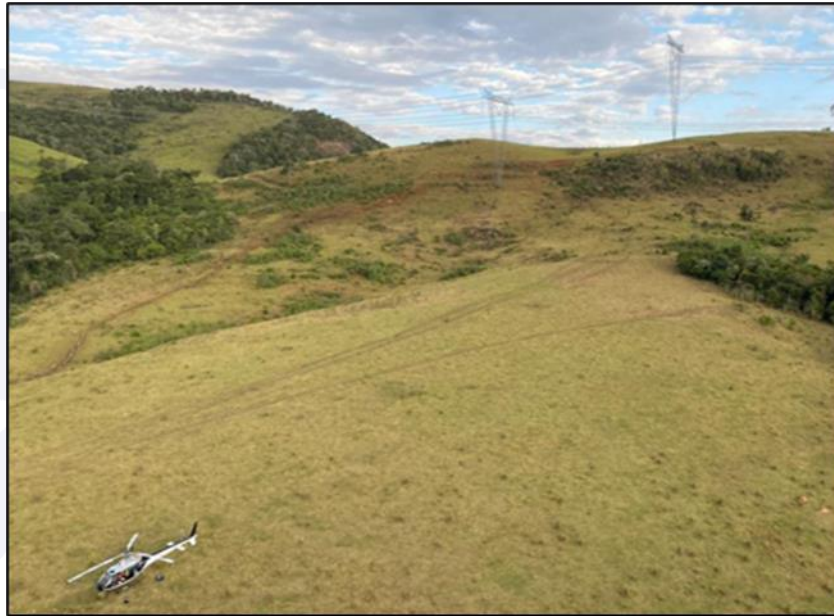
After noticing a strong oscillation in the cyclic command, the PIC led the PP-PIT to an emergency landing in an open area. As can be seen in Figure 4, the flight took place in a valley.

Figure 4 - Final position of the aircraft after the emergency landing.
