FINAL REPORT IG-136/CENIPA/2013

OCCURRENCE:	SERIOUS INCIDENT
AIRCRAFT:	PP-PTU
MODEL:	ATR-72-212A
DATE:	26JUL2013

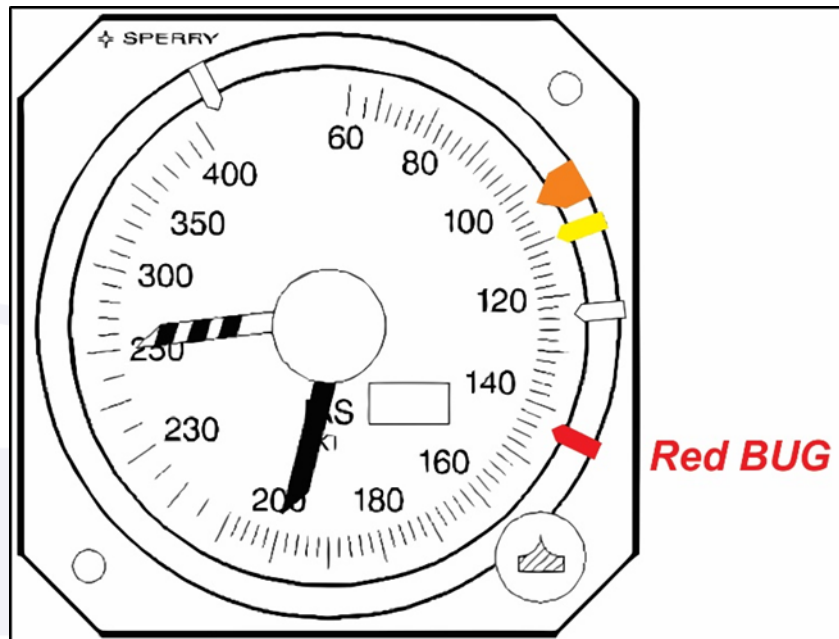
Figure 4 - ATR-72-212A speedometer illustration.

During the initial field investigation, it was observed that only the instrument on the right post had the Red Bug installed and it was set at 160 kt. It was also found that there was no record of the absence of Red Bug in the aircraft technical logbook.

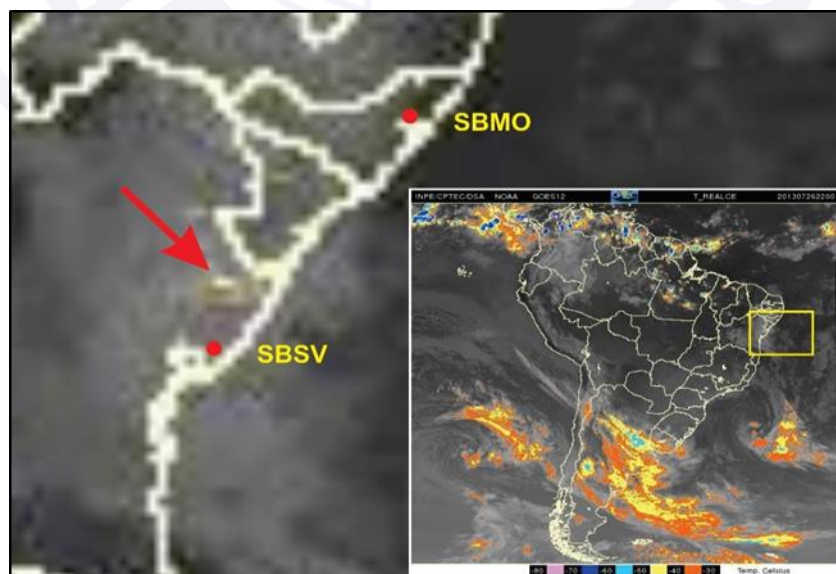
Figure 8 - Highlight of the region analyzed by CMV-RE. The arrow indicates the position where the loss of control of the aircraft occurred.

The aircraft flew on FL160, between the Isotherms from 0° C to -10° C, where it is possible to form ice (light, moderate or strong).

According to the survey of the real-time conditions, the diagnosis of the parameters and the meteorological phenomena in question, it was found that the weather conditions were not favorable to the air operations on the screen route between flight levels FL100 and FL210.

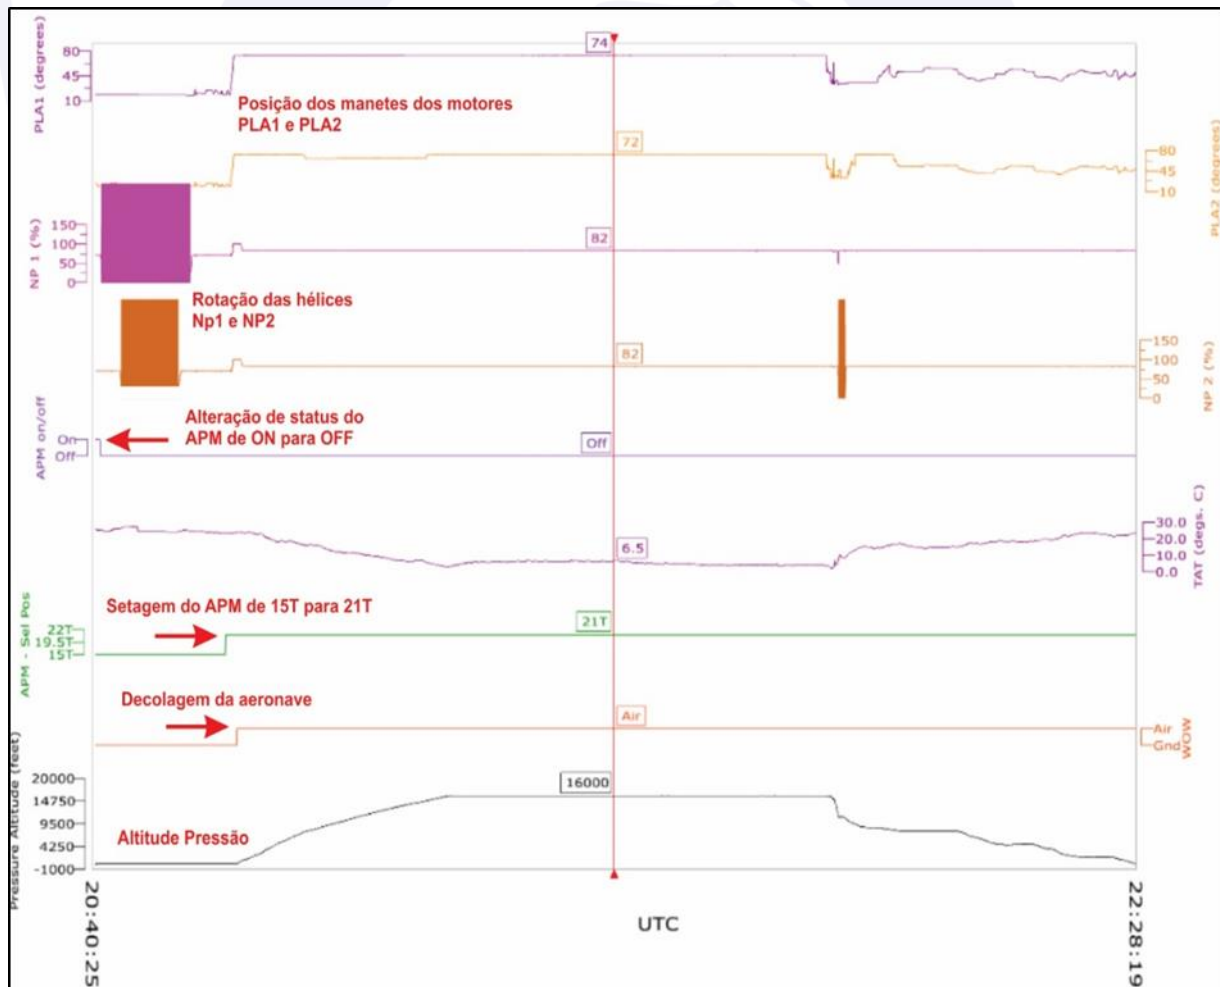
Figure 9 - DFDR data of the PP-PTU aircraft.

During the evaluation of the aircraft DFDR data, it was found that at the end of the pre-flight stage of the occurrence, the APM changed its status from ON to OFF, remaining in this condition throughout the flight.

The APM was in the OFF status at the end of the previous flight, on the ground. When the APM was OFF, calculations were performed normally, but alerts were inhibited.

Also, it was possible to verify that the APM was adjusted from 15T to 21T (21 Tons, corresponding to the aircraft weight) before the takeoff (Figure 9).

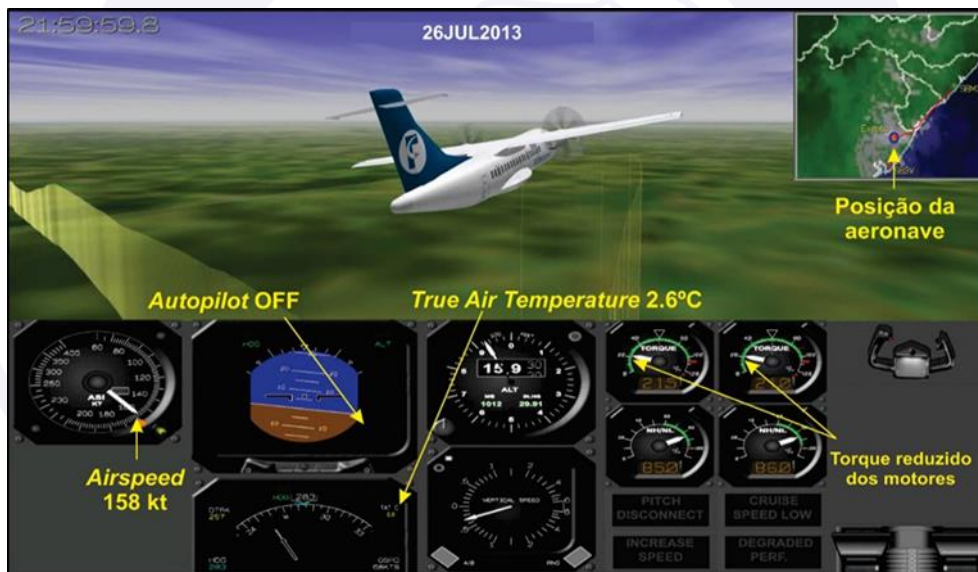
Figure 17 - Flight parameters of the PP-PTU aircraft at 21h59min59s (UTC).

At 21h59min59s (UTC), the indicated TAT was 2.6°C. The CVR recorded a loud vibrating noise from the aircraft and IAS had dropped to 184 kt.

Both engine throttle levers have been reduced to 50° PLA (20% TQ). With reduced power and ALT engaged autopilot, the aircraft pitch angle increased and IAS rapidly reduced to 158 kt (minimum ice-operating speed was 161 kt). According to the Captain, he disengaged the autopilot. At the same time, the torque of the engines reached 21% (Figure 17).

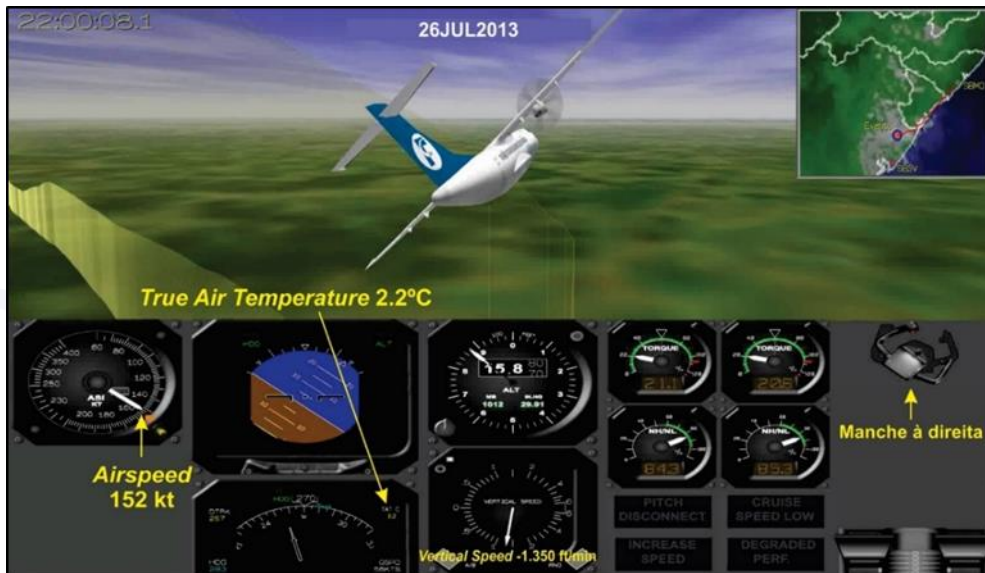
Figure 18 - Flight parameters of the PP-PTU aircraft at 22h00min08s (UTC).

The stick pusher activated. Since the captain countered the stick pusher, the AOA increased (local AOA LH 10.3° and 24 RH 10.6°) and both stick shakers were activated.

Following, the aircraft had a sharp wing turn (43°), although the stick was commanded to the right. The vertical speed indicated a drop of 1,350ft/min. (Figure 18).

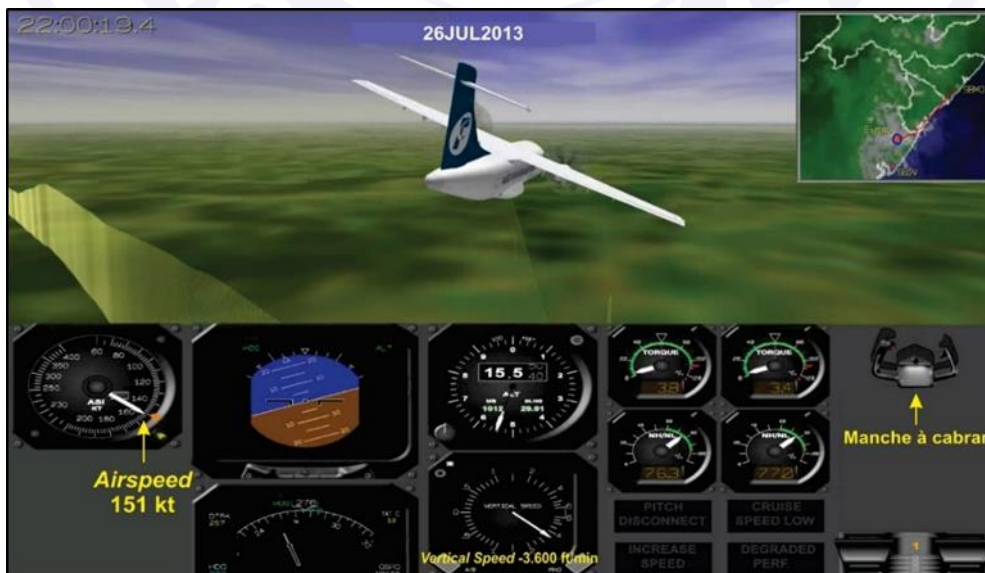
Figure 19 - Flight parameters of the PP-PTU aircraft at 22h00min19s (UTC).

AOA went below the threshold, hence the stick pusher and stick shaker deactivated for a second. The pitching angle increased again and reached 1° . The stick pusher and stick shaker engaged for the third time (AOA LH location: 12.6° and RH 14.6°).

The pitch angle remained at 1° and reached a roll angle of 24° to the right (Figure 19). Nose down input from the captain's side was recorded 10 second after the continuous activation of the 3rd stick pusher.

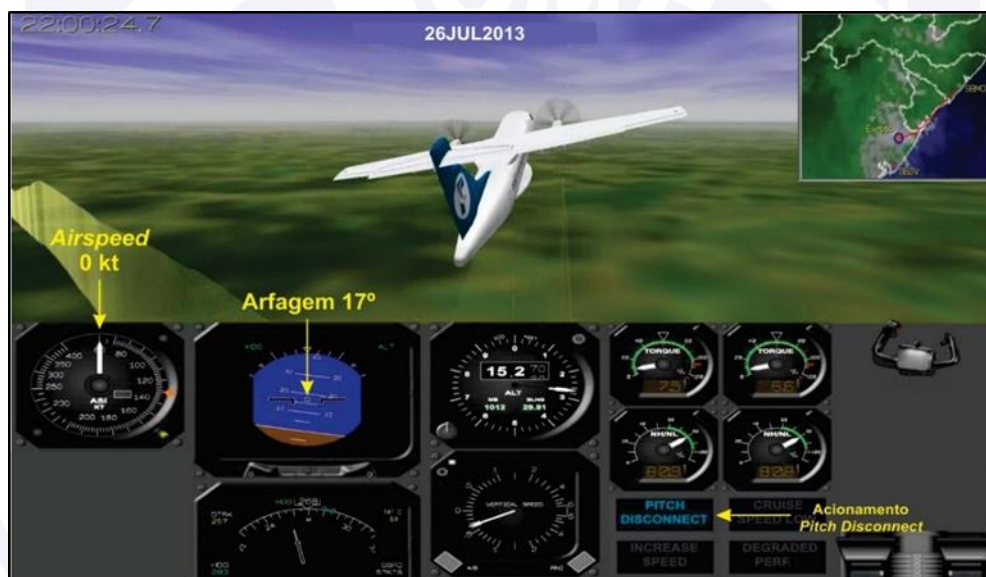
Figure 20 - Flight parameters of the PP-PTU aircraft at 22h00min24s (UTC).

Following, the pitching angle reached 17° and the speedometer indicated 0 kt (Figure 20).

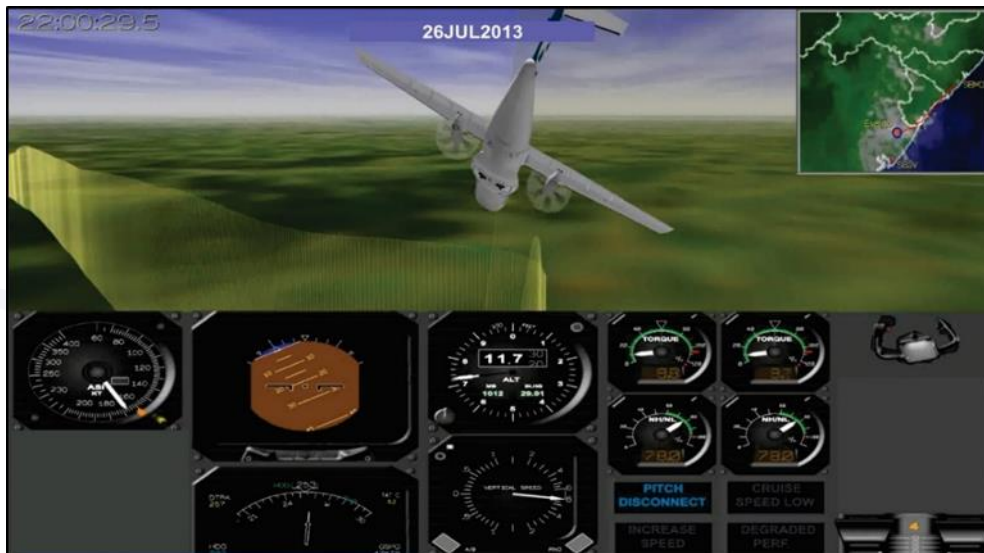
Figure 21 - Flight parameters of the PP-PTU aircraft at 22h00min29s (UTC).

The CVR recorded the sound of a triple alarm followed by intermittent stick shaker triggering. The stick pusher and stick shaker remained active for 34 seconds (Figure 21).

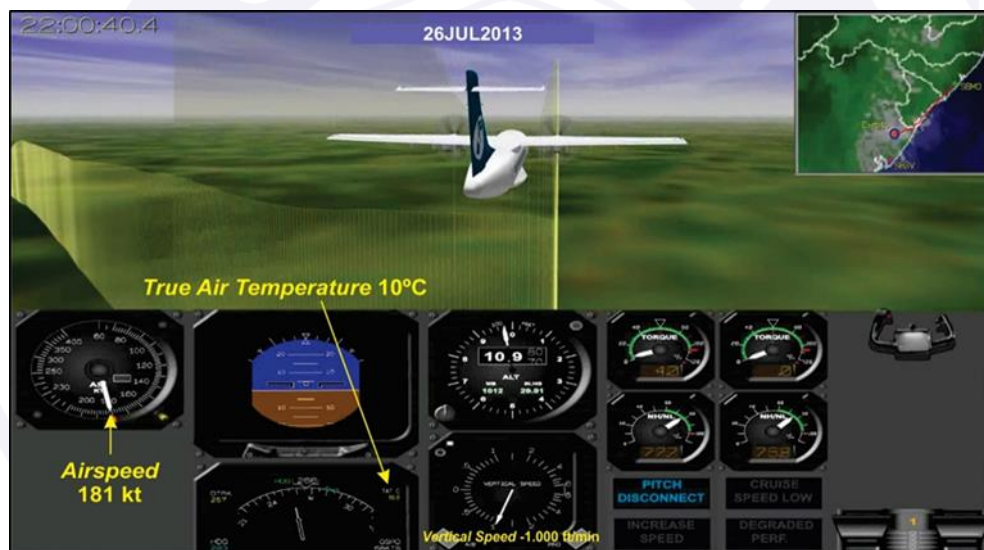
Figure 22 - Flight parameters of the PP-PTU aircraft at 22h00min40s (UTC).

At 22h00min40s (UTC), the aircraft crossed the FL110, with a 1,000ft/min descent rate, 181 kt IAS and the TAT increased to 10°C (Figure 22).
