COMANDO DA AERONÁUTICA
CENTRO DE INVESTIGAÇÃO E PREVENÇÃO DE
ACIDENTES AERONÁUTICOS

FINAL REPORT
A-128/CENIPA/2018

OCCURRENCE:	ACCIDENT
AIRCRAFT:	PP-SZN
MODEL:	C90GTI
DATE:	29JUL2018

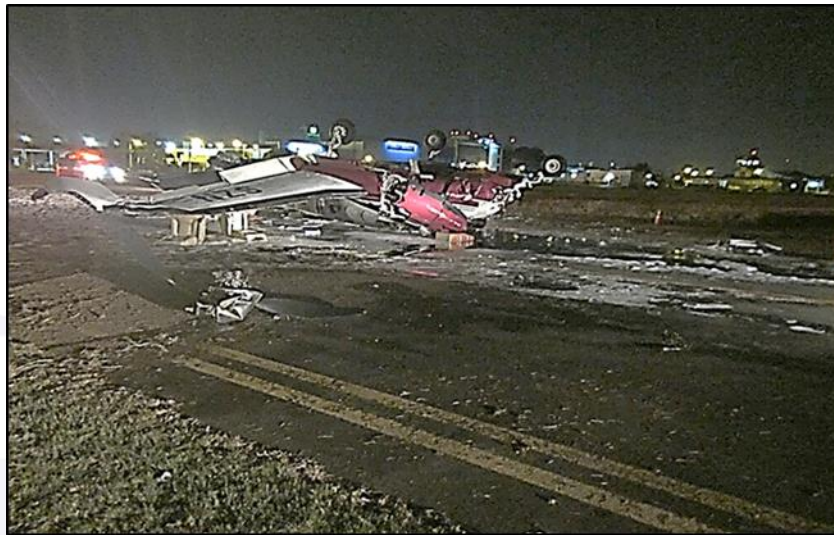
The forward section of the fuselage remained preserved, with lateral wrinkles and significant dents in the upper part of the left-hand side of the command cabin.

Figure 1 - Condition of the wreckage after the airplane came to a stop.

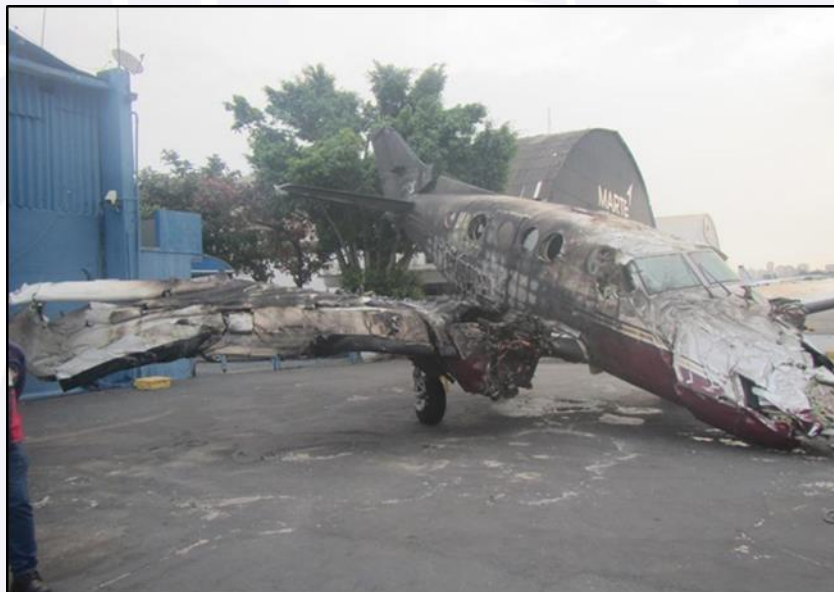
Figure 2 - View of the aircraft wreckage after removal from the accident site.

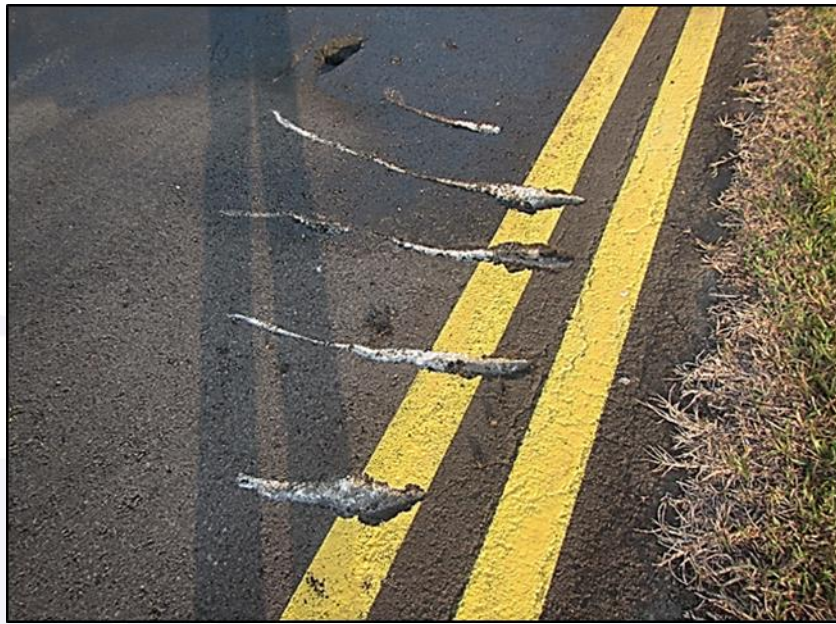
The first impact, on the upper side of the fuselage, occurred with the aircraft nearly in a 180-degree left bank position, with the landing gear extended, followed by the impact of the right engine and the onset of flames due to the friction of the fuselage with the ground (Figure 22).

Figure 22 - Cuts in the asphalt made by the propeller blades of the right engine.

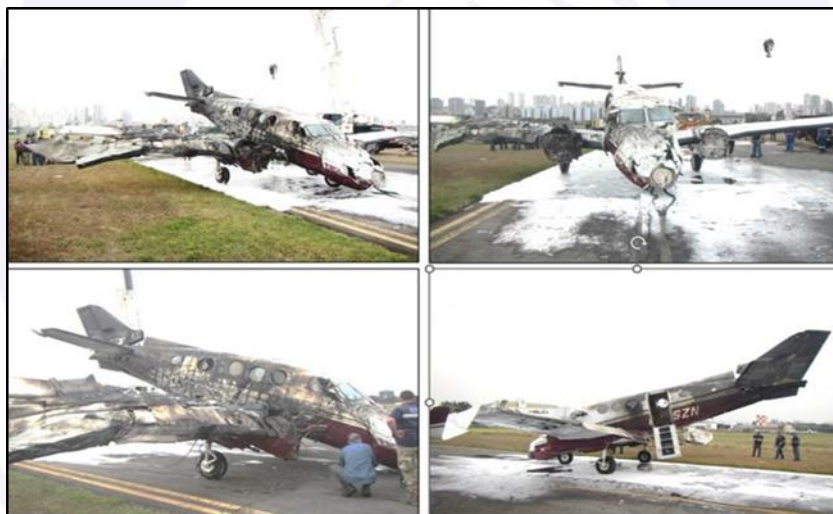
The right wing, left wing, empennage, and landing gear remained attached to the structure of the airplane. The damage was observed mainly on the right wing and on the right side of the fuselage, where the flames were more intense.

Figure 23 - Aspect of the wreckage after removal of the airplane from the accident site.

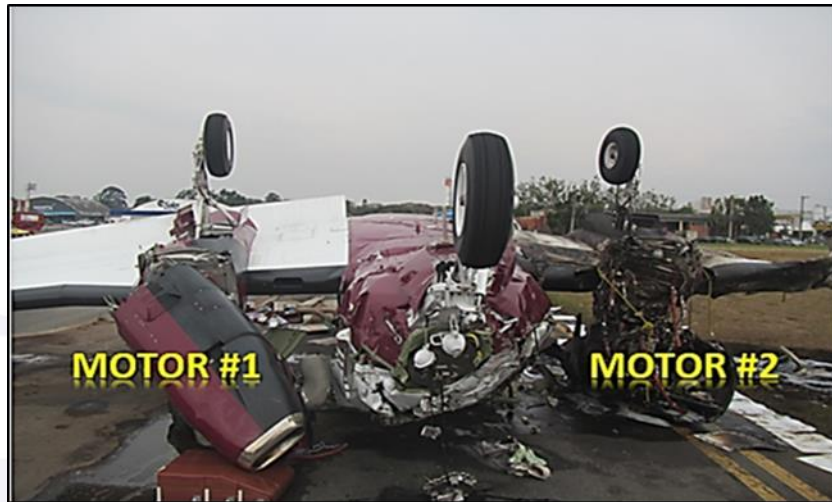
Both engines remained secured in their mounts; however, the left propeller separated due to the rupture in the reduction gearbox upon impact with the ground, with this gearbox being found at a distance of 40 meters from the aircraft (Figure 24).

Figure 24 - Aspect of the engines and position of the landing gear after the impact.

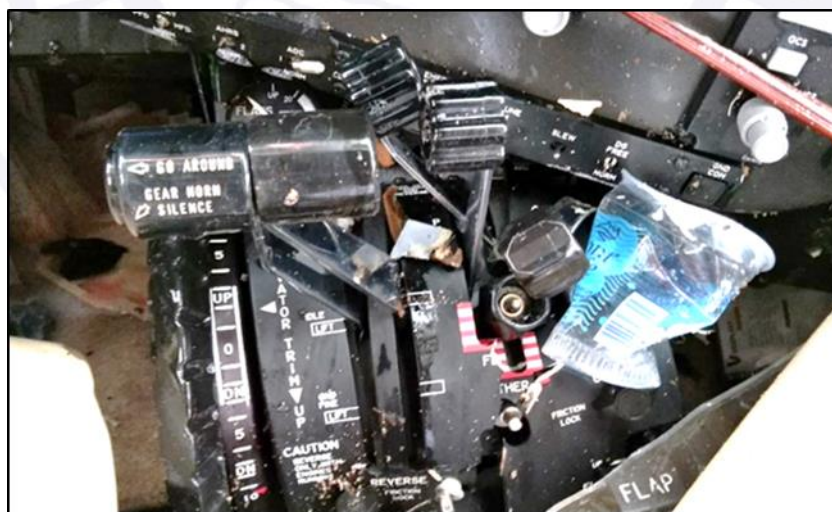
The power, propeller, and fuel levers were in the forward position; however, this may not reflect their condition at the time of impact due to the possible movement during the aircraft’s impact or during the extraction of the occupants, given that the final configuration of the cockpit was considerably small, with little space for internal movement.

Figure 25 - Position of the levers and elevator trim tab.

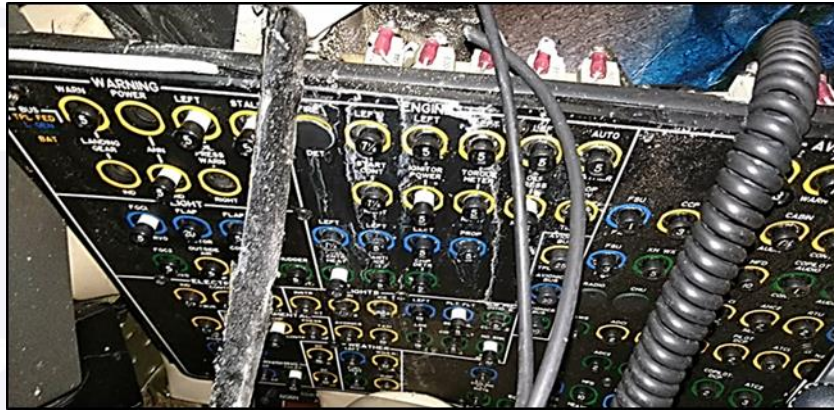
The right circuit breaker panel was broken and dislodged from its housing. It showed eleven circuit breakers tripped and three missing, possibly due to the high temperature from the flames and/or the significant energy absorbed by the fuselage upon impact with the ground (Figure 26).

Figure 26 - Circuit breaker panel on the right hand side.

- Oil Press (WARN) - tripped;
- Stall (WARN) - tripped;
- Power (WARN) - missing;
- Power (WARN) - INS - tripped;
- Landing Gear (WARN) - missing;
- Oil Press (WARN) right - missing;
- Engine / Ignitor Power Right - tripped;
- Fuel Center Heat Right - tripped;
- Flight FGC2 Servo - tripped;
- Electrical / Environmental Temp - tripped;
- Furnishing Toilet - tripped;
- Lights / PLTFLT / Side PNL - tripped;
- Lights / No SMK / FSB & Reading – tripped; and
- Engine / Oil Press Right - tripped.

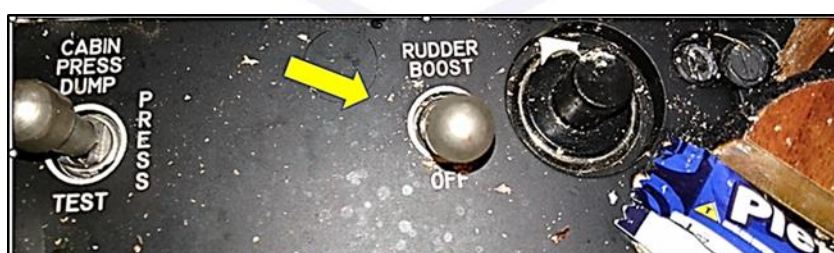
The RUDDER BOOST SYSTEM control switch was in the “OFF” position; however, it may have been subject to movement during the evacuation of the occupants (Figure 27).

Figure 27 - Position of the Rudder Boost System switch, as found amid the wreckage.

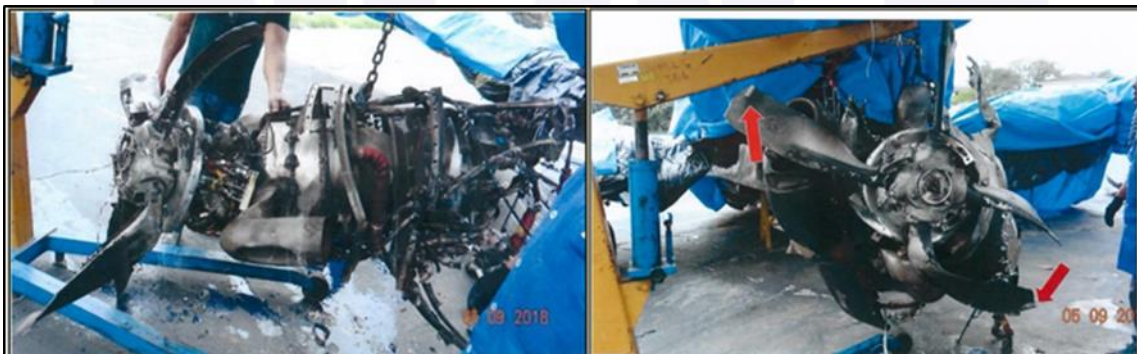
During the disassembly of the right engine (model PT6A-135A, SN PCE-PZ0738), no evidence of lack of lubrication was observed. The examined bearings showed no damage or characteristics indicative of poor lubrication. There was no metal contamination in the chip detectors or in the return oil filter of the reduction gearbox.

Figure 33 - View of the engine and right propeller, showing the blades with forward bending.

The engine presented signs of intense rubbing between the compressor turbine blades and the segmented ring, and all the blades had fractures. The blade fragments left marks when they detached and were centrifuged. The engine diaphragm, in its correct position, also showed intense rubbing. Such marks indicate that the engine was operating normally at the time of the impact.

The power turbine also had rubbing marks, and some of the stator vanes were broken. One also observed that all the blades on the turbine rotor disk detached or broke near the root, and were found inside the exhaust duct.

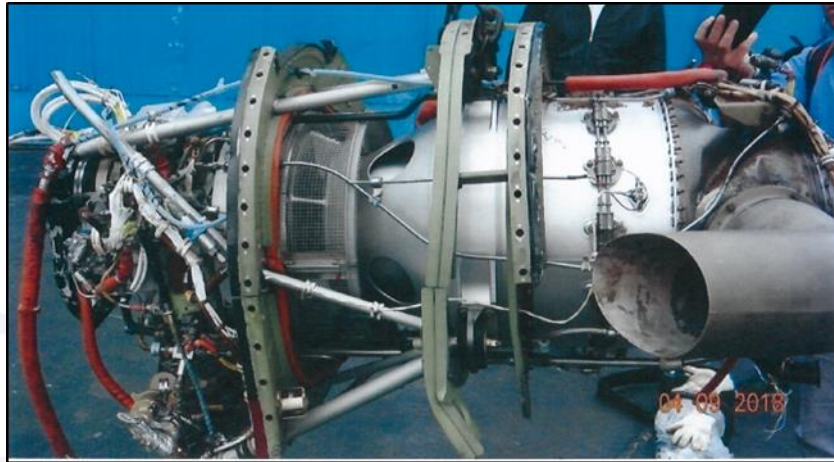
The left engine (model PT6A-135A, SN PCE-PZ0743), showed internal less intense marks in comparison to those found on the right engine, but it also exhibited severe damage resulting from the impact and action of the fire.

Figure 34 - View of the right side of the left engine.

The roots of the rotor blades of the compressor turbine showed less intense rubbing marks, when compared to the right engine. The blades were intact, not causing damage to the segmented ring. No rubbing marks and/or damage were found on the thermocouples of the power turbine diaphragm. Some blades broke halfway along their length, and the remaining blades exhibited deformation.

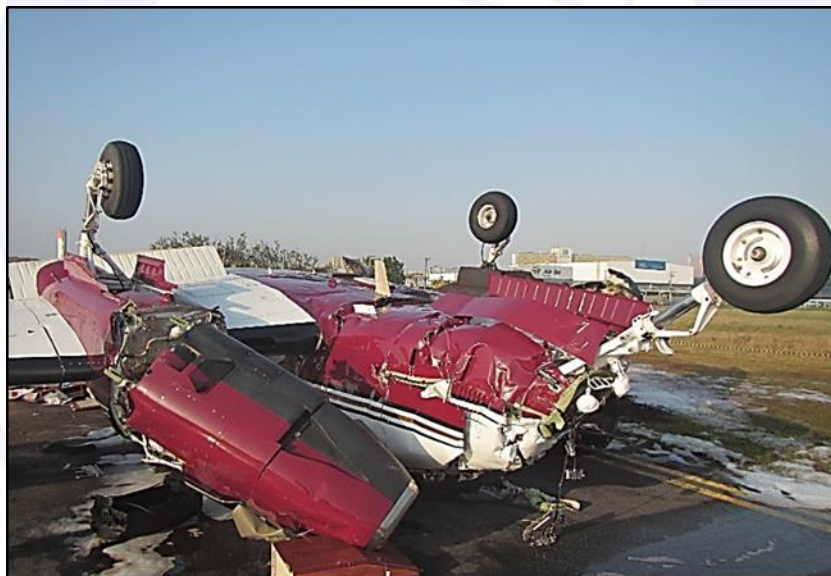
Figure 36 - Position and condition of the landing gear assembly after the final stop.

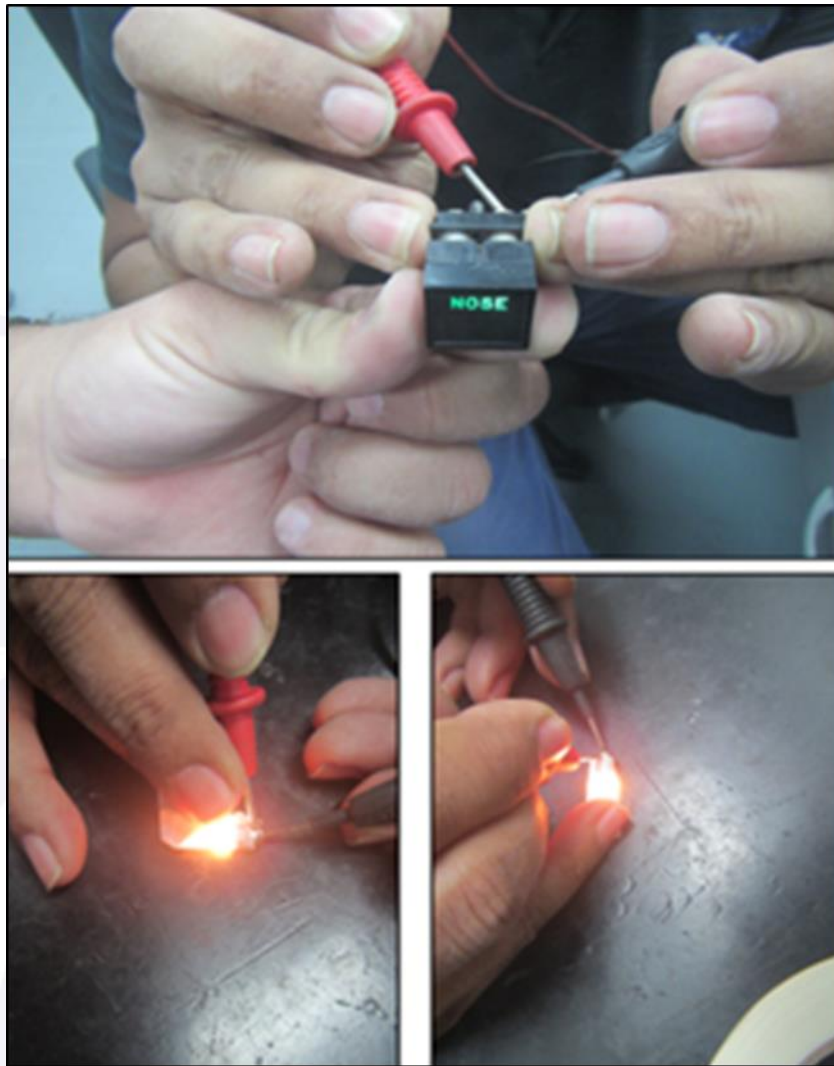
One observed that both indicator lights for the nose landing gear were in good working order.

Figure 39 – Testing the lights of the nose landing gear position indicator.

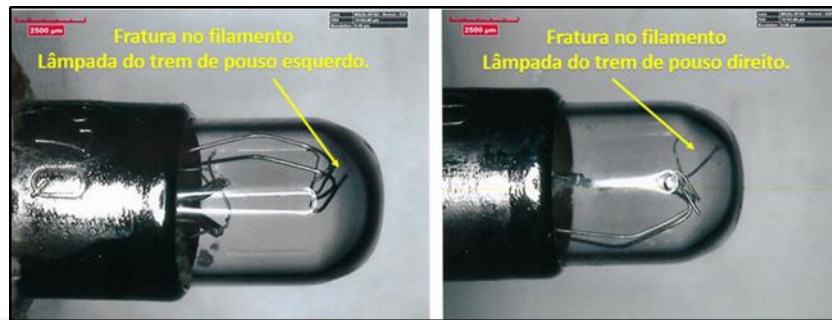
The respective lights were sent for laboratory testing, and showed fracture characteristics typical of breakage when the lights are off (Figure 41).

Figure 41 - Laboratory test of the lamps.
