**FINAL REPORT**  
**IG - 040/CENIPA/2021**

| <b>OCCURRENCE:</b> | <b>SERIOUS INCIDENT</b> |
| <b>AIRCRAFT:</b> | <b>PP-UGS</b> |
| <b>MODEL:</b> | <b>A109S</b> |

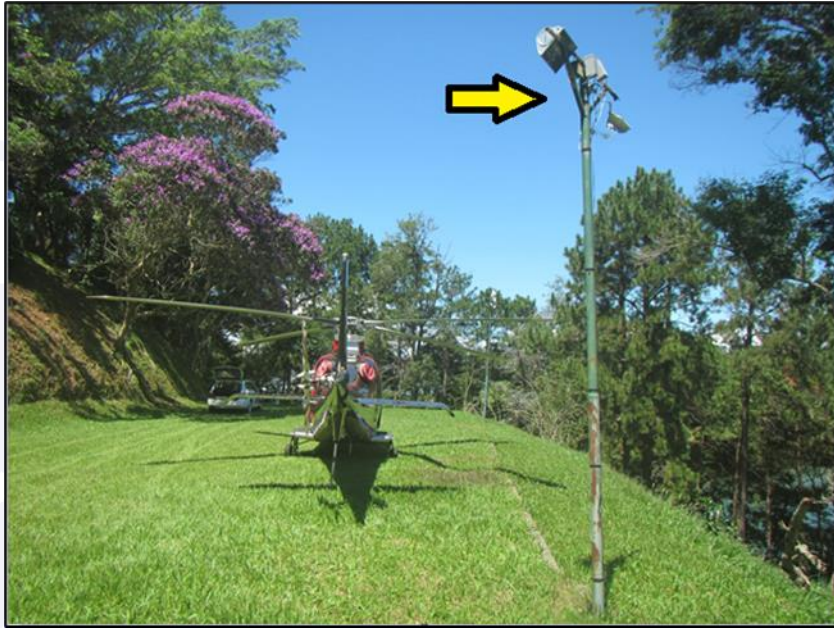
Figure 1 - Final position after the occurrence and highlighting the lighting pole hit by the tail rotor.

In the final part of the approach, the tail rotor blades collided with the top of the lamp post.

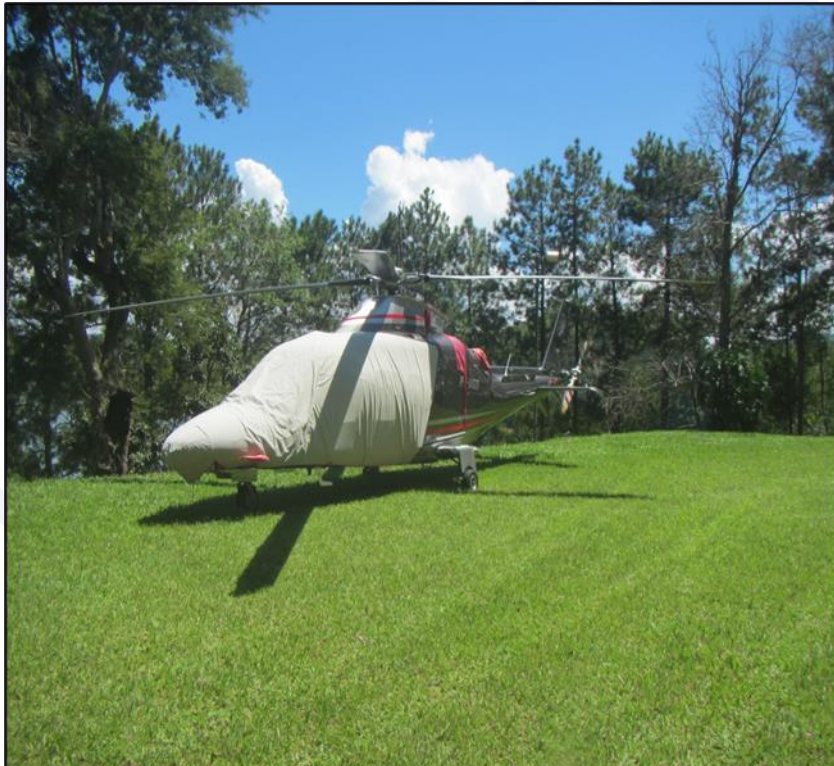
Figure 2 - Front view of the aircraft after the occurrence.

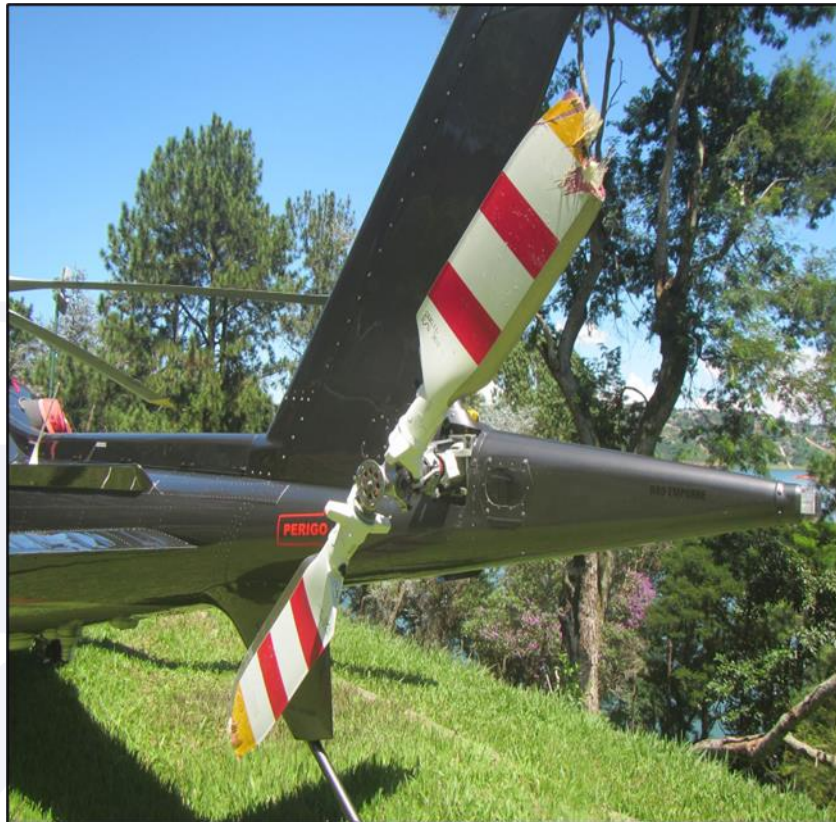
The aircraft had light damage, restricted to the tail rotor.

Figure 3 - Detail of damage to the tail rotor.

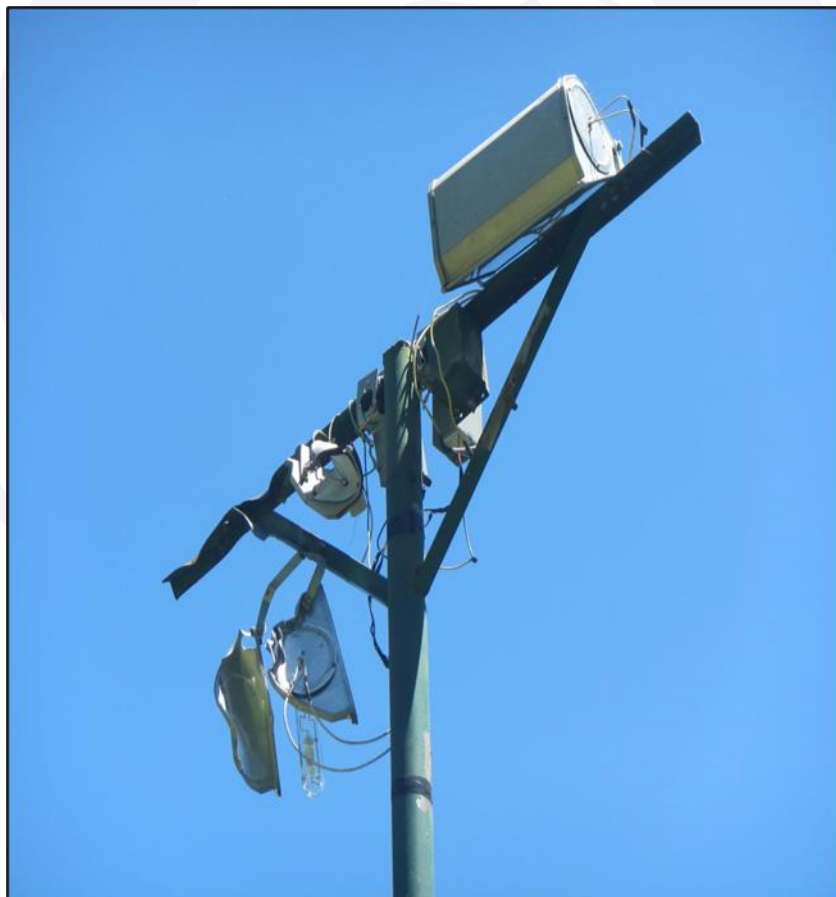
There was damage to the light pole.

Figure 4 - Detail of the damage to the light pole that was hit.

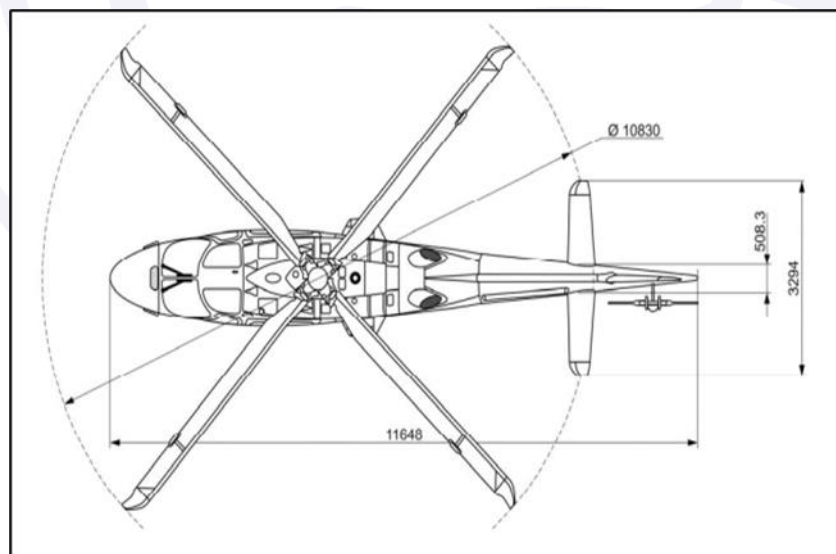
According to the Rotorcraft Flight Manual A109S, Rev. 1 of 01JUN2005, this model was 11,648 m long and 10,830 m in diameter of the main rotor, as shown in Figure 5.

Figure 5 - Dimensions of the A109S model.

Observing the helicopter's dimensions and the landing site's width, it was found that there were about 1.5 m of a margin between the obstacles and the tips of the main rotor blades.

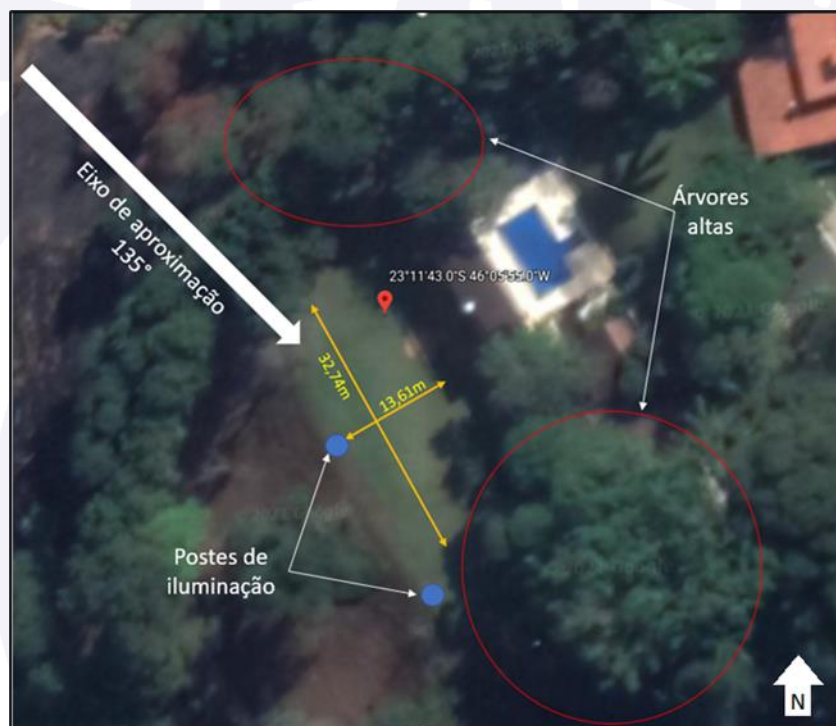
The house was Northeast of the landing site for boarding. On the lateral, there were two lamp posts, approximately 5 m high, and a slope of the terrain to the Southwest, as shown in Figure 6.

Figure 6 - Sketch of the intermediate landing site.

The obstacle-free area of the site was approximately 33 m lengthwise by 14 m across.

According to the regulations in force at the time, the unregistered landing area should have a minimum free radius of 30 m from obstacles and people up to the touchdown point, for eventual use by helicopters.
