FINAL REPORT
A-028/CENIPA/2022

OCCURRENCE:	ACCIDENT
AIRCRAFT:	PP-XDB
MODEL:	---
DATE:	27FEV2022

This is the Final Report of the 27 February 2022 accident involving the aircraft of registration marks PP-XDB. The accident was typified as “[SCF-PP] Engine failure or malfunction and [LOC-I] Loss of control in flight”.

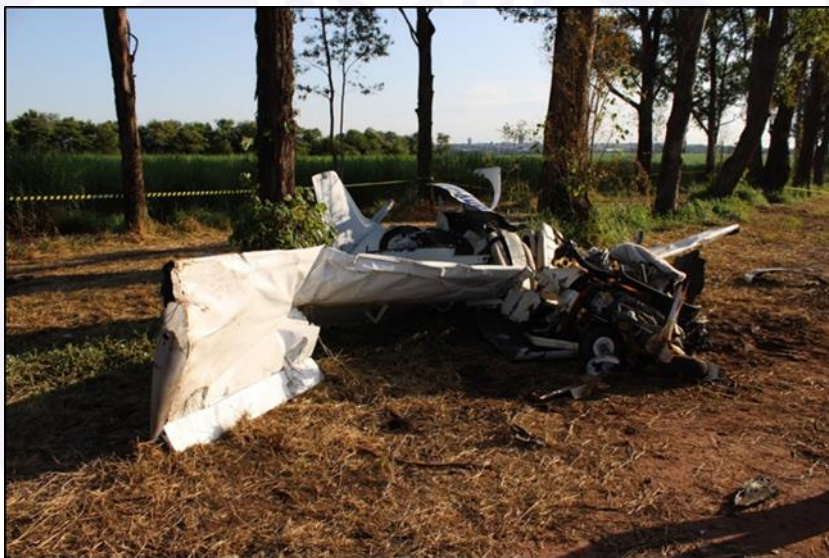
Figure 1 – Picture of the aircraft taken at the initial investigation action.

All the landing gear struts were broken. The wings along with their control surfaces sustained significant twists and bends, the fuselage was substantially damaged, and the tail cone was severed, being the part of the aircraft with the least apparent damage.

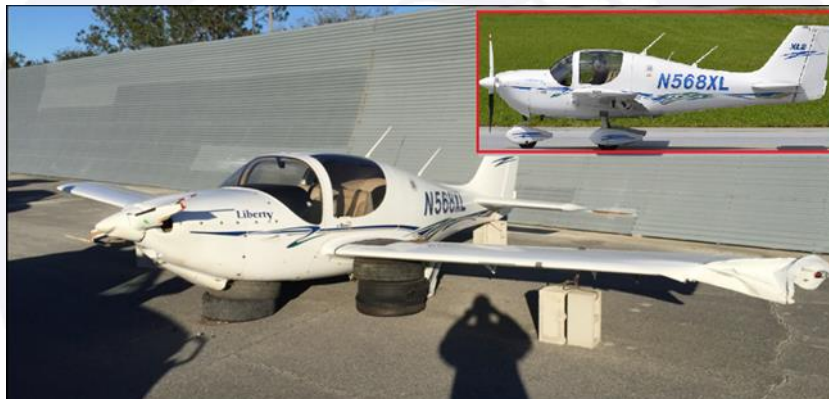
While browsing the website of the NTSB (National Transportation Safety Board, accident investigation authority in the United States) one found an accident record of the N568XL dated 20 February 2016 (Figure 4). The documents used in the investigation were available in the “doctet” (file repository) of the aforementioned authority. One verified that the engine of the N568XL aircraft was the same one installed in the PP-XDB (SN 400086).

Figure 4 – (Larger picture) Liberty XL2 aircraft (N568XL) after the 20 Feb 2016 accident. (Smaller picture), the same aircraft before the accident.

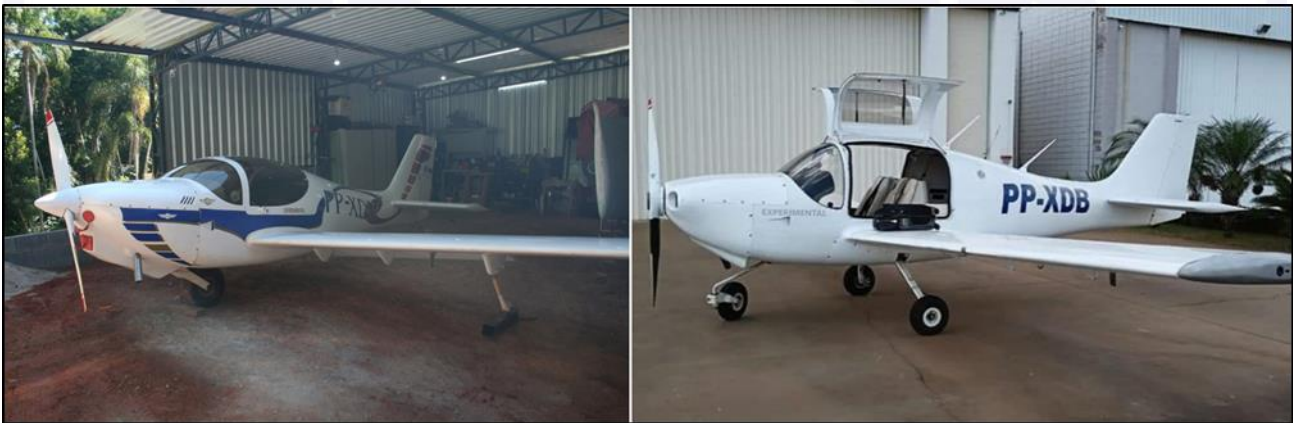
Finally, upon checking the documents and photographs sent to the ANAC in 2020 for the issuance of the PP-XDB's CAVE, one verified that the photographs received corresponded to the aircraft originally built in 1999 - and not the one involved in the accident (Figure 5, left-hand side). The photographs depicted an aircraft fitted with monowheel landing gear, a carbureted Teledyne Continental engine (SN A06EA069) and a number of other differences.

Figure 5 - Comparison between the Europa aircraft with registration marks PP-XDB (on the left - photograph sent to ANAC) and the Liberty XL2 aircraft involved in the accident in question (on the right).

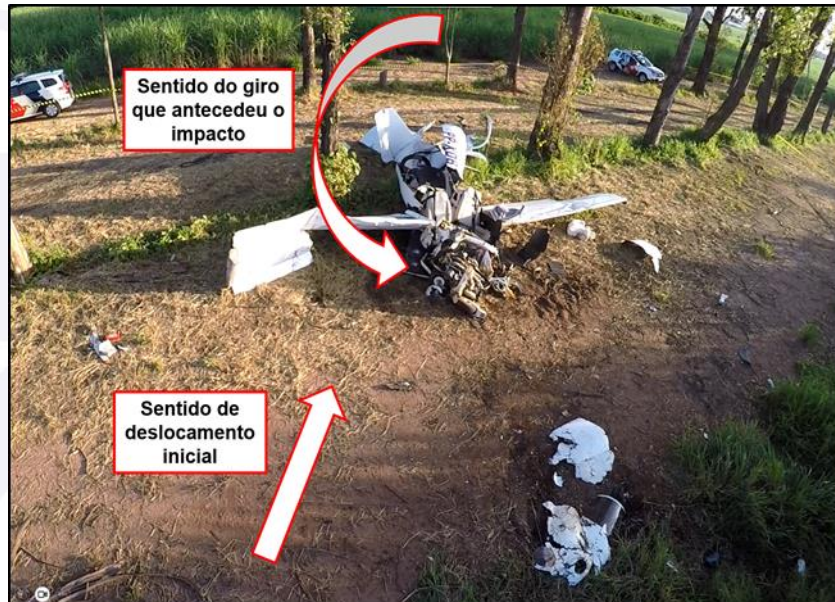
The torsion marks observed on the fuselage, and the final position of the wreckage indicated that a 180°-rotation relative to the takeoff path had been made (Figure 8). The presence of broken branches in the trees indicated that the aircraft's final trajectory was practically vertical.

Figure 8 - General view of the wreckage and of the impact dynamic.

The debris had a concentrated aspect, characterizing an impact at low speed and high angle, with barely any forward movement. Parts of the engine cowling and one of the propeller blades were projected toward the front of the aircraft at the impact.

Also, even though the cabin controls and indicators were severely damaged, one was able to identify that the power lever was fully advanced and that the fuel selector was in the "ON" position.

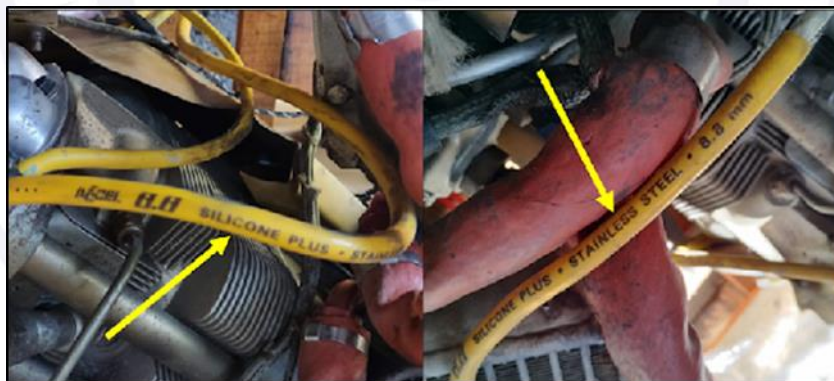
The analysis began with a checking of the ignition system installations, in which one observed that the spark plug wires had the following identification: ACCEL 8.8 SILICONE PLUS - STAINLESS STEEL 8.8 mm (Figure 9). Subsequent study revealed that those components were proper for automotive applications.

Figure 9 – Spark-plug cables used in the aircraft engine.

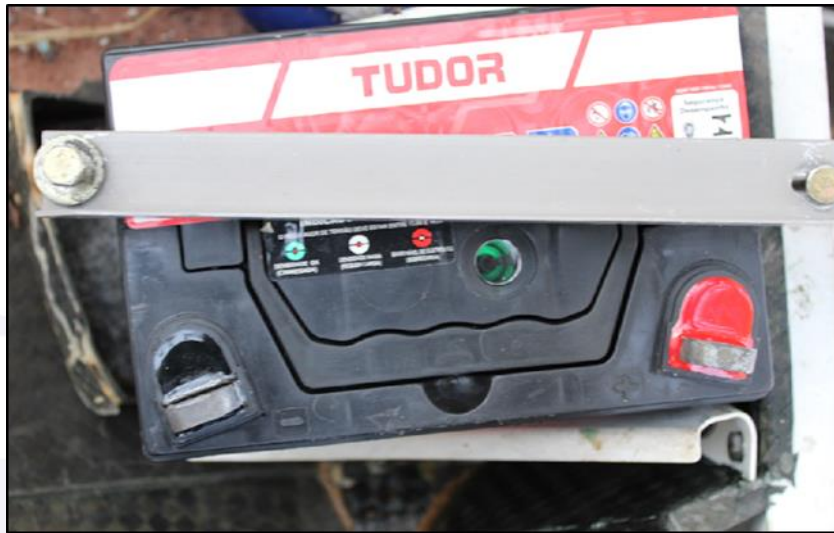
Upon observing other components of the aircraft, one found that the battery was also for automotive applications (Figure 10). According to writings on its label, the battery was certified in accordance with the norms of the Brazilian Association of Technical Standards (ABNT) NBR 15914 and 15940, which referred to lead-acid batteries for use in motor road-vehicles with four wheels or more.

Figure 10 - Main battery installed on the aircraft.

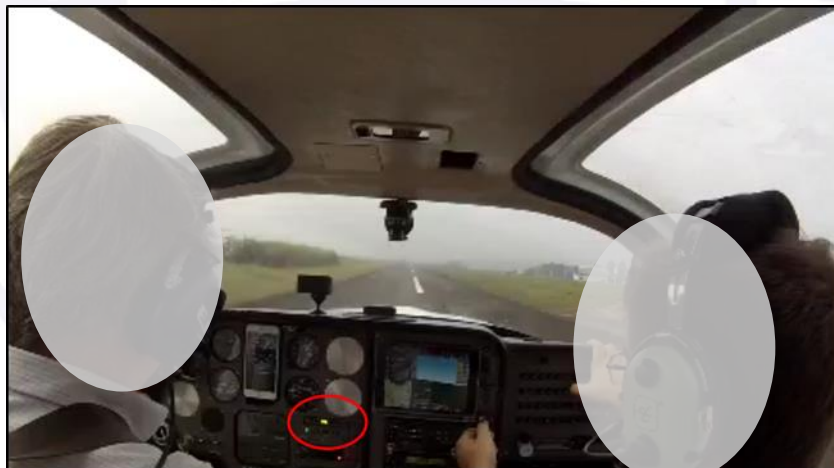
Approximately 13 seconds after the release of the brakes, the FADEC CAUTION light on the annunciator panel illuminated (Figure 13). It remained illuminated for 2 seconds, then came on after eight seconds, remaining lit for 1 minute and 20 seconds. A third episode of illumination of the referred warning light with duration of 10 seconds was observed when the aircraft was approximately 2 minutes into the flight.

Figure 13 - Takeoff run in SDNI. The red circle highlights the "FADEC CAUTION" light illumination on the HSA panel.

Despite the lack of sufficient data to confirm the reason for the aircraft's loss of performance, the warning lights in the FADEC system, observed in the recordings of the previous flight, indicated that a first failure in the system had already occurred and, according to the AFM, a second failure would result in total or partial loss of engine power.

Considering that the FADEC CAUTION warning and other lights on the HSA panel were already indicating failures of the system, the most likely hypothesis is that they worsened during the takeoff from SDBB, leading to the loss of power that preceded the loss of control in flight.

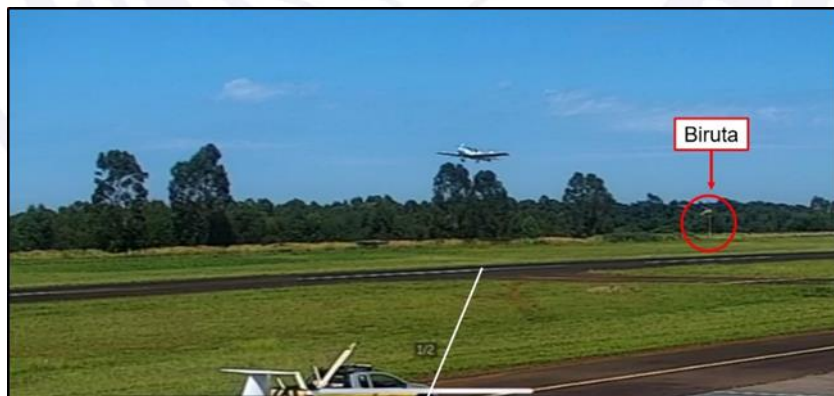
As for the takeoff from SDBB, images from a camera installed at the *Aeroclube de Bebedouro* made it possible to observe that, at approximately halfway down the runway, the PP-XDB was off the ground but had not yet reached the height of the neighboring trees, which were approximately 10 m tall. (Figures 18 and 19).

Figure 18 – Video frame of the aircraft taking off from SDBB, moments after passing by the windsock, and close to the central intersection of the runway.

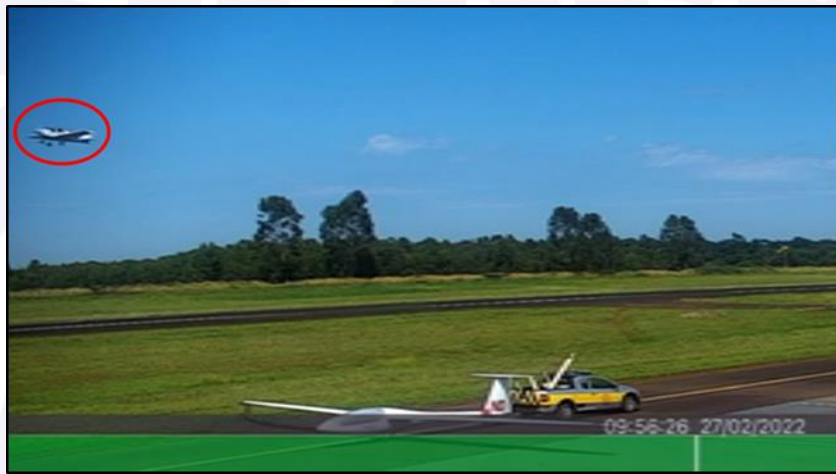
The images collected allowed one to observe just part of the takeoff. It was possible to notice that the aircraft maintained a low rate of climb after rotating. External observers, who also watched this video, described that the aircraft gained little or no height at all after passing over the left lateral limit of the image captured by the camera (Figure 20).

Figure 20 - Last image (in highlight) of the aircraft captured by the surveillance camera of *Aeroclube de Bebedouro*.

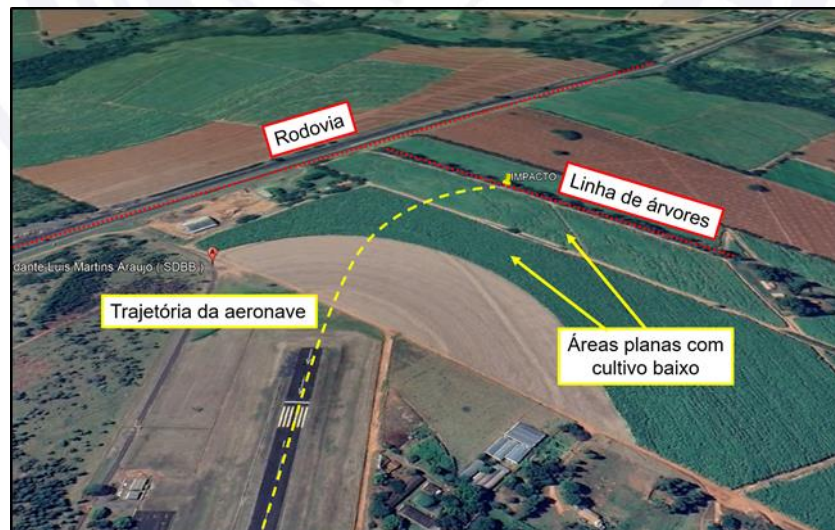
One verified the existence of several areas both to the right and to the left of the aircraft that could have been used for an emergency landing, had the flight controls of the aircraft been applied in time to maintain its speed above the limit at which the loss of lift would occur.

Figure 21 - Aircraft trajectory to the point of impact, highlighting the areas in which an emergency landing could have been made.
