COMANDO DA AERONÁUTICA
CENTRO DE INVESTIGAÇÃO E PREVENÇÃO DE
ACIDENTES AERONÁUTICOS

FINAL REPORT
A-055/CENIPA/2020

| AIRCRAFT: | PP-ZCA |
| MODEL: | RV-7A |

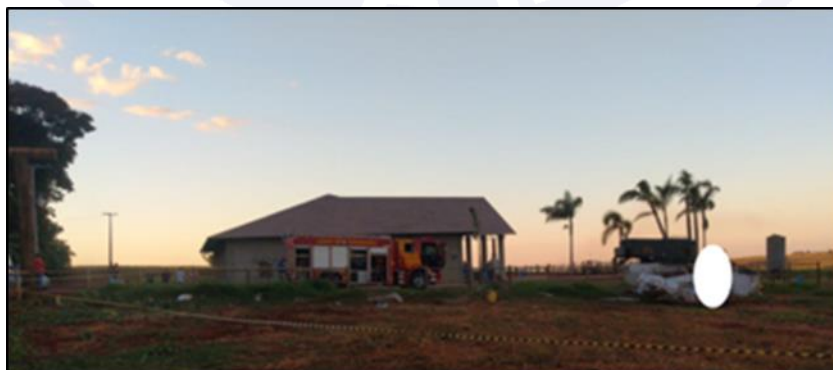
Figure 1 - Aircraft crash-site, and the sky without restrictive/significant weather conditions.

According to the meteorological data gathered, the conditions were consistent with VFR flights.]

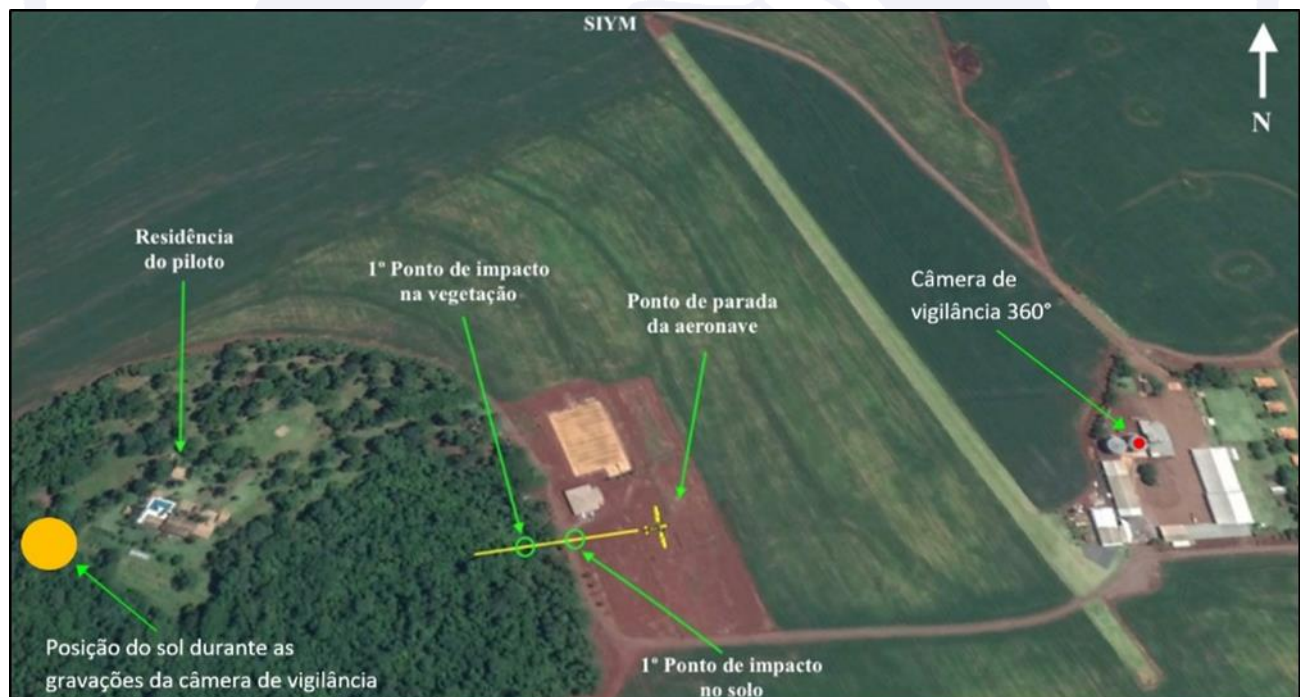
[One verified that the crash-site was located between the airstrip of SIYM and the pilot's residence. Reports from witnesses informed that the airplane, after taking off with a passenger on board, remained flying at low altitude, performing a number of maneuvers both over the airstrip and the pilot's residence (Figure 2).

Figure 2 – A sketch of the occurrence, highlighting the points of impact on the trees and on the ground, as well as the final stop of the aircraft.

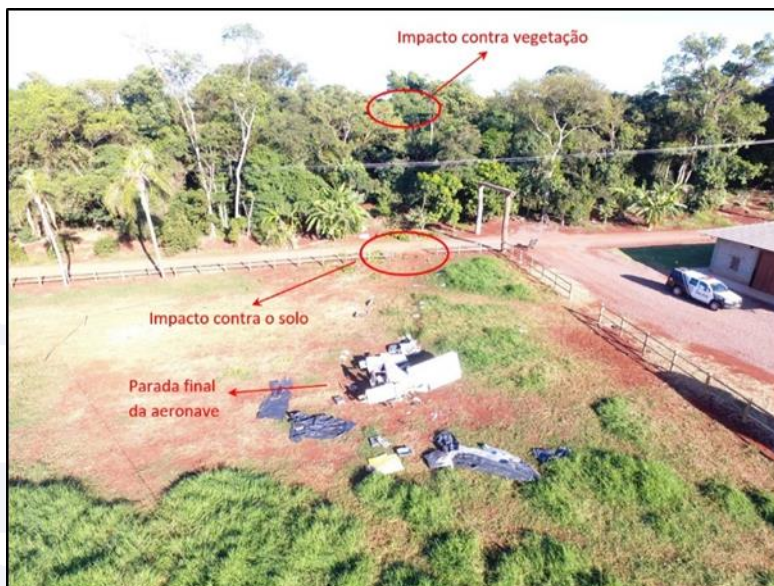
The aircraft first collided with tree branches and then with the ground, skidding for about 45 meters before coming to a complete stop (Figure 3).

Figure 3 - View of the impact points on the vegetation and on the ground. |

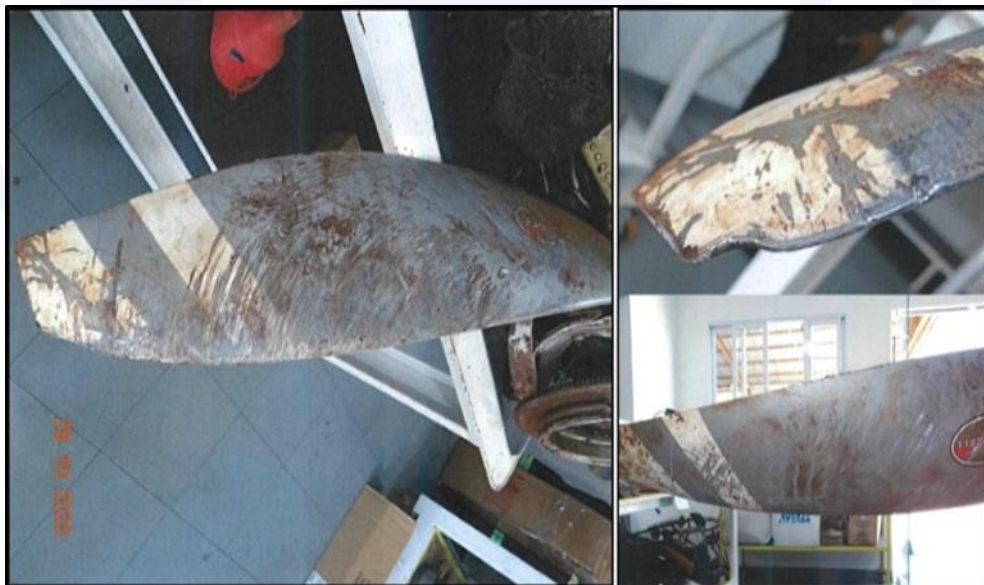
The propeller blades showed evidence of engine power development at the time of the accident. There were transverse scratches on both blades, which presented forward bends (Figure 4).

Figure 4 - (LE) View of the transverse scratches on the blade.

(DIR) Transversal scratches and forward bending at the end of the blade.

A rupture occurred at an angle of 45° on the crankshaft, next to the coupling flange with the propeller. That was another evidence of the normal operation of the engine, with development of power at the time of the accident.

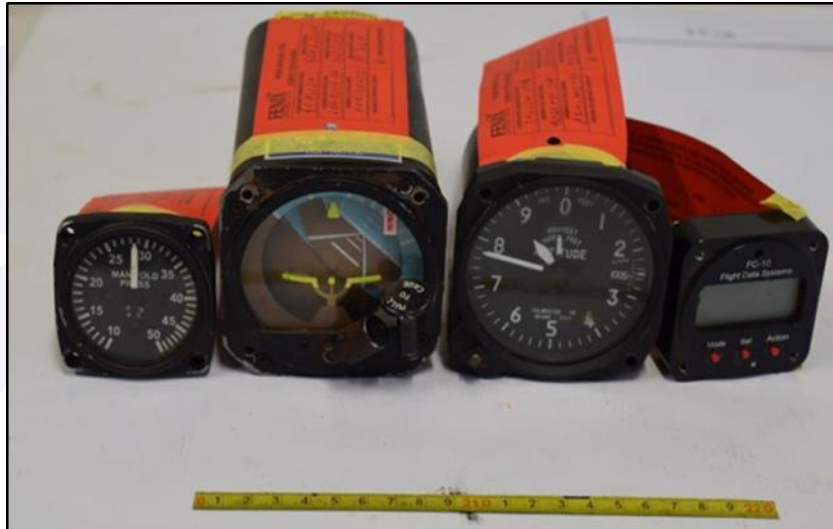
The stereoscopic examinations of the instruments revealed no marks of impact of the internal movable surfaces against the respective protective glass. Thus, it was not possible to identify any flight parameters by means of that analysis.

There were fractures on the back of the Indicator Altitude Gyro and the Fuel Computer, due to overload in both of them.

The fact that the Fuel Computer instrument was digital, and without non-volatile memory information, made it impossible to read out the data (Figure 6).

Figure 6 - View of the Manifold Indicator, Indicator Altitude Gyro, Altimeter and Fuel Computer instruments. |

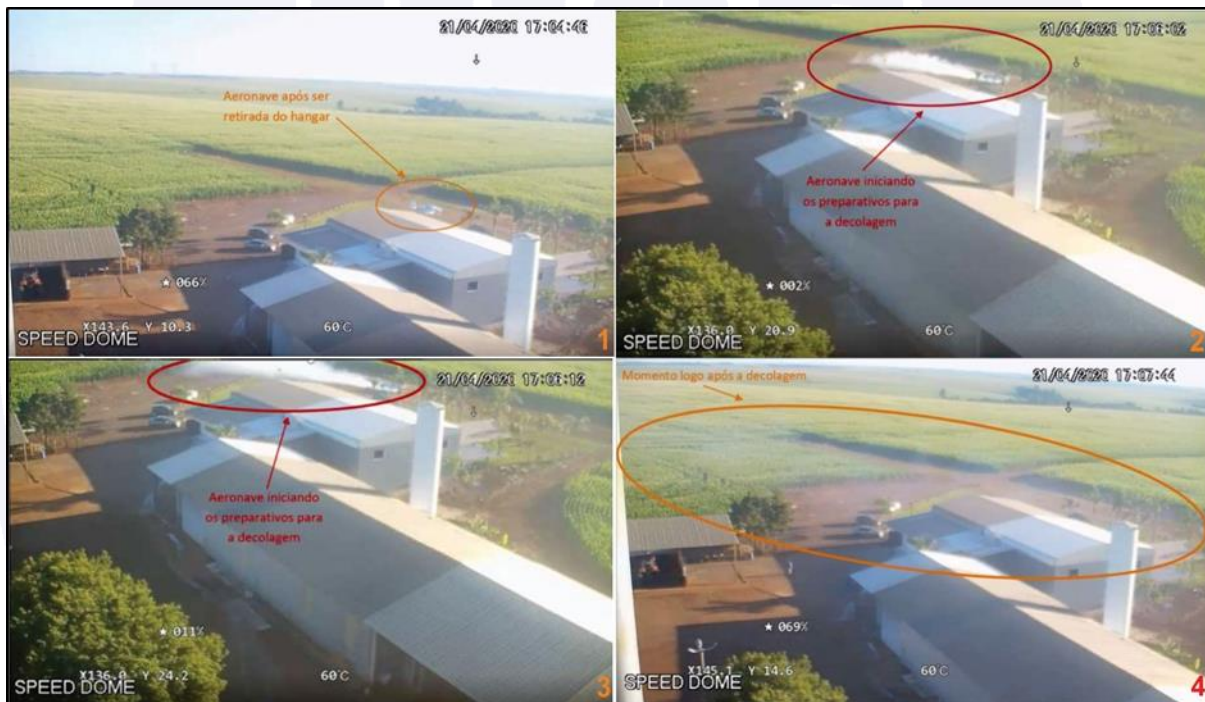
Figure 7 - (Images 1, 2 and 3) Aircraft starting preparations for takeoff.

(Image 4) Moment right after takeoff showing smoke still present on the runway.

When the pilot accelerated the aircraft's engine to start the takeoff run, the security camera revealed dense smoke coming out of the aircraft's exhaust. Such smoke was produced by a special piece of equipment that threw oil into the hot exhaust, aiming to make the aircraft leave a white trail of smoke along the flight path. This is a commonly desirable effect in aerobatic aircraft.
