**COMANDO DA AERONÁUTICA**  
**CENTRO DE INVESTIGAÇÃO E PREVENÇÃO DE**  
**ACIDENTES AERONÁUTICOS**

**FINAL REPORT**  
**A - 082/CENIPA/2018**

<b>OCCURRENCE:</b>	<b>ACCIDENT</b>
<b>AIRCRAFT:</b>	<b>PP-MHJ</b>
<b>MODEL:</b>	<b>PZL-SW4</b>
<b>DATE:</b>	<b>04MAY2018</b>

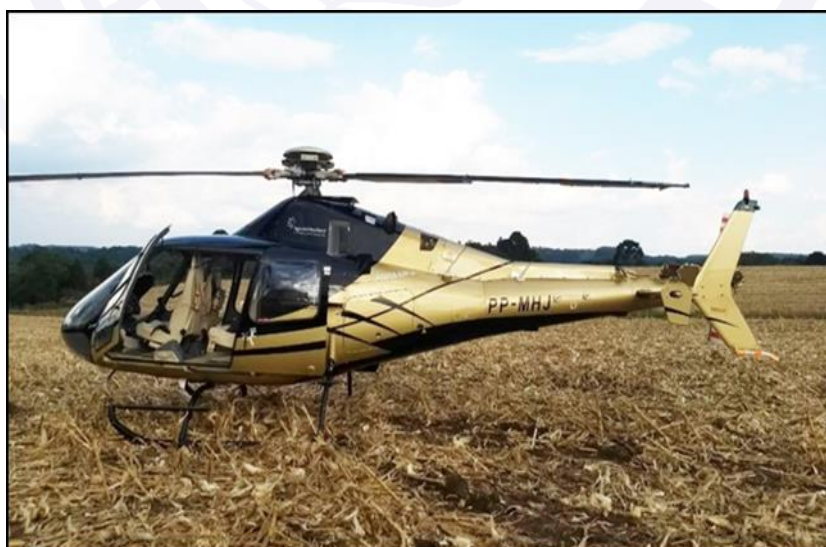
The aircraft had substantial damage to the main rotor, the structure (transmission fairing on the right side), the tail cone and the horizontal stabilizer (Figures 1, 2, 3 and 4).

Figure 1 - PP-MHJ aircraft shortly after the occurrence.

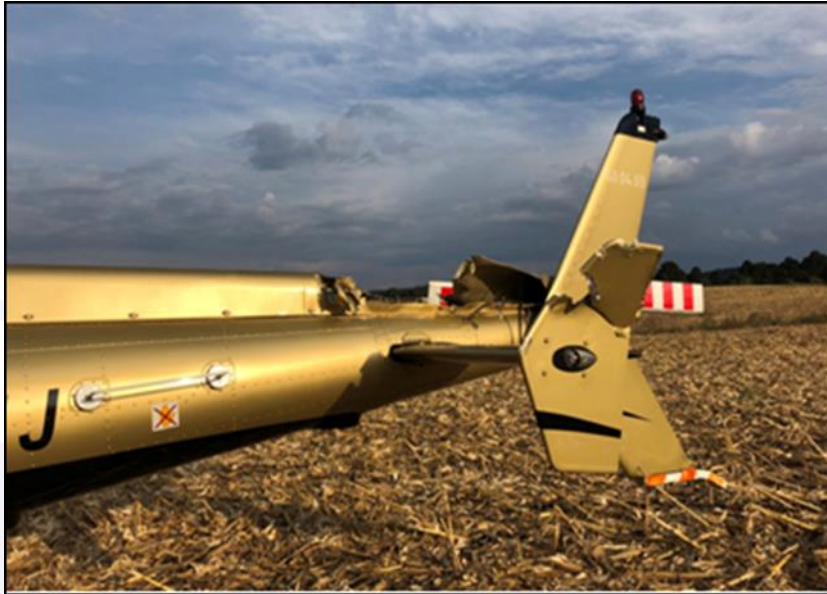
Figure 2 - Damage to the aircraft's tail cone and horizontal stabilizer.

The aircraft touched the ground and ran about 15 meters. At the moment of the touch, the blades of the main rotors collided with the tail cone and against the horizontal stabilizer.

The damage observed in the outermost portion of the main rotor blades, in the tail cone and in the horizontal stabilizer were compatible with an impact after landing.

The investigators also concluded that the damage observed in the outermost portion of the main rotor blades, the tail cone and the horizontal stabilizer occurred during landing, due to an involuntary and / or very wide movement of the cyclic control.

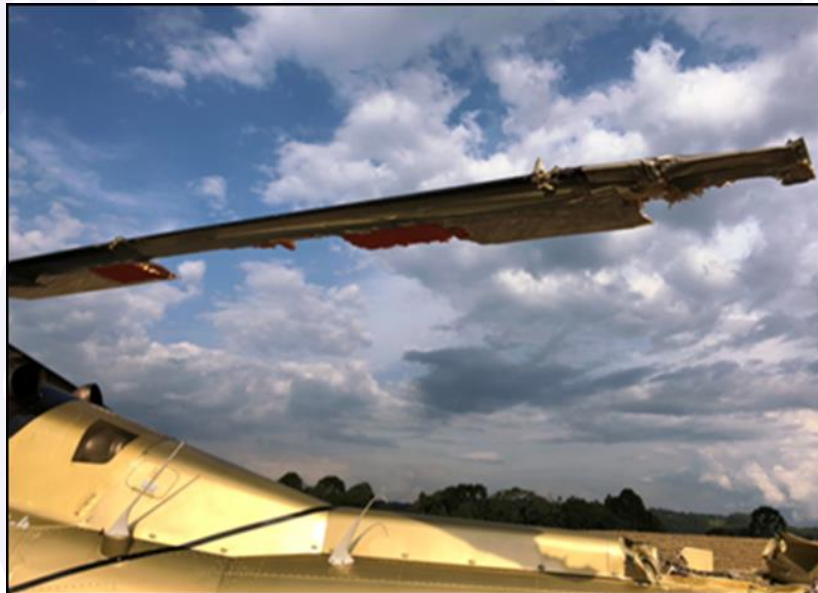
Figure 3 - Damage to the main rotor blades.

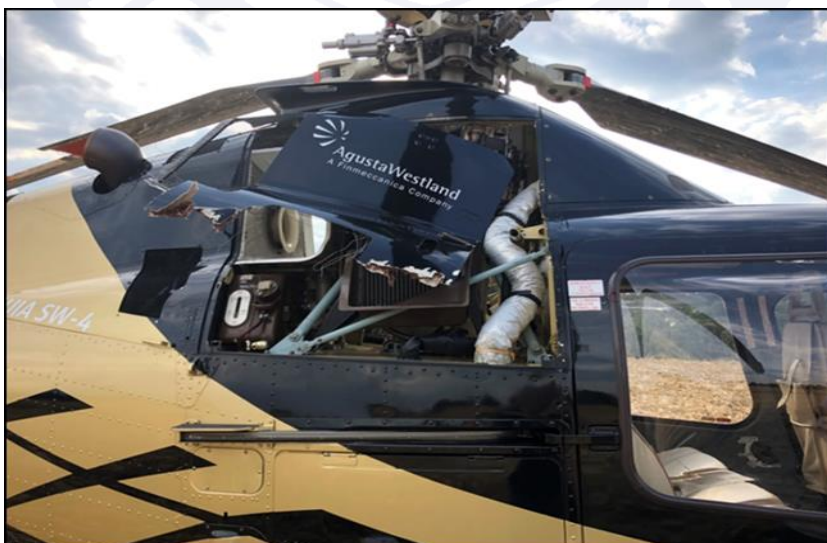
Figure 4 - Damage to the transmission fairing door on the right side.

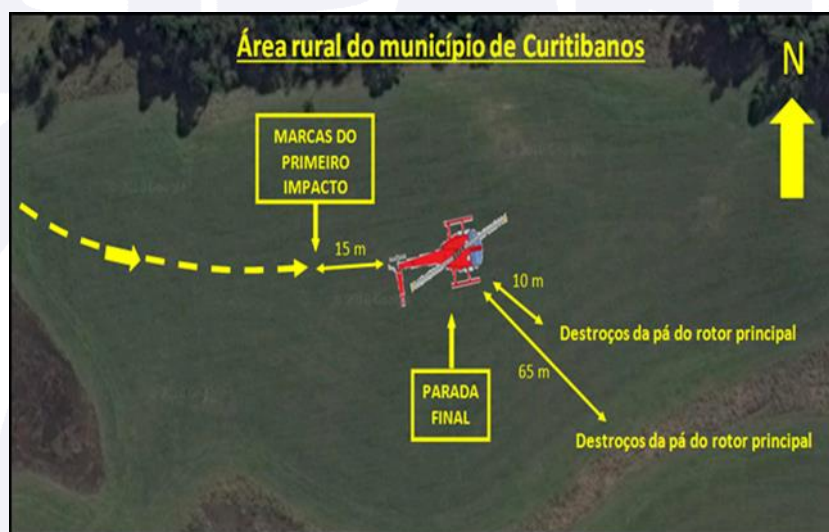
Some wreckage from the main rotor blade were found about 65 meters away from the aircraft (Figure 5).

Figure 5 - Aircraft trajectory until the final stop spot.

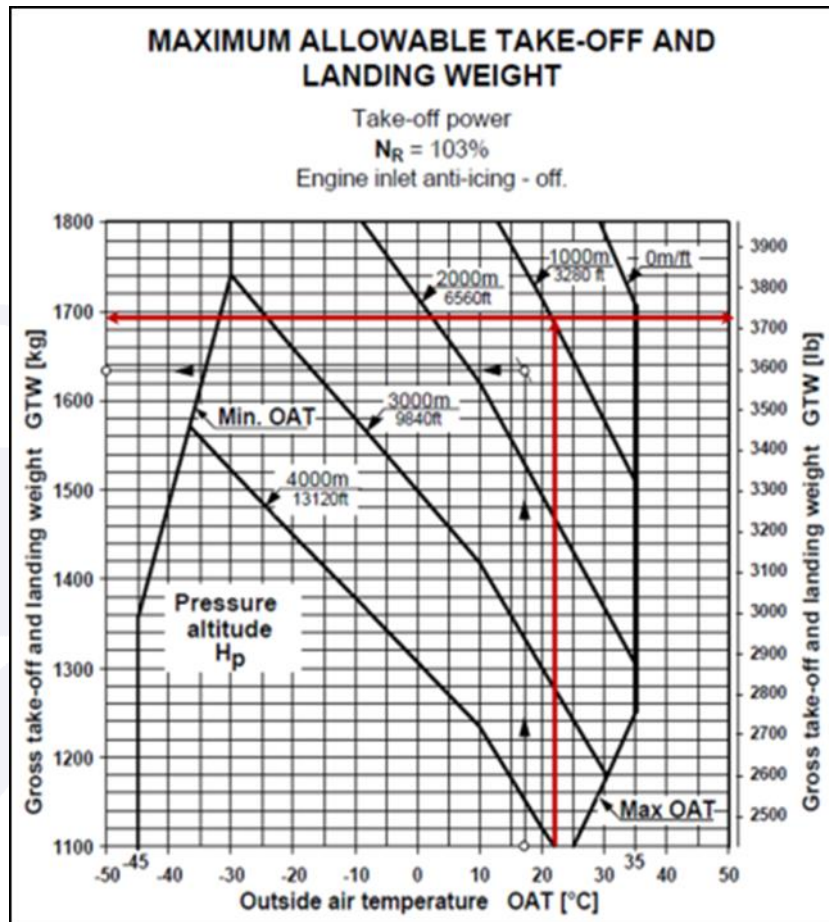
The altitude of the departure Aerodrome (SSKU) was 3,209 feet (978m). According to the pilot, the temperature was of 22°C. Based on these data, it was calculated that the maximum take-off weight of SSKU would be 1,695 kg (Figure 6).

Figure 6 - Calculation of the maximum takeoff weight for a temperature of 22°C.

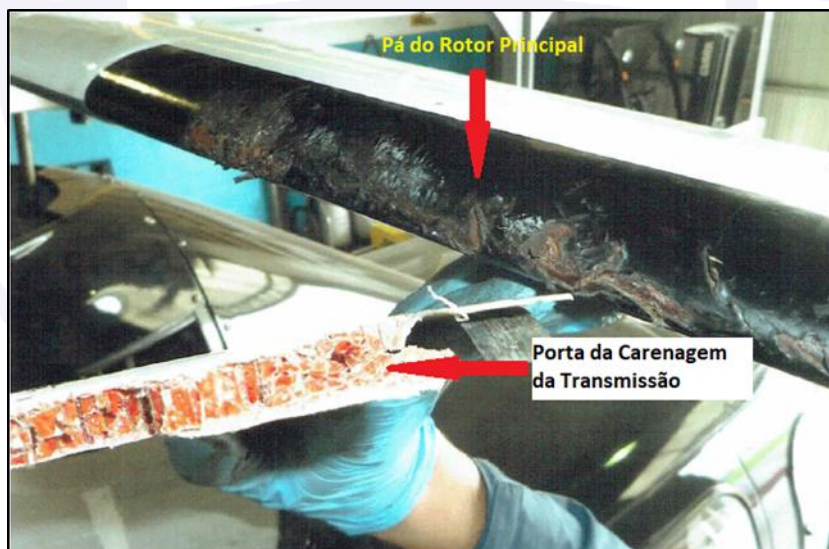
The Examination of the main rotor blades revealed the presence, in one of them, of damage to its leading edge, in a region close to its root (Figure 7).

Figure 7 - Damage marks on the leading edge of the rotor blade and the fairing door.

These damages, apparently, were not enough to produce major changes in its aerodynamic function.

The damage observed on the leading edge of one of the blades of the main rotor, in a region close to its root, apparently, was not sufficient to produce major changes in its aerodynamic function.

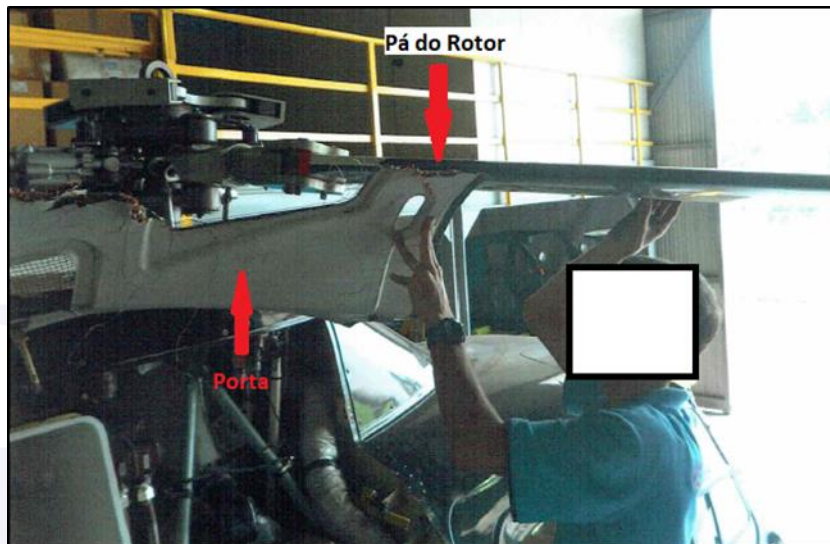
The transmission fairing door had a fracture in a region aligned with the passage of the main rotor blades. (Figure 8).

Figure 8 - Alignment between the fairing fracture and the rotor blade.

Examinations by the IAE Materials Division showed that there was no significant damage to the four grooves of the lock latch on the damaged fairing door. There was no evidence of fracture or severe damage to indicate that the latches had broken their grooves.

On the other hand, the examinations performed on the right door of the transmission fairing showed that it had a fracture in a region aligned with the passage of the blades of the main rotor. The existence of corresponding damage to the leading edge of one of the blades,

in a region close to its root, led investigators to conclude that the aforementioned door opened in flight and was hit by the main rotor.

Considering that there was no significant damage to the four grooves of the locks and that there was no evidence of fracture or severe damage to the latches that kept this door closed and locked, it was concluded that, during the preparation for takeoff, it was left in a condition that allowed it to open in flight.
