**FINAL REPORT**  
**IG - 048/CENIPA/2017**

<b>OCCURRENCE:</b>	<b>SERIOUS INCIDENT</b>
<b>AIRCRAFT:</b>	<b>PP-PTQ</b>
<b>MODEL:</b>	<b>ATR-72-212A</b>
<b>DATE:</b>	<b>23MAR2017</b>

This is the Final Report of the 23MAR2017 serious incident with the ATR-72-212A aircraft model, registration PP-PTQ. The accident was classified as “[SCF-NP] System/Component Failure or Malfunction Non-Powerplant – With Flight Commands”.

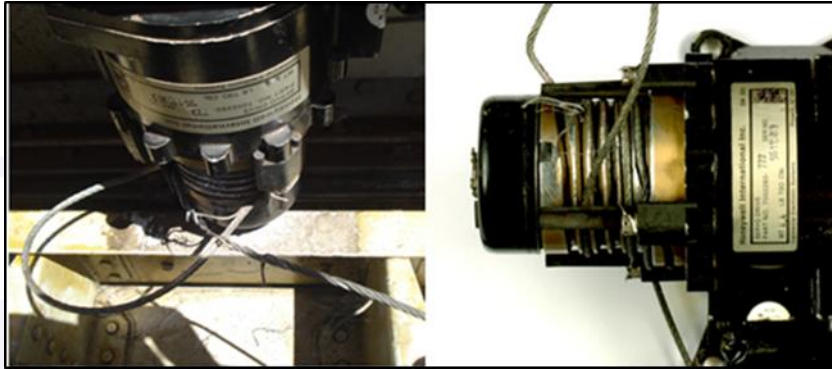
After removing the Servo Drive from the plane, together with the broken control cable, it was found that the rotating mechanism where the cables were rolled up, called capstan, was blocked and prevented from turning (Figure 6).

Figure 6 - Servo Drive removed from the aircraft with its cable broken.

Thus, it was concluded that the capstan was locked due to the control cable becoming entangled in the drum after breaking. In turn, the restrictions on the aileron command were due to the capstan being blocked by the broken cable.

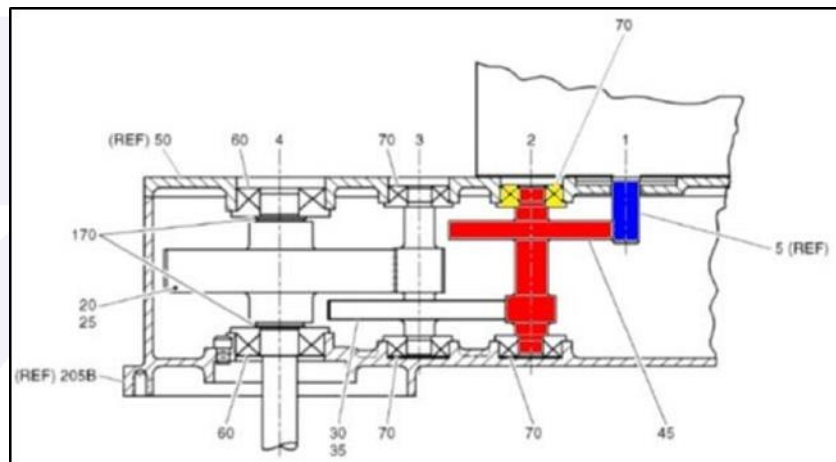
After separating the section of the electric engine / gearbox, with the disconnection of its gear set (n° 45, in red in the diagram below), the front block could be rotated without any resistance. However, the electric engine shaft (part n° 5, in blue) showed some resistance to manual rotation. The bearing (n° 70, in yellow) appeared to be in good condition (Figure 8).

Figure 8 - Identification of the electric engine / gearbox coupling components to the central body of the Servo Drive.

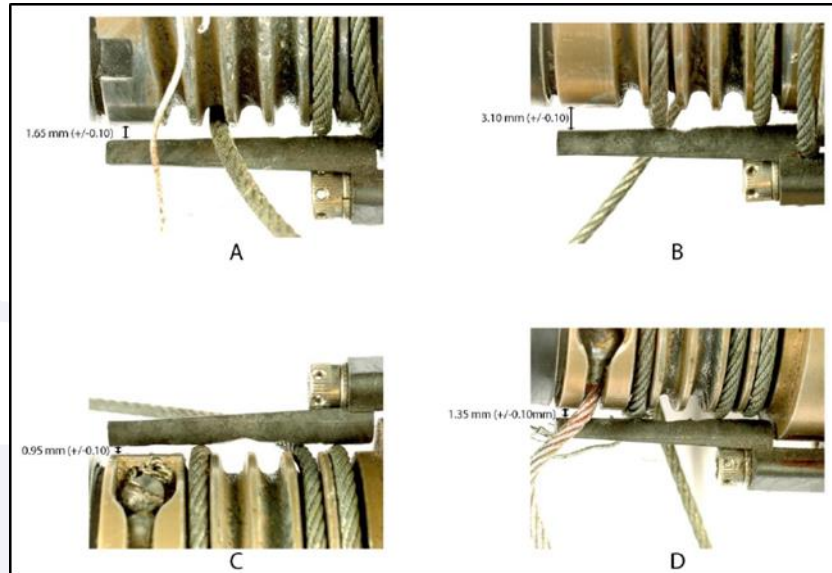
They ranged from 0.95 to 3.10mm (+/- 0.10mm). The CMM required a maximum of 0.040 inches (1.016mm). No wear on the cable keepers was observed with the naked eye at the measurement positions. Wear areas have been identified in other regions, probably due to the friction between the cable keepers and the cables (Figure 10).

Figure 10 - Details of measurements and wear observed on cable keepers.  
Source: BEA.

In addition, measurements of the distances between the four cable keepers and the drum showed that three of them were further away from the capstan than recommended in the CMM and that they had regions of wear, probably due to the friction between them and the control cables.

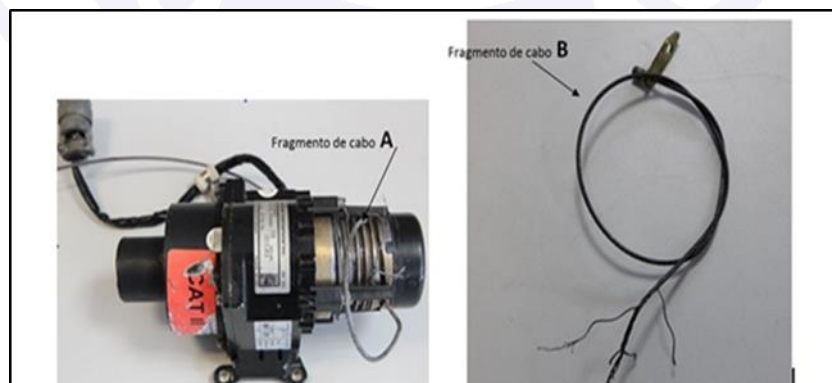
Figure 12 - Cable fragment connected to the Servo Drive (A) and cable fragment that was connected to the bellcrank (B).

The tests carried out showed that there were signs of wear, plastic deformation and ductile fractures, as well as the presence of corrosion on the surface of the cable.

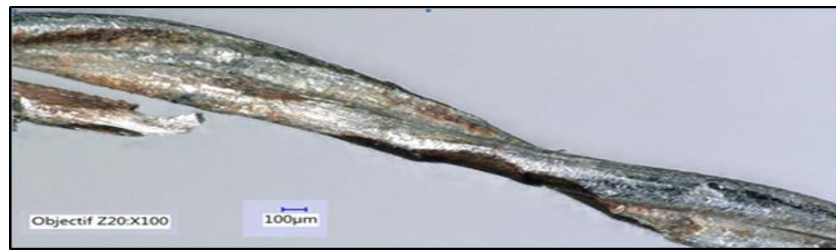
Figure 13 - Enlarged view of control cable wires removed from the Servo Drive with marks of plastic deformation and oxidation on the surface.

The corrosion found on the surface of the cable could be a consequence of the time elapsed from the breaking event until the moment of analysis in the laboratory.

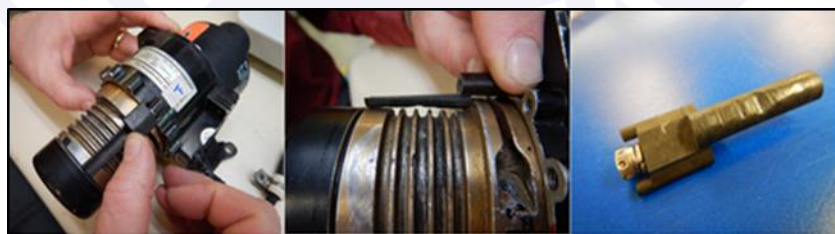
- the cable keepers were worn on the part facing the cable drum (capstan).
- most of the wear on the cable keepers was on the inner face associated with the three internal notches (closest to the clutch) of the cable drum (Figure 19).

Figure 19 - Cable keeper positioned and a wear detail.

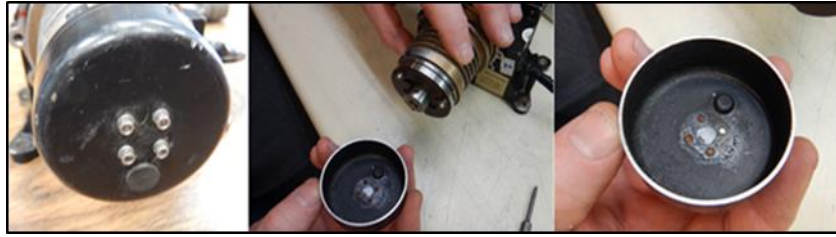
- the clutch mechanism cover screws were not tightened (they appeared to have been adjusted only with the fingers).
- all the braking wires had been removed: each screw was without the required braking wire.
- after removing the cover from the clutch mechanism, a small amount of debris was found in the capsule itself (Figure 20).

Figure 20 - Cover without the braking on the screws and detail of the debris.

Regarding the clutch mechanism cover screws, which were not tightened, the absence of the braking wire and the cable keepers and their fastening elements, which were not in the intended place, it was noted that this occurred during a partial disassembly, previously performed at the BEA facilities.

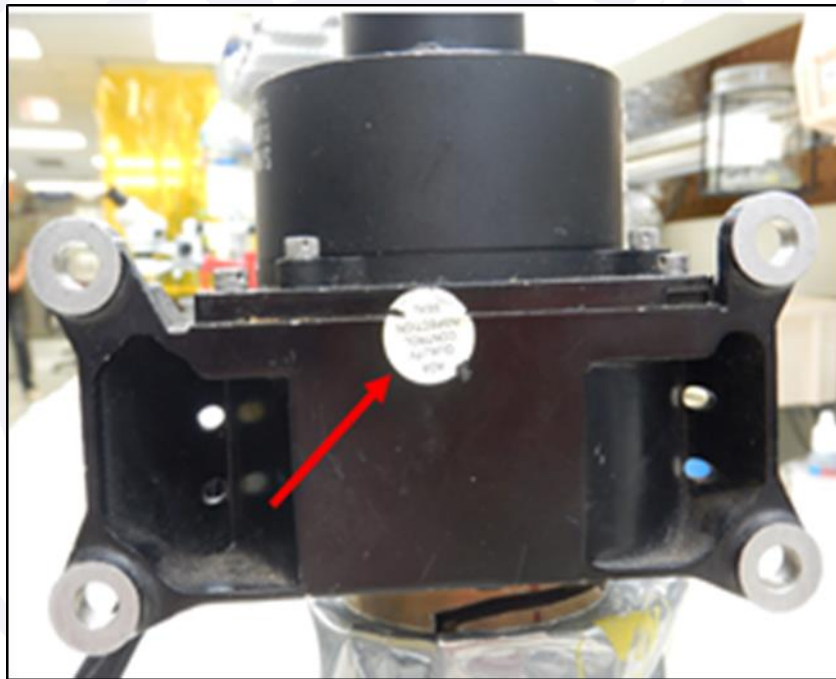
- the quality control seal on the underside, located between the engine cover and the gears train, was broken (Figure 22).

Figure 22 - Quality control seal broken.
