COMANDO DA AERONÁUTICA
CENTRO DE INVESTIGAÇÃO E PREVENÇÃO DE
ACIDENTES AERONÁUTICOS

FINAL REPORT
A-046/CENIPA/2022

OCCURRENCE:	ACCIDENT
AIRCRAFT:	PR-AAM
MODEL:	A188B
DATE:	14ABR2022

This is the Final Report of the 14th April 2022 accident with the model A188B aircraft, registration marks PR-AAM. The occurrence was typified as “[LALT] Low altitude operation”.

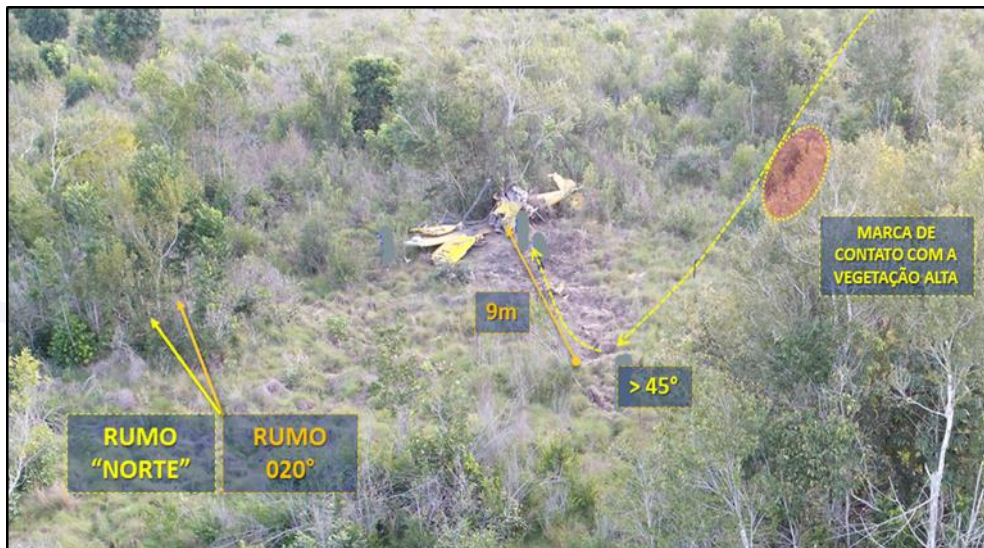
Figure 3 - Estimated aircraft crash trajectory.

The aircraft initially collided with the treetops, when its heading was approximately 020°.

Subsequently, the aircraft hit the ground, first, with the left wing, in a “pitch-down” attitude and banking to the left, causing separation of the left wing from the fuselage, as well as separation of the propeller assembly from the engine shaft. The aircraft traveled another 9 m before coming to a stop.

The wreckage was concentrated, with the fuselage resting in an upside down position and close to 120° in relation to the axis of movement on the ground (Figure 3).

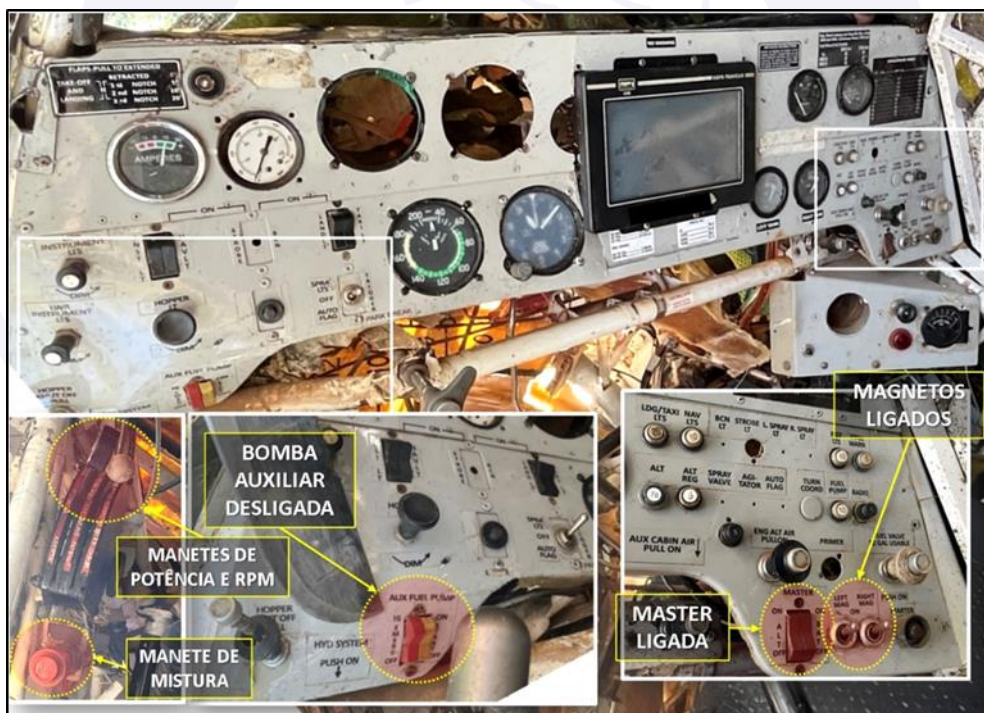
Figure 4 - Detail of the aircraft panel after the accident.

As for the controls and instruments in the cockpit, the magneto switches were at the "ON" position, the power and RPM levers at $\frac{3}{4}$ of their course, the mixture lever at "RICH", the auxiliary fuel pump at "OFF", the master at "ON", indicating that the aircraft was configured for normal flight, showing no evidence of configuration for emergency operation (Figure 4).

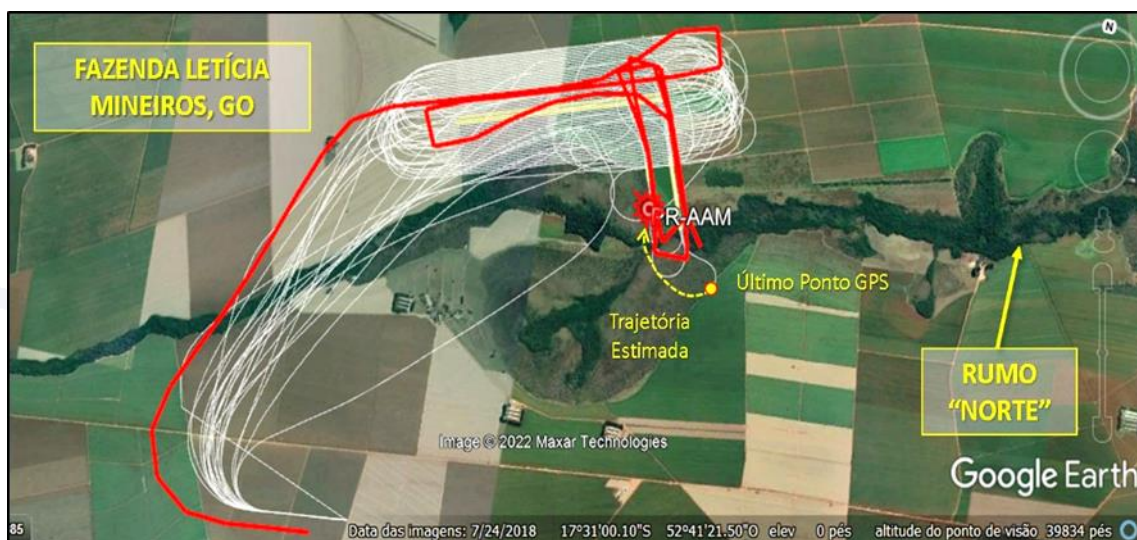
Figure 5 - Horizontal trajectory flown by the aircraft. Source: DGPS of PR-AAM – Adapted from Google Earth, 2022.

The non-volatile memory of the Digital Global Positioning System (DGPS) made it possible to verify the operation on *Fazenda Leticia*, relative to the previous flight of 11 April 2022 (white lines) and the operation of the flight on the day of the occurrence (red lines), with identification of the horizontal trajectory flown by the PR-AAM aircraft (Figure 5).

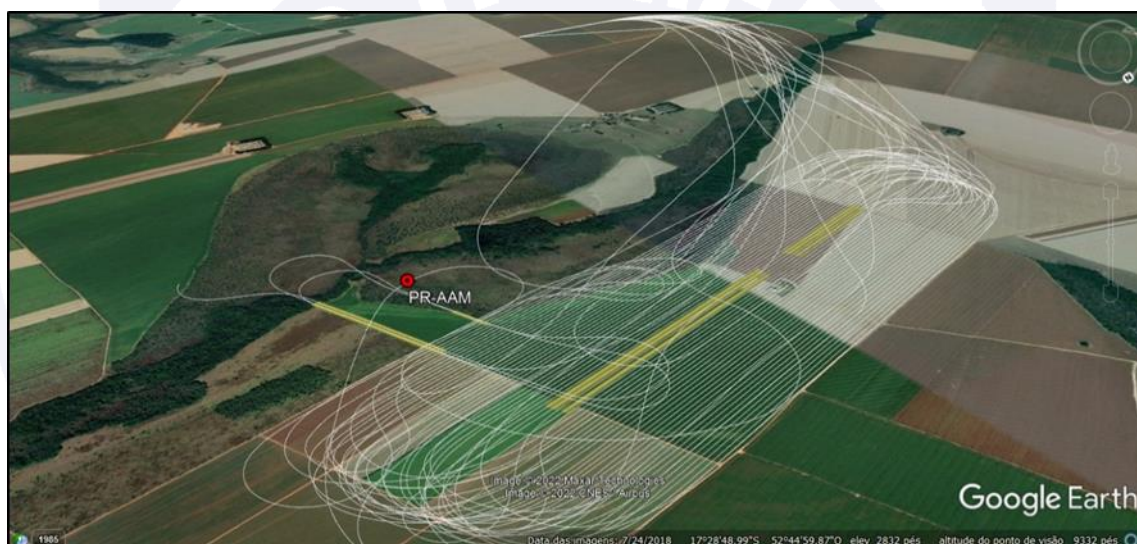
Figure 6 – Side perspective of the aeroagricultural application carried out by the aircraft. Source: DGPS of PR-AAM - Adapted from Google Earth, 2022.

Additionally, it was possible to observe, from a lateral perspective, the points of application in a direction perpendicular to the application of the day before, on a North-South axis (Figure 6).

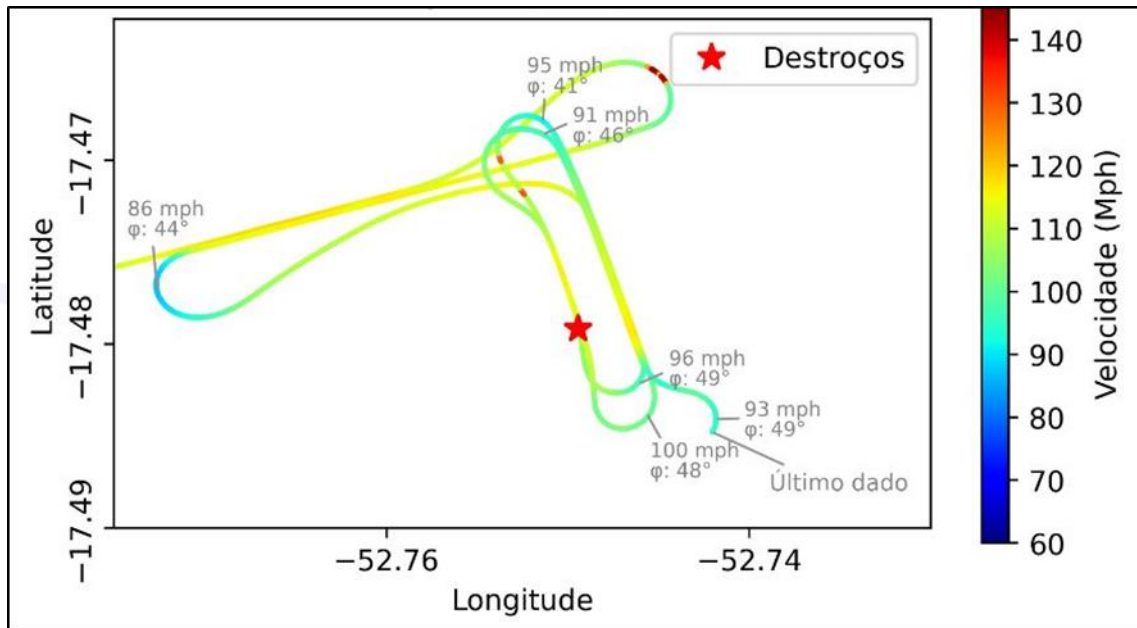
Figure 7 - Flight trajectory with estimated speed and wing banking.
Source: DGPS of the PR-AAM aircraft.

In addition to the profile and trajectory extracted from the DGPS, a simplified model was built to evaluate the flight pattern performed by the aircraft, correlating it with the performance data (Figure 7).

It was noted that the aircraft followed a trajectory with an opening of approximately 45° to the left, then turned to the right with an estimated wing banking of 49° at a speed of 93 MPH, as illustrated in Figure 7.

Although the last record of the aircraft speed showed values above the stall speed, it is not possible to rule out a possible increase in the wing banking angle to values greater than 45°, which may have caused a stall condition and loss of control of the aircraft.
