COMANDO DA AERONÁUTICA
CENTRO DE INVESTIGAÇÃO E PREVENÇÃO DE
ACIDENTES AERONÁUTICOS

FINAL REPORT
A-074/CENIPA/2021

OCCURRENCE:	ACCIDENT
AIRCRAFT:	PR-ABN
MODEL:	PA-25-235
DATE:	18MAI2021

This is Final Report of the 18 May 2021 accident with the PA-25-235 aircraft, registration marks PR-ABN. The accident was typified as “[SCF-PP] Engine failure or malfunction | Engine Failure in Flight.”

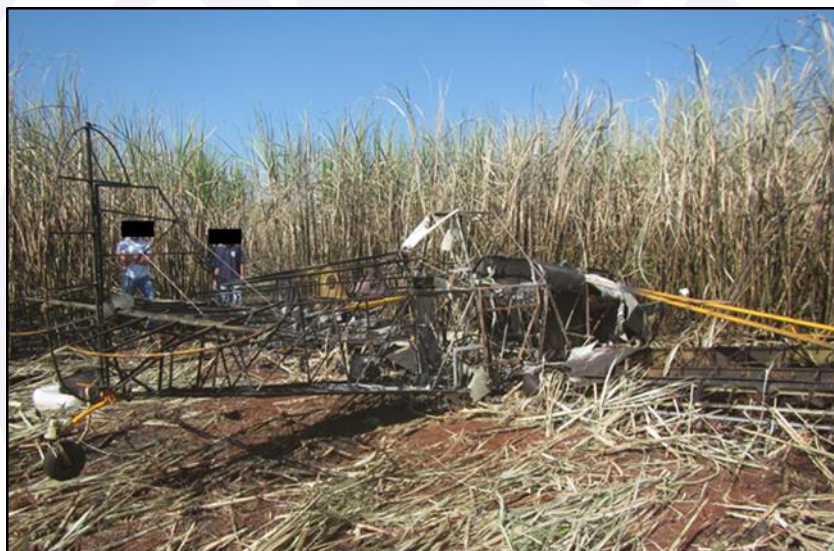
Upon landing, the aircraft caught fire and ended up destroyed.

Figure 1 - View of the aircraft after coming to a complete stop.

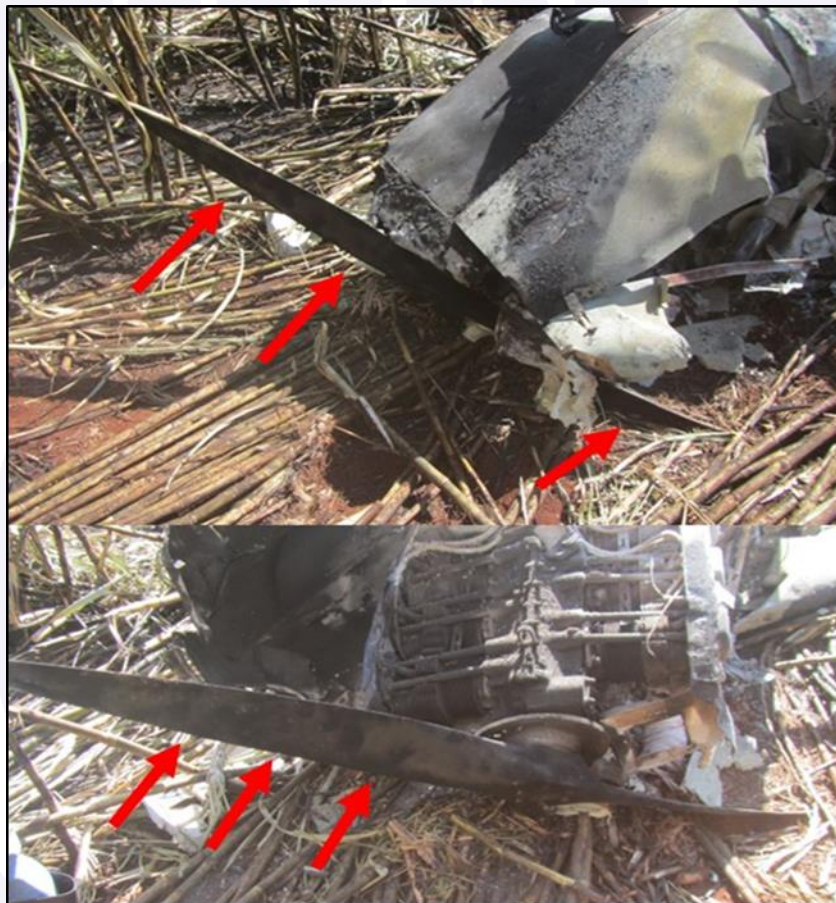
Due to the impact against the ground, the lower part of the aircraft and one of the propeller blades got bent before the fire engulfed the aircraft. The other blade had no marks or twists, showing that it had not made contact with the ground, and that the engine was not developing power at the time of the impact (Figure 3).

Figure 3 - Propeller of the PR-ABN

According to reports from the PIC and the characteristics evidenced in the wreckage during the initial action of the investigation, it was possible to conclude that the propeller was not functioning at the time of the impact, a condition that led to further examinations related to the propulsion of the aircraft.

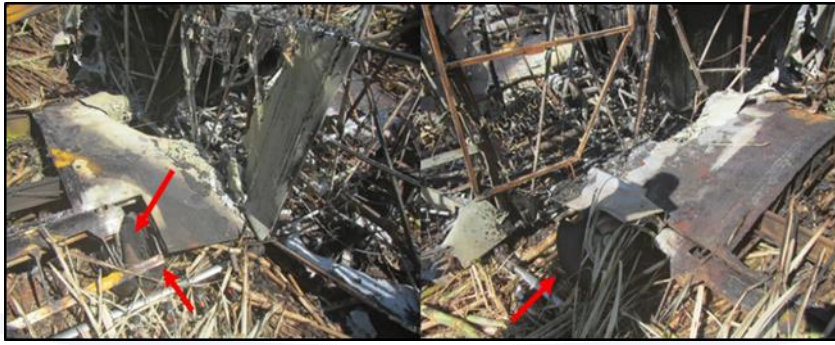
After the collision, the fire started in the front of the aircraft, and spread quickly. The flaps were in the down position (Figure 4), and the rudder deflected to the right (Figure 5); however, due to the destruction caused by the fire, it was not possible to verify the positions of the other control surfaces the aircraft.

The fixed-type main landing gear was broken near the connection with the aircraft (Figure 4), whereas the nose wheel showed no damage resulting from the impact (Figure 5).

Figure 4 - Flap lowered, with the left- and right- main gear attached to the aircraft.

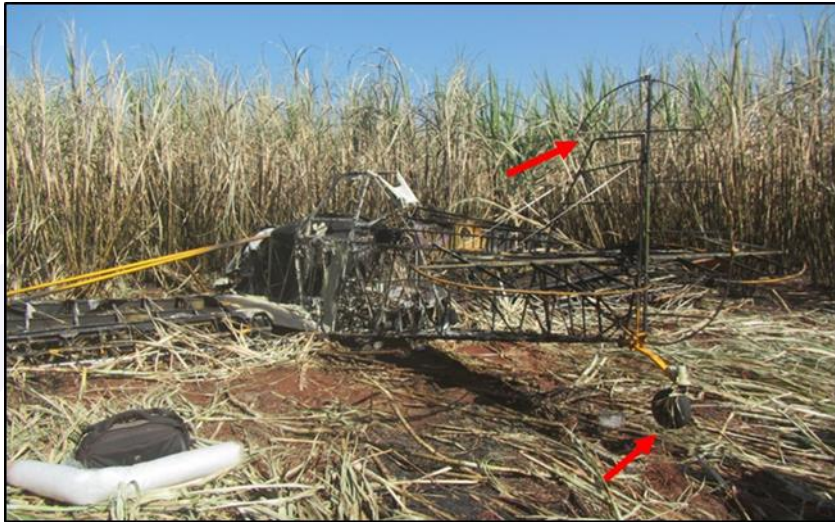
Figure 5 - Rudder deflected to the right, and tail-wheel of the aircraft.

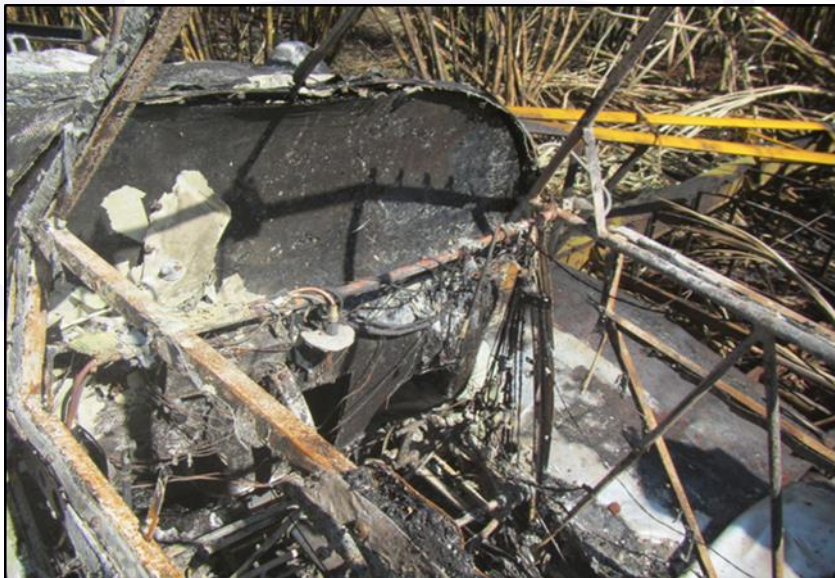
The level of destruction and charring of the aircraft made it difficult to verify the aircraft's pieces of equipment, accessories, and flight instruments (Figure 6).

Figure 6 - Charred cabin and instrument panel.

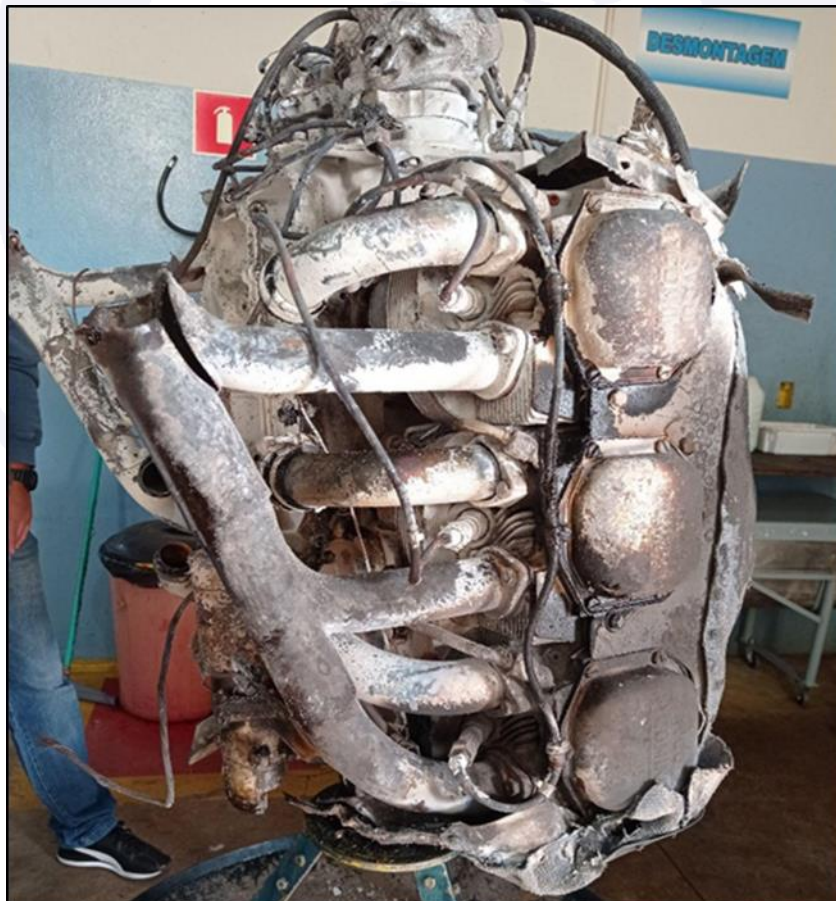
Figure 7 - View of the engine during the technical analysis.

The technical analysis of the engine showed severe damage caused by fire after the impact. The carbonized condition of the engine accessories and components prevented a comprehensive analysis of the engine system.

During the exams, one noticed that the engine's cylinders, pistons, conrod bushings, connecting rods, and bearings, did not have a color typical of lack of lubrication, making it evident that the engine's lubrication system had been functioning properly.

Inside the engine, there was no residue of lubricating oil due to the long exposure to the fire heat, which caused the fluid to evaporate. For this reason, the bushing of both the support bearings and connecting rods had no signs of oil on them. Also, it became evident that such evaporation did not occur during the flight, otherwise, the components already mentioned, together with the main bearing journals and connecting rods journals of the crankshaft, would have either melted or deformed, and would be presenting abnormal color.

It was not possible to make a proper assessment of the carburetor, exhaust system, muffler and fuel shut-off valve as they had been severely damaged by the fire, as seen in figures 6 and 7.

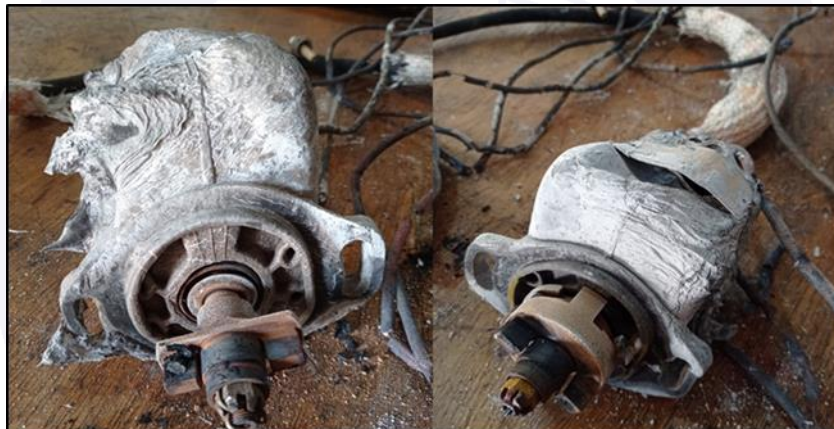
Doubts subsisted regarding the operability of the engine's ignition and fuel supply systems. The fire consumed or, at least, damaged the components of the abovementioned systems. Such condition prevented any type of analysis aimed at identifying whether or not the affected components contributed to the failure of the PR-ABN aircraft's engine.

Figure 8 - View of the damaged engine magnetos.

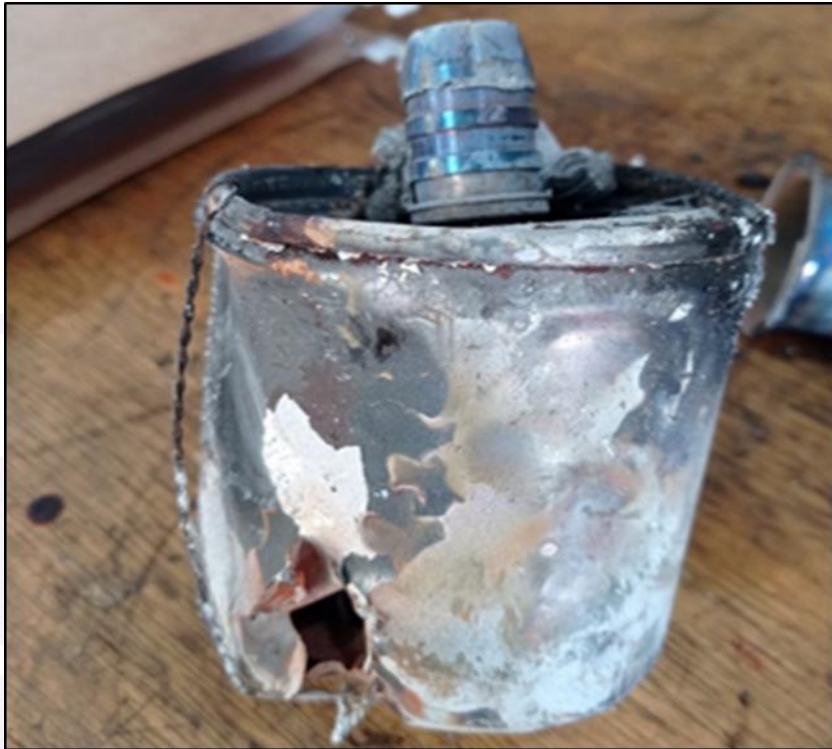
It was not possible to collect samples of the aircraft's engine oil for testing, due to the degree of carbonization of the engine.

Figure 9 - Charred oil filter.

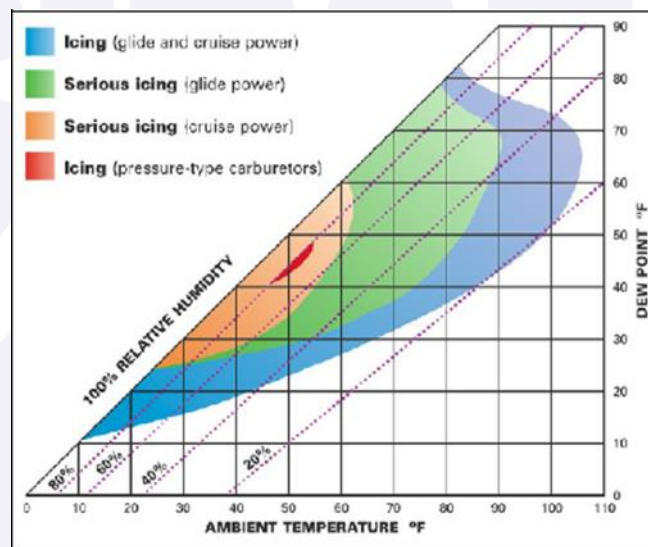
Using the temperature of 23° C (73.4° F) and the dew point of 15° C (59° F) reported in the SBYS METAR in the graphic above, a situation of high probability of ice occurrence would be found at glide power.

The carburetor icing hypothesis was ruled out, because using the air temperature and dew point reported on the SBYS METAR, 14 NM from the accident site, on the graphic presented in the FAA Bulletin, one would arrive at a situation of high probability of icing occurring (serious icing), in a glide power situation, however, it was reported by the PIC that he was not using reduced power in the reported event.
