COMANDO DA AERONÁUTICA
CENTRO DE INVESTIGAÇÃO E PREVENÇÃO DE
ACIDENTES AERONÁUTICOS

FINAL REPORT
A-050/CENIPA/2022

OCCURRENCE:	ACCIDENT
AIRCRAFT:	PR-AUG
MODEL:	SR22
DATE:	17ABR2022

This is the Final Report of the 17 April 2022 accident involving the SR22 aircraft, registration marks PR-AUG. the accident was typified as “[SCF-NP] System/Component Failure or Malfunction and [RE] Runway Excursion”.

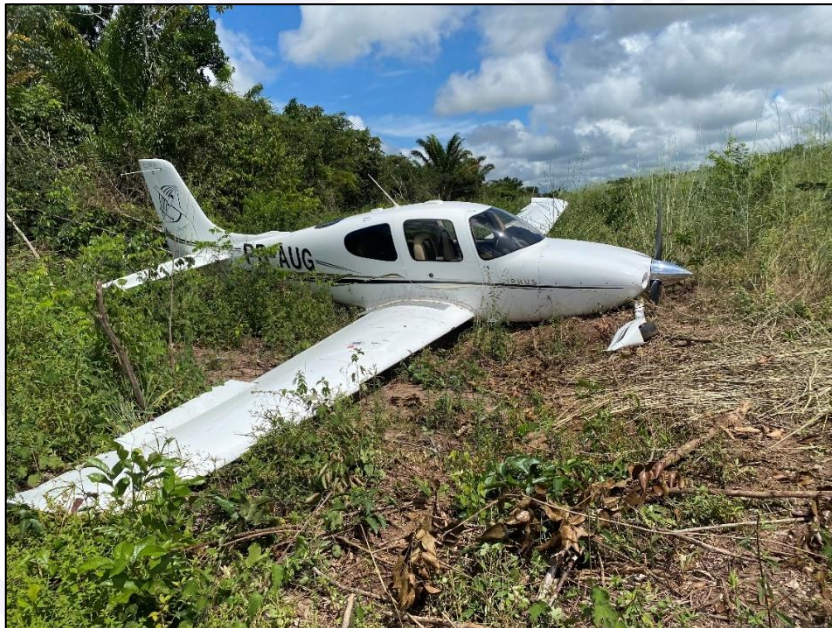
Figura 1 - Aeronave após o acidente.

The aircraft sustained substantial damage. The main and auxiliary landing gears broke and there was minor damage to the wings, fuselage, and tips of the propeller blades.

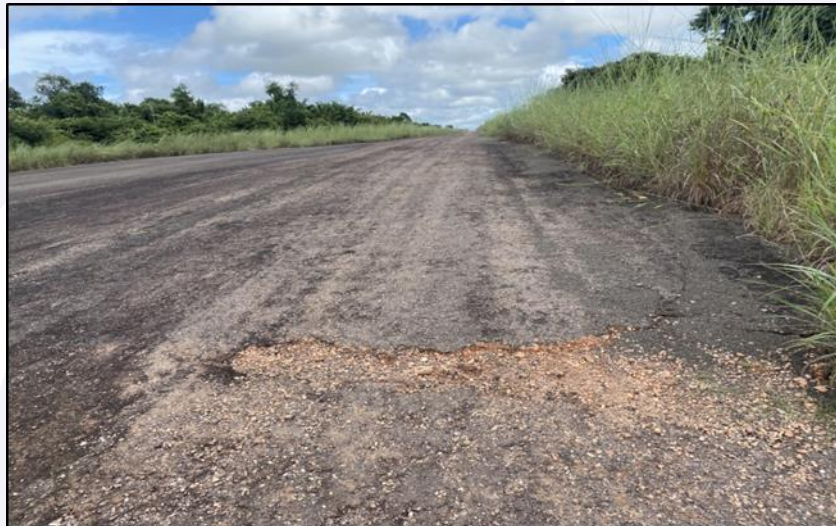
There were loose rocks along the entire length of the runway (Figure 5). Furthermore, according to reports from the pilot, the runway surface was wet at the time of the accident due to the rain in the region.

Figure 5 - Asphalt runway with loose rocks.

However, according to the pilot, the runway surface was wet, in addition to featuring loose stones along its entire length, something which would increase the required landing distance.

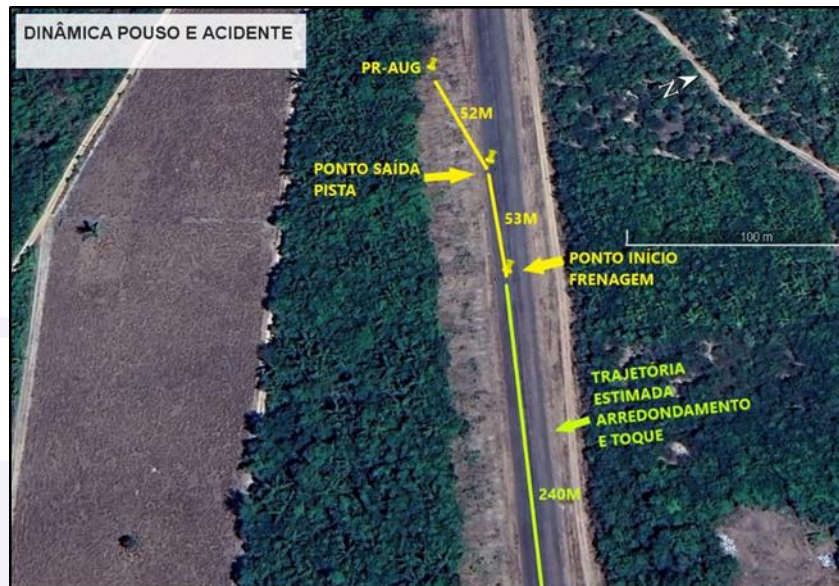
The approach and landing were performed at a heading of approximately 310° , and it was not possible to determine the point of touchdown on the runway. However, when the brakes were applied, at about 240 m past the landing threshold, the aircraft veered to the left at a distance of 53 m and exited the runway.

Figure 6 - Dynamic of the landing and subsequent accident.
Source: adapted from Google Earth.

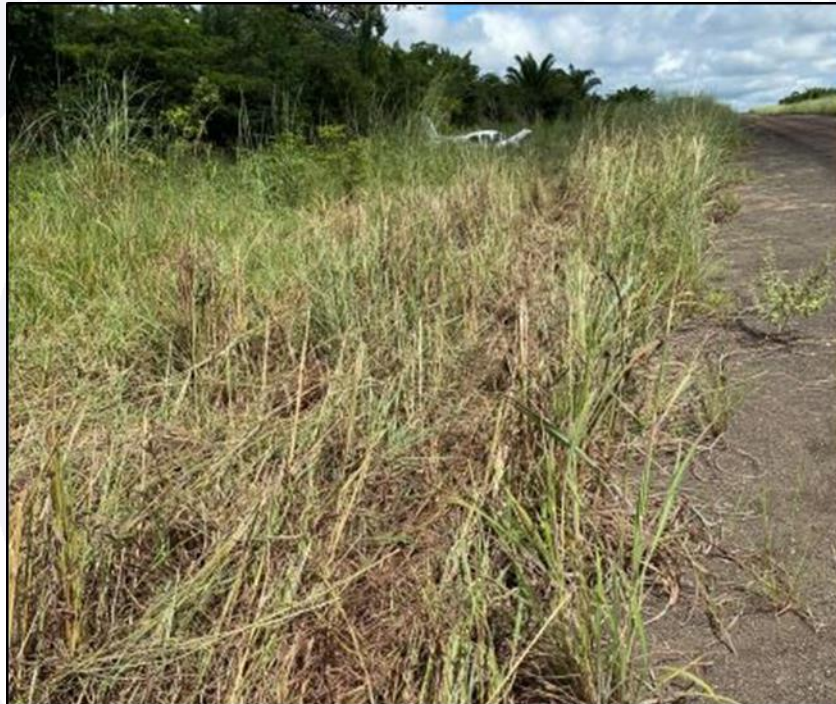
The aircraft then traveled another 52 m through an area of vegetation (Figure 6), rotating and skidding laterally (Figure 7), breaking its main and auxiliary landing gears, until coming to a complete stop aligned with the azimuth 056° .

Figure 7 - Vegetation marked by the aircraft leaving the runway and skidding before coming to a complete stop.

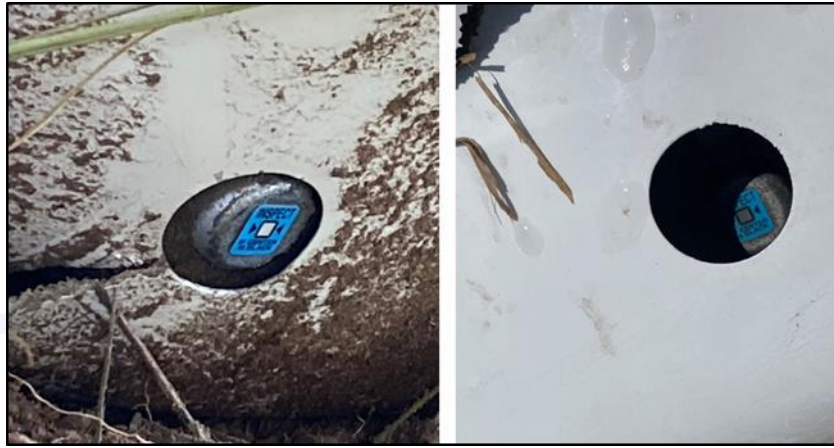
The inspection window indicating the temperature of the right main landing gear was black, while the corresponding window of the left main landing gear was white (Figure 8).

Figure 8 – Sequentially, the inspection windows for the left and right main gear.

Despite the PIC's report, the analysis carried out by the investigators did not find any discrepancies in the aircraft's brake system. Nevertheless, at the initial action of the investigation, it was found that the temperature indicator window of the right-hand landing gear was black, showing that the correspondent brake assembly had overheated.

In this way, it is possible that the brakes were applied improperly, which may have caused overheating, leading to the darkening of the inspection window of the right-hand brake and its loss of effectiveness, as reported by the PIC, with no time for corrective action, resulting in the aircraft veering off the left side of the runway.

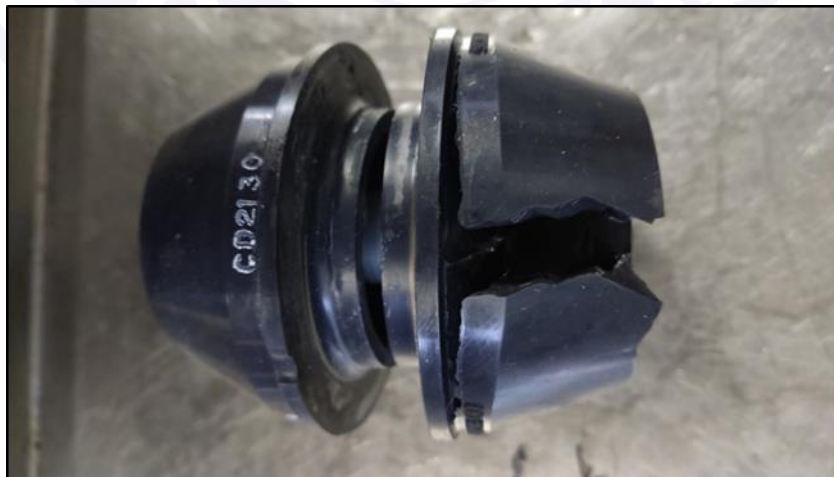
However, the rubber of one of the engine support shock absorbers was found cracked, and it was not possible to determine when such damage had occurred (Figure 9).

Figure 9 - Cracked rubber of one of the engine support shock absorbers.

Notwithstanding, it was found that one of the shock-absorbing rubbers of the engine support was cracked, and it is possible that vibration in question was a result of this damage. However, it was not possible to determine when the damage had occurred.
