FINAL REPORT
A-106/CENIPA/2020

OCCURRENCE:	ACCIDENT
AIRCRAFT:	PR-AUR
MODEL:	Gulfstream 200
DATE:	07SET2020

This is the Final Report of the 07th September 2020 accident involving the Gulfstream 200 aircraft, registration marks PR-AUR. The occurrence was typified as “[RE] Runway Excursion”.

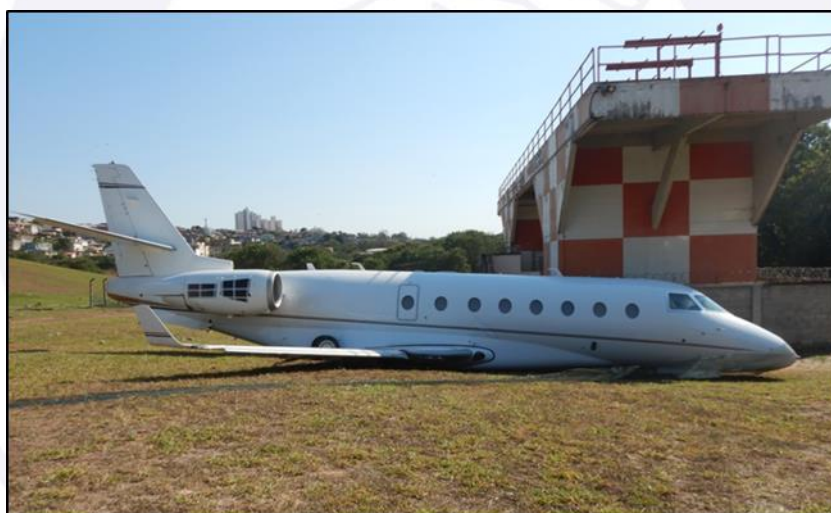
Figure 1 – Situation of the PR-AUR aircraft after coming to a stop.

The aircraft sustained substantial damage to the entire length of its underside. The landing gear struts collapsed after impacting the terrain off the runway.

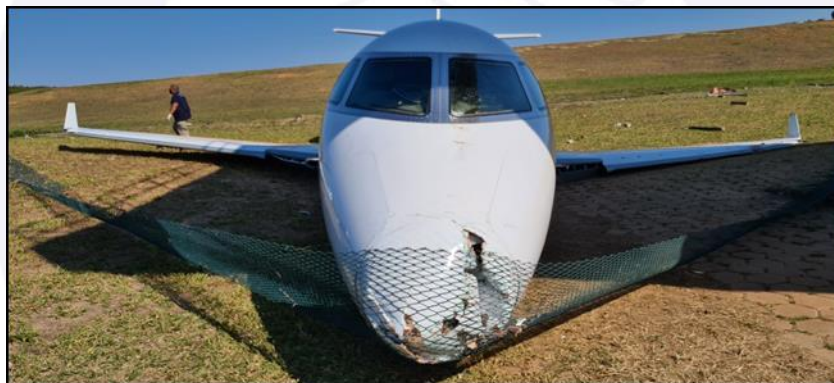
There was substantial damage to the protective fences located near the departure end of the runway 13.

Figure 6 - Detail of the fence against which the aircraft collided after departing the runway.

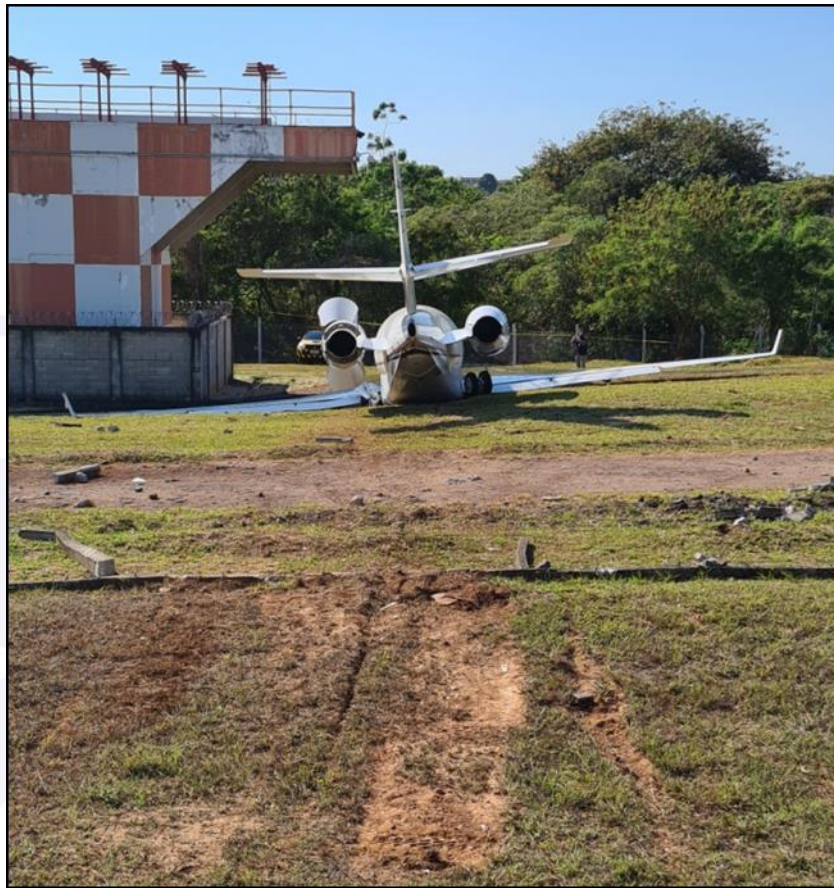
The aircraft overran the departure end of SBBH runway 13 and traveled approximately 68 m before hitting a gutter.

After that, the aircraft collided with a protective fence and stopped approximately 155 m off the runway limits, slightly to the right of the extension of the runway central axis (Figures 6 and 7).

Figure 7 - Trajectory traveled by the aircraft after departing the runway.
