**COMANDO DA AERONÁUTICA**  
**CENTRO DE INVESTIGAÇÃO E PREVENÇÃO DE**  
**ACIDENTES AERONÁUTICOS**

**FINAL REPORT**  
**IG - 016/CENIPA/2017**

| <b>OCCURRENCE:</b> | <b>SERIOUS INCIDENT</b> |
| <b>AIRCRAFT:</b> | <b>PR-AZG</b> |

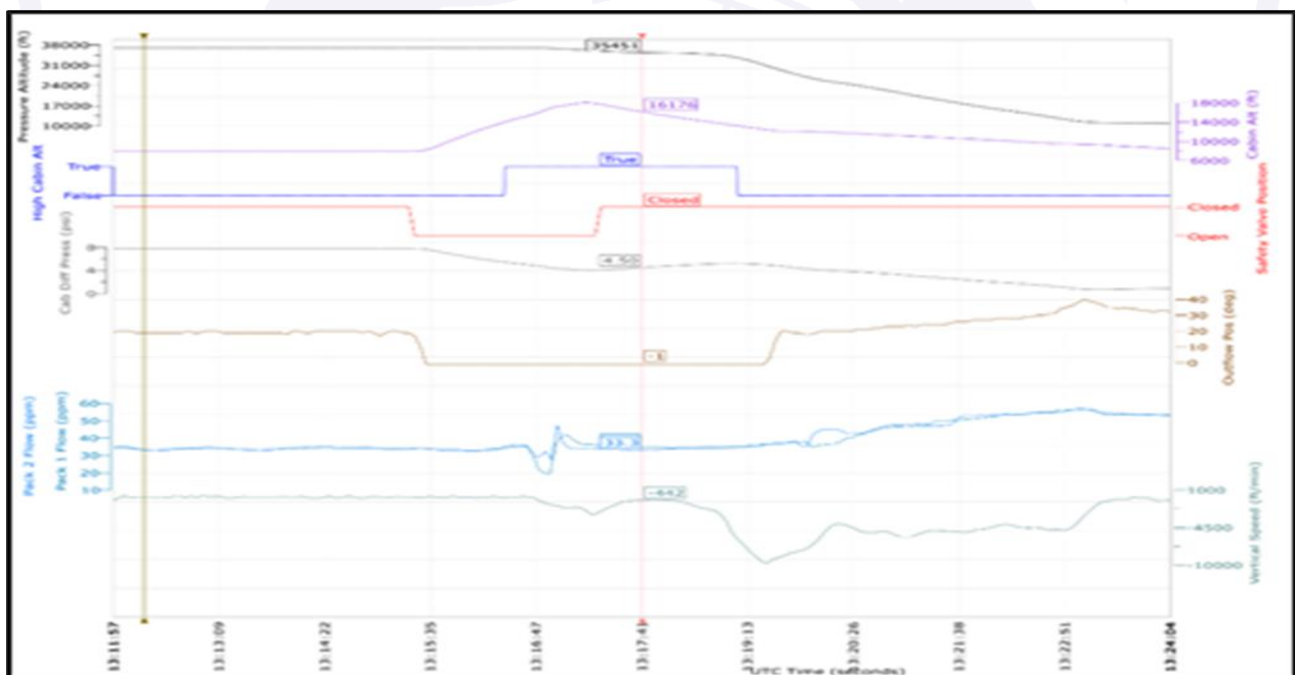
Figure 5 - Pressurization parameters extracted from flight recorders.

In Figure 5, it is possible to observe the change in position of the Positive Relief Valve (Safety Valve Position parameter, indicated by the red line) from closed to open, at 01:15:25 pm (UTC), and the pressure differential between the cabin and the external environment, which at that time it was 7.78 psid (536 hPa). The Positive Relief Valve remained open for two minutes and three seconds.

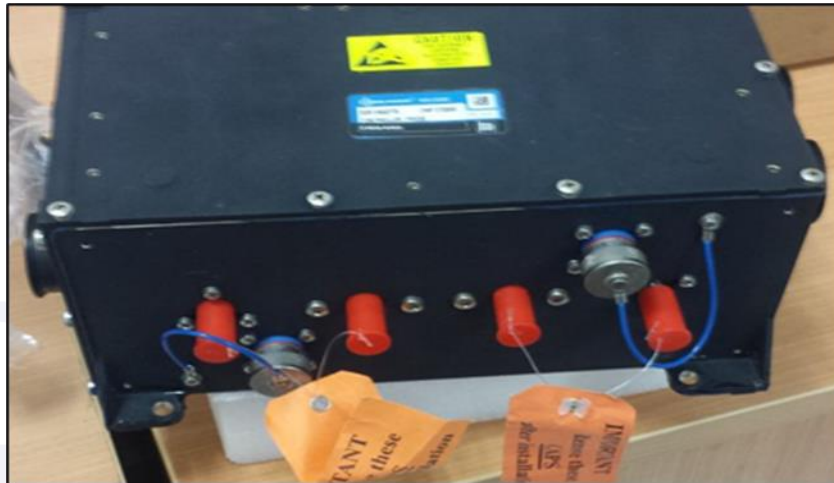
Bench tests were performed in the CPCS. The resistance referring to the covering of the component was out+ the predicted values. However, no failures were found in the logic tests performed.

Figure 6 - CPCS removed from the aircraft.

The logical behavior of the CPCS allows to rule out any contribution of this component to the sequence of events of the depressurization of the aircraft, despite the resistance related to the coverage of the component outside the predicted values found in the bench tests.

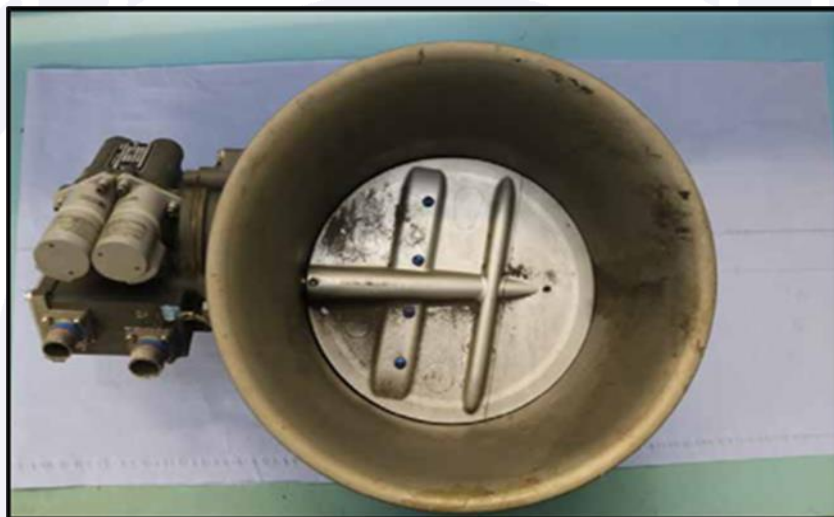
Electrical and leakage functional tests were carried out at the OFV, in addition to visual inspections. All tests were within the established parameters.

Figure 7 - Outflow Valve overview.

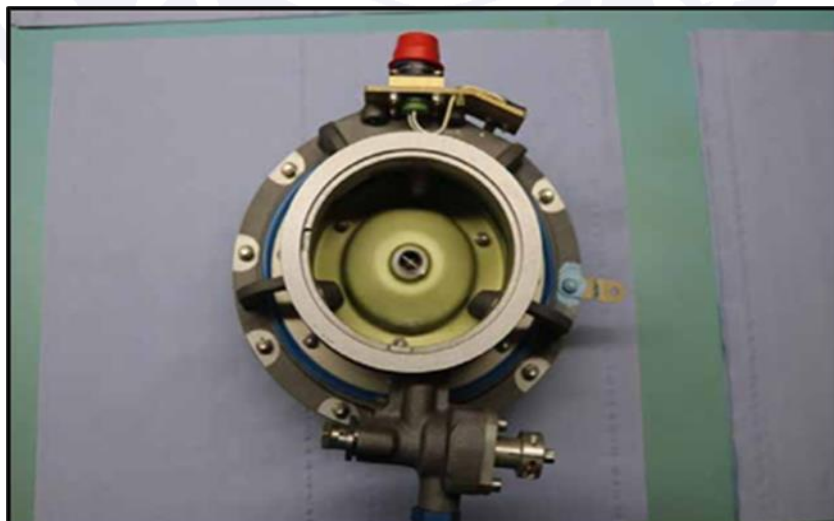
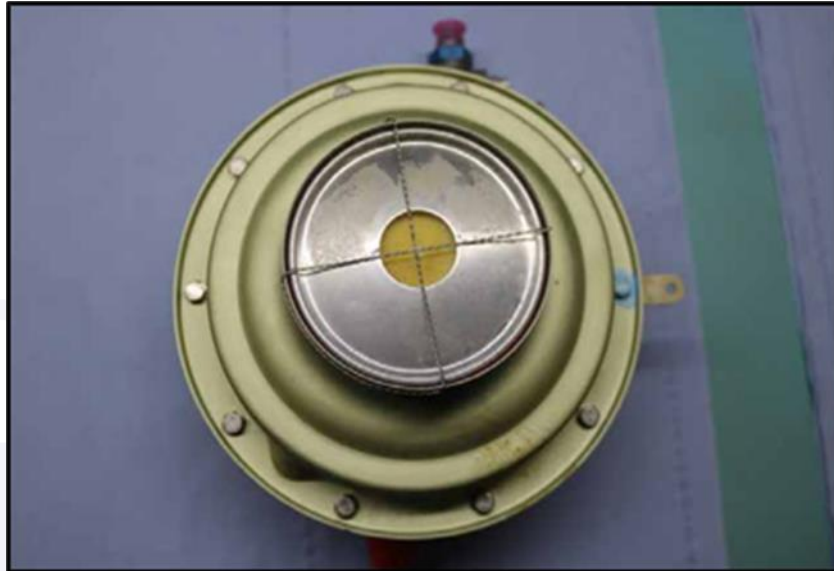
Figure 8 - Positive Relief Valve viewed towards the external, non-pressurized section of the aircraft.

Figure 9 - Positive Relief Valve viewed towards the internal, pressurized, section of the aircraft.

No discrepancies were found in the initial inspection.

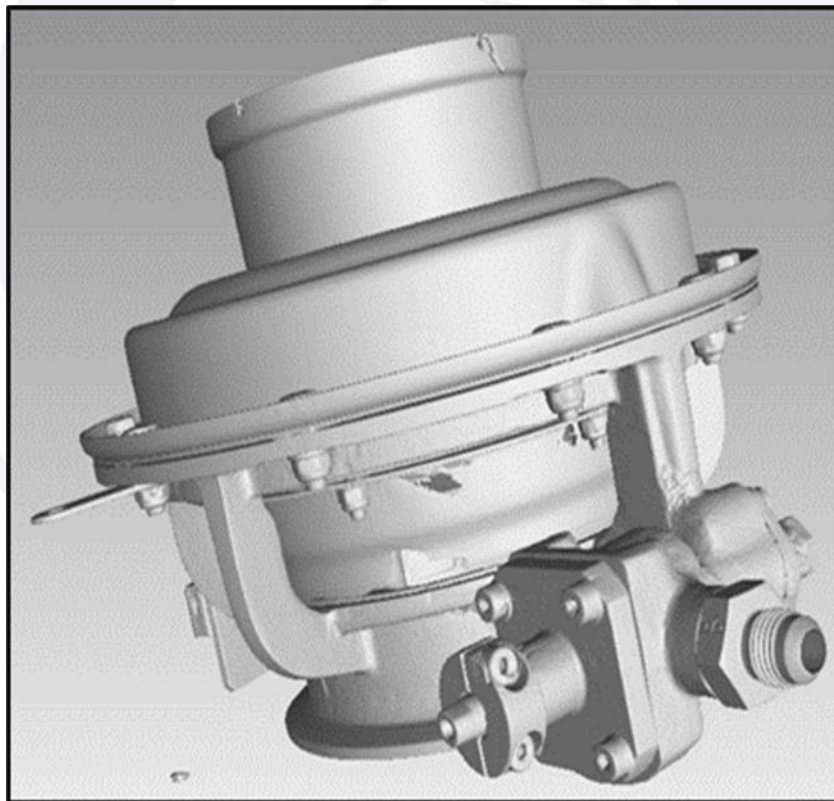
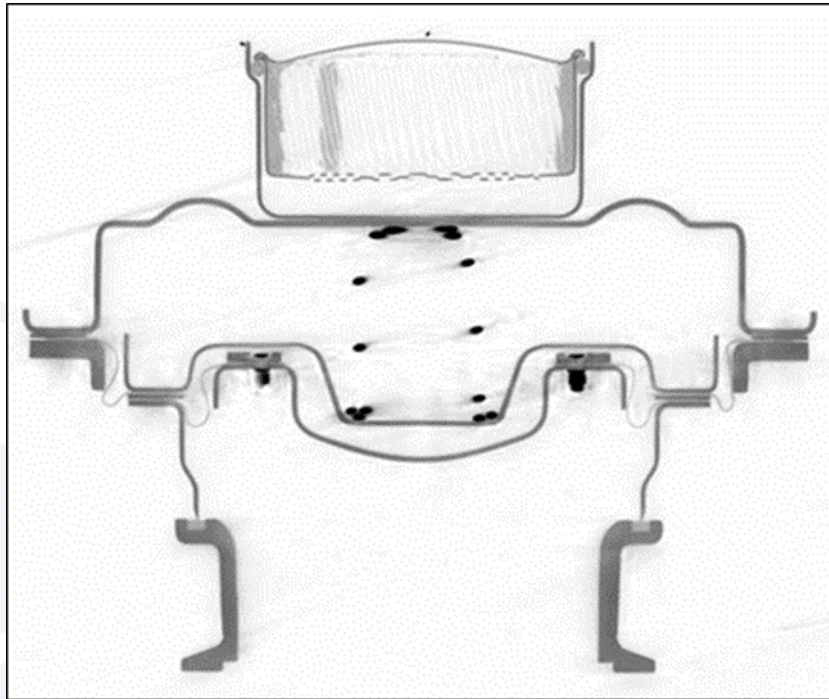
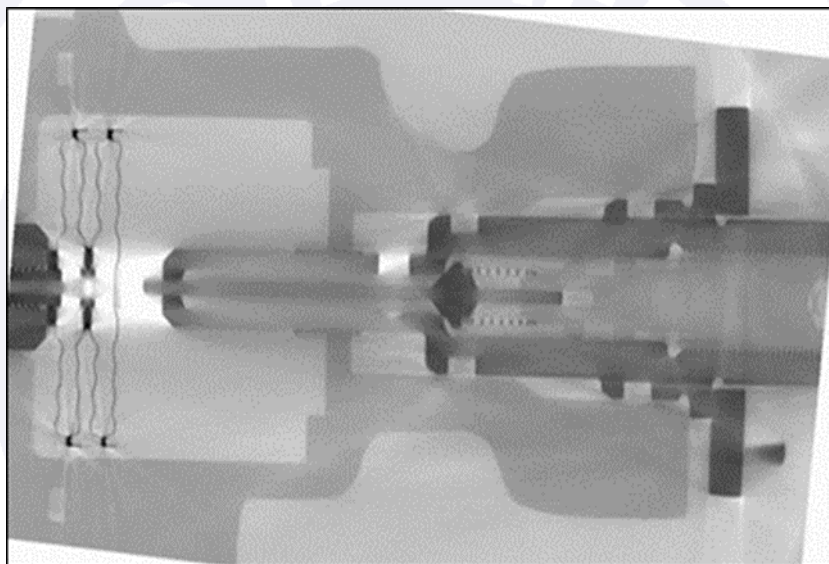
Figure 10 - Computed tomography of the Positive Relief Valve. Perspective view.

Figure 11 - Computed tomography of the Positive Relief Valve. Cross-section view.

Figure 12 - Computed tomography of the Positive Relief Valve needle.

The CT scan did not reveal any foreign objects or conditions that could cause the valve to open in flight.

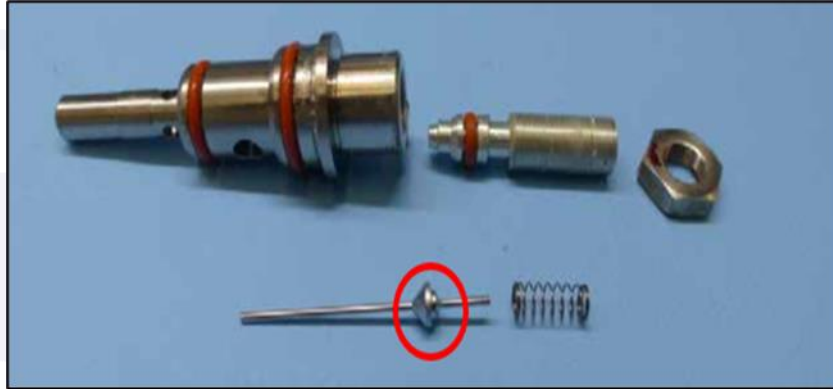
The parameters of spring resistance force and needle leakage of the Control Unit were in accordance with the values established in the manuals. No defects or mechanical irregularities were found inside the unit. It was only verified the presence of small points of contamination in the region indicated in Figures 13 and 14, below:

Figure 13 - Disassembly of the Needle of the Controller Unit. Highlighted, where signs of contamination were found.

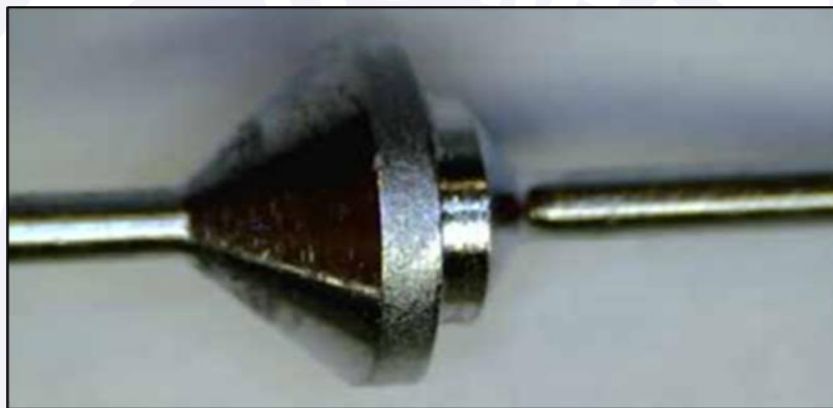
Figure 14 - Small points of contamination inside the Control Unit.

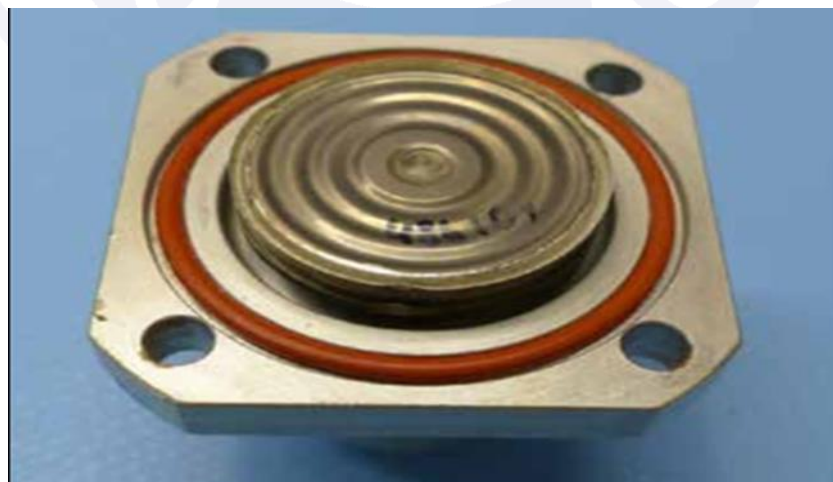
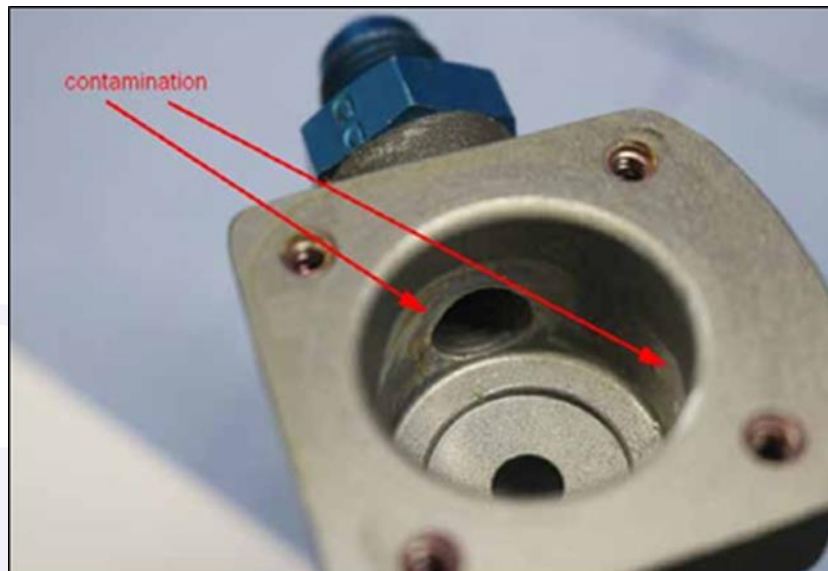
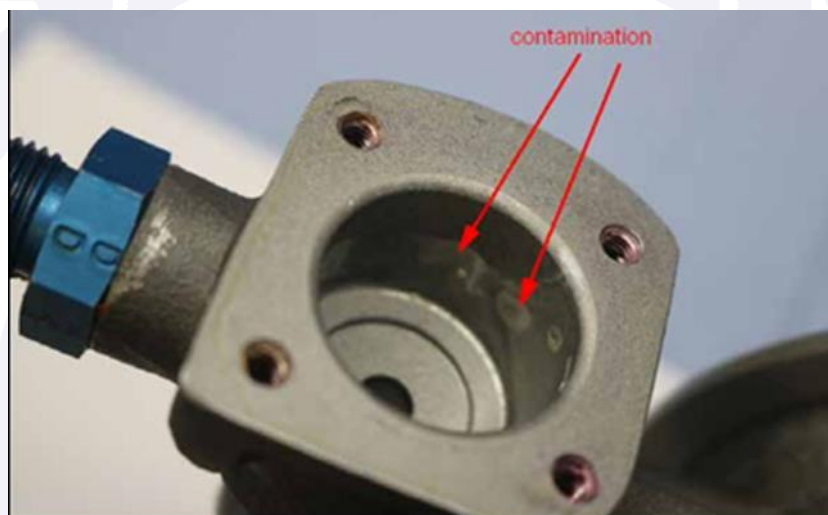
The Control Unit's pressure capsule was also dismantled and examined. The wall inside the capsule was contaminated by residues of solid material, as shown in Figures 15, 16, and 17, below:

Figure 16 - Points of contamination inside the pressure capsule (View 1 of 2).

Figure 17 - Points of contamination inside the pressure capsule (View 2 of 2).

The tests carried out at the Positive Relief Valve, PN: 21615-02 and SN: 09112694, showed signs of contamination by residues of solid material in the pressure capsule of the Control Unit, without the identification of any foreign body in the valve, corroborating the hypothesis of that there was ice formation in flight, when the conditions were right and, when these were no longer present, the ice melted.

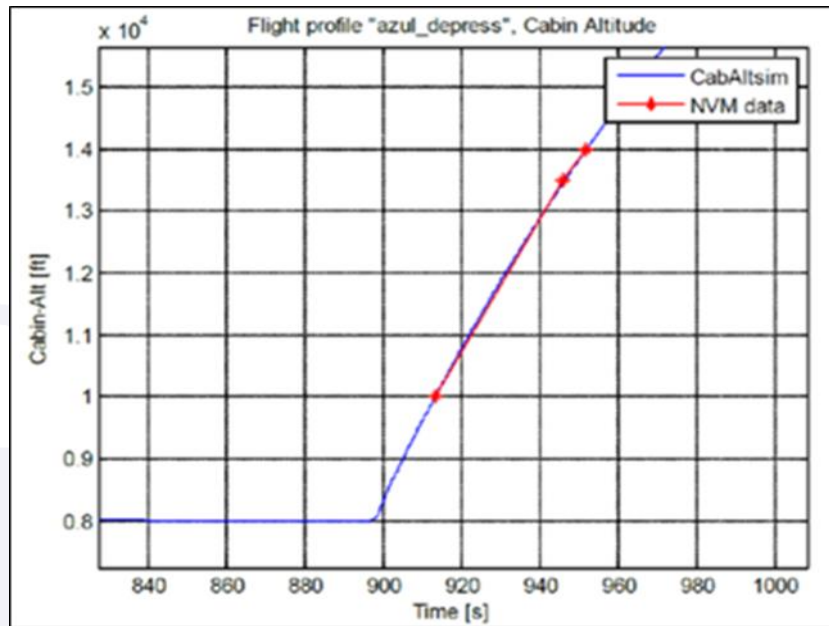
The simulation result is shown in Figure 18. The red line represents the data extracted from the CPC's NVM and the blue line the simulation data using the simulation parameters.

Figure 18 - Simulation of depressurization with the opening of the Positive Relief Valve performed by the component manufacturer.

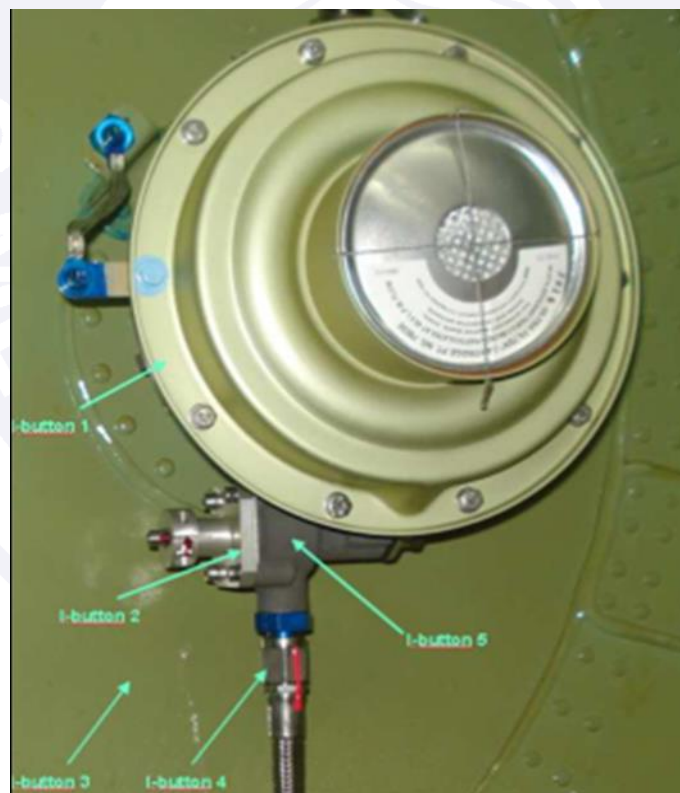
Figure 19 - I-buttons installation locations on a Positive Relief Valve.

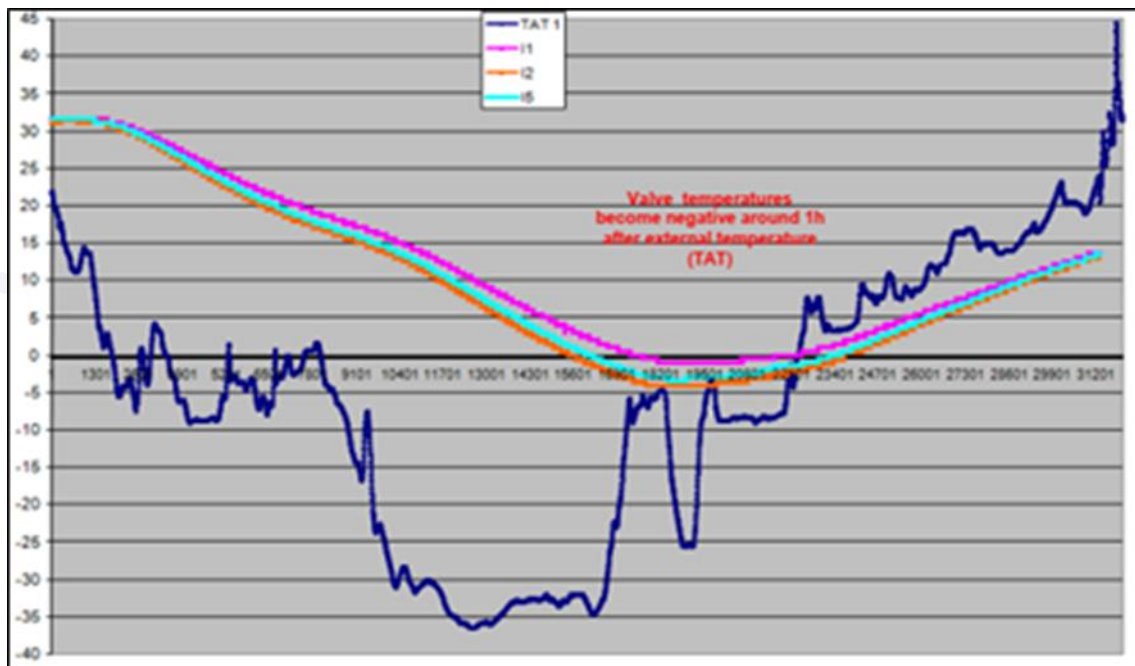
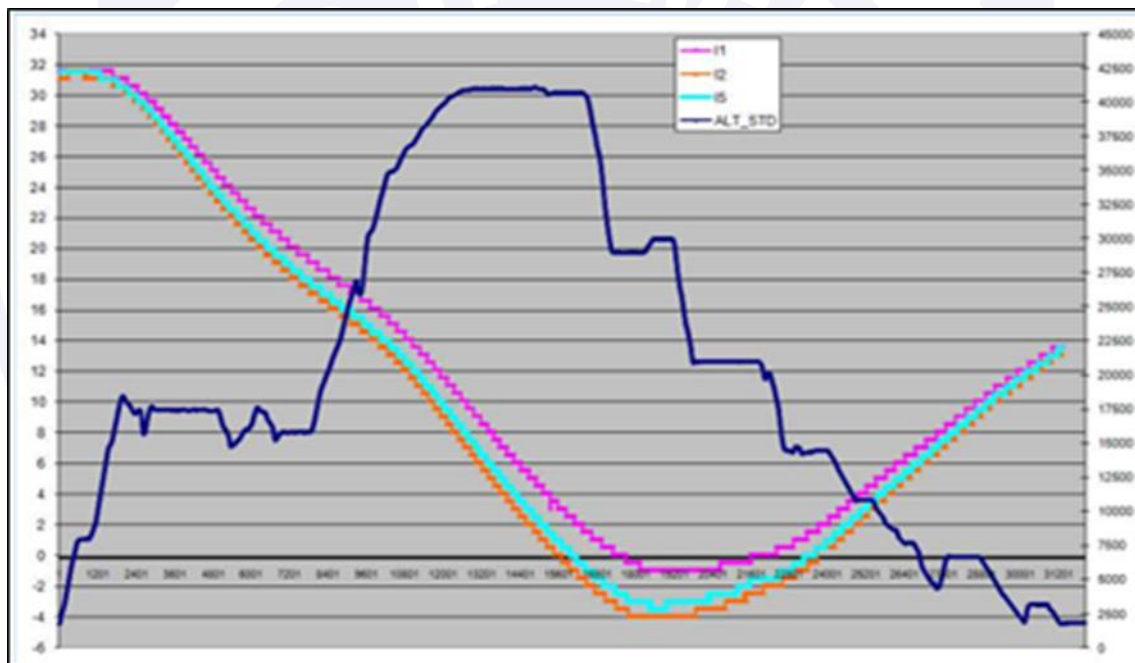
In-flight tests with the I-buttons installed in the Positive Relief Valve showed that values below 0°C were reached after one hour of flight at negative temperatures measured by the TAT sensor.

Figure 20 - Comparison between the measurement of the Positive Relief Valve temperature sensors and the external temperature.

Figure 21 - Comparison between the measurement of the Positive Relief Valve's temperature sensors and the altitude of the aircraft.

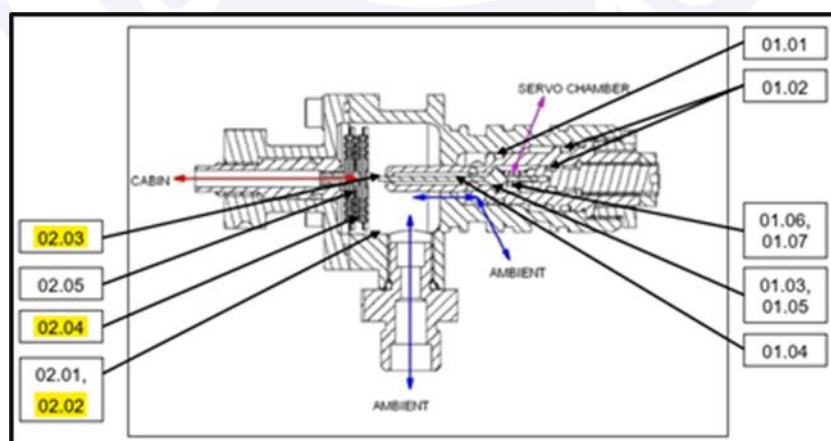
Based on the evidence of solid material found in the Positive Relief Valve Control Unit, three failure modes were identified in which ice formation would result in an opening with a lower pressure differential than anticipated:

- ice formation inside the control valve chamber causing displacement of the pressure capsule;
- ice formation between the pressure capsule and the needle of the Control Unit, resulting in the reduction of the space between the two parts; and
- ice formation inside the pressure capsule, resulting in its deformation.

The failure modes are shown highlighted in Figure 23 represented by codes 02.02, 02.03, and 02.04, respectively.

Figure 23 - Positive Relief Valve Control Unit failure modes raised by the component manufacturer.
