COMANDO DA AERONÁUTICA
CENTRO DE INVESTIGAÇÃO E PREVENÇÃO DE
ACIDENTES AERONÁUTICOS

FINAL REPORT
A-110/CENIPA/2021

OCCURRENCE:	ACCIDENT
AIRCRAFT:	PR-BVB
MODEL:	1124A
DATE:	28SET2021

This is the Final Report of the 28 September 2021 accident with the 1124A (Westwind II) aircraft, registration marks PR-BVB. The occurrence was typified as “[RE] Runway Excursion”.

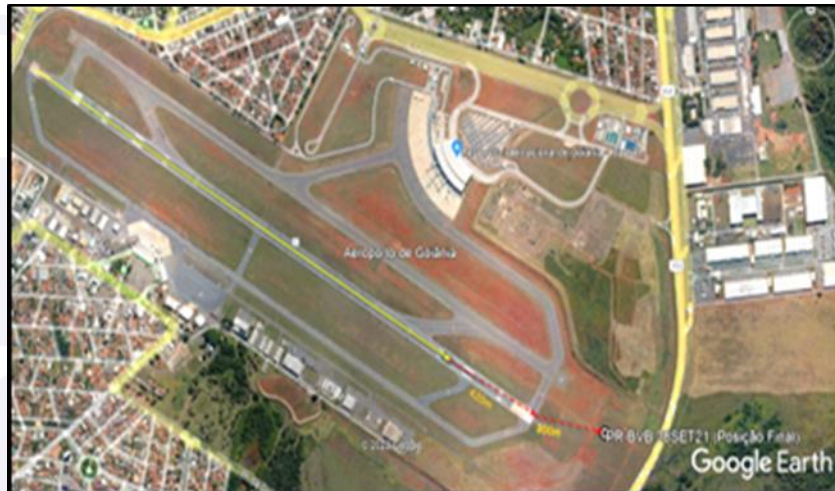
Figures 5 and 6 show the croquis of the occurrence and the final position of the aircraft.

Figure 5 - Croquis of the aircraft's trajectory in the occurrence.
Source: Adapted from Google Earth.

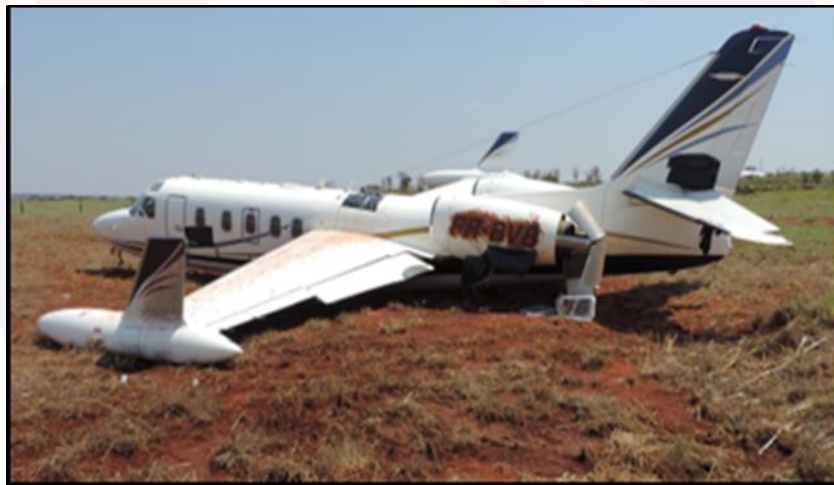
The aircraft sustained substantial damage to the landing gear, left-hand flap, left-hand stabilizer, left-hand engine reverse rods, aircraft intrados, as well as to the right- and left-hand wingtips.

Upon exiting the runway, the aircraft collided with a pylon at the threshold 32.

Figure 6 - Final position of the aircraft.

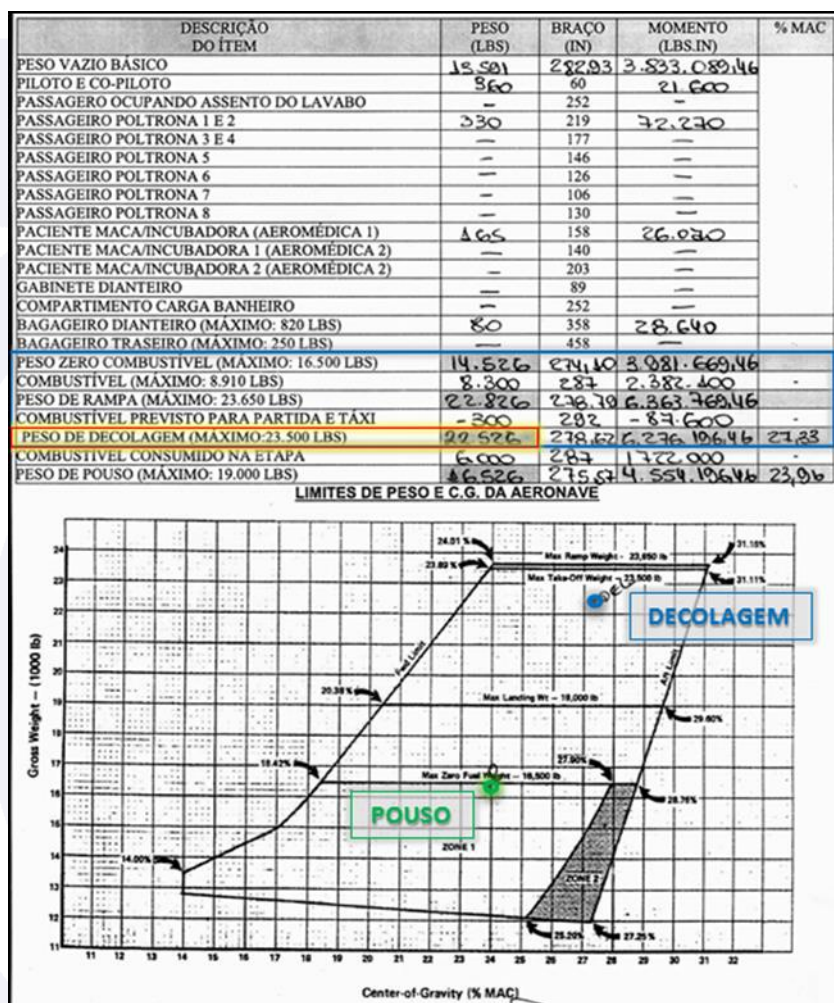
In accordance with the crew and with the cargo manifest presented, the aircraft was fueled with 8,300 lbs; the zero fuel weight was 14,526 lbs, totaling a ramp weight of 22,826 lbs, and a takeoff weight of 22,526 lbs (300 lbs for taxiing); such value was below the maximum one certified for the aircraft, i.e. 23,500 lbs (Figure 9).

Figure 9 – Cargo manifest presented.

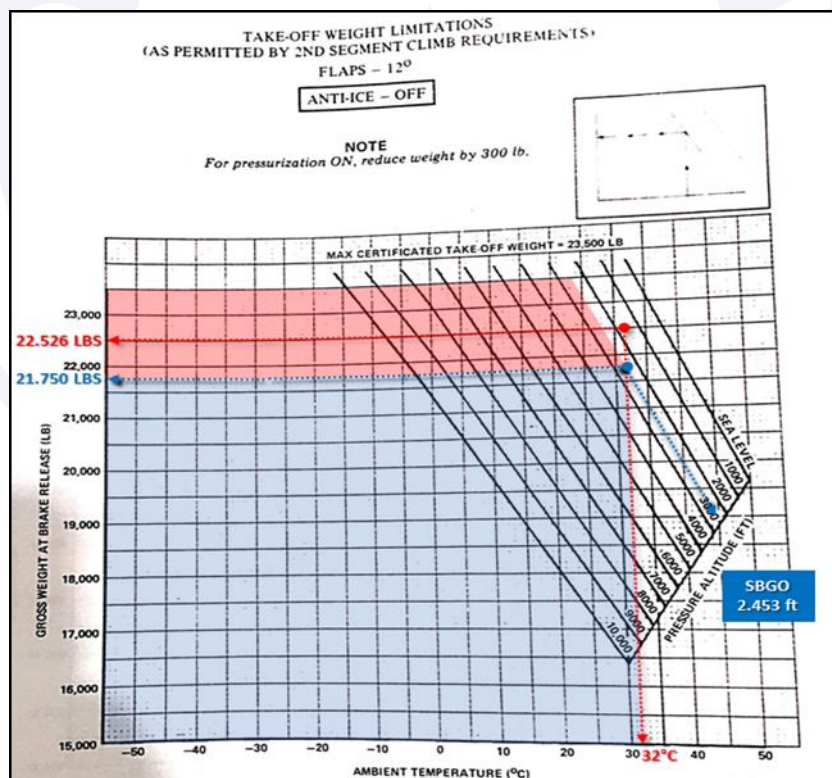
Figure 11 - MTOW diagram for 12° flaps, considering density altitude and temperature.

Thus, for an aircraft configured with flaps at 12°, considering compliance with the requirements of the second climb segment, considering the density altitude of SBGO (2,453 ft), the temperature of 32°C, Anti-Ice Off, pressurization on, and assuming that the weights

of crew, passengers, "Aeromedica 1" configuration, and luggage carriers are correct; one concluded that the weight limit for local conditions at 15:00 UTC would be 21,750 lbs (blue), below the weight declared on the load manifest of 22,526 lbs (red), for the requirements of the second climb segment.

After consulting the three items of information, and selecting the lowest value for the MTOW, one concluded that the weight limit for takeoff was 21,750 lbs (under the local conditions at 15:00 UTC, following all certification parameters and specific regulations), with limiting factors being the temperature and the altitude of the field. Such value was lower than the weight declared in the cargo manifest (22,526 lbs), which corresponded to 776 lbs (352 kg) above the limit specified.

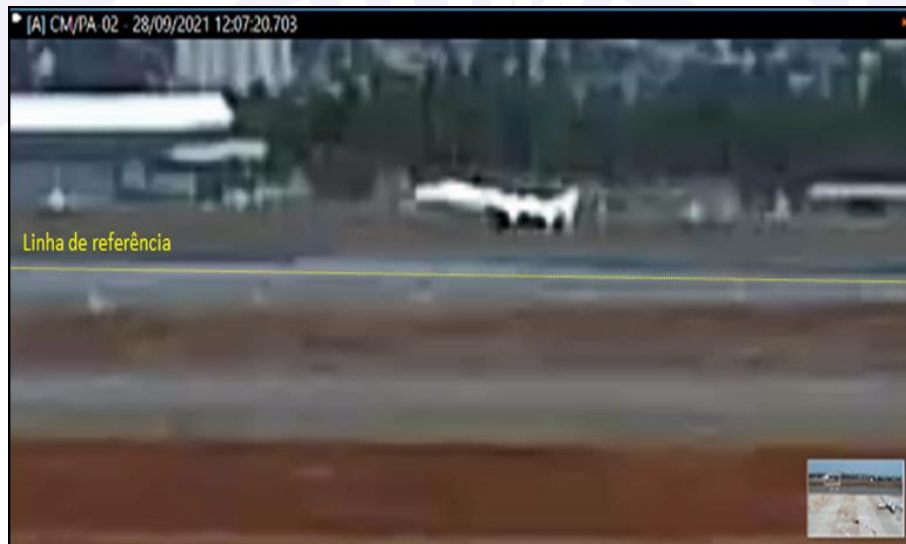
The aircraft rotated and left the ground as shown in Figure 14.

Figure 14 - Video frame from the airport administration, allowing view of the aircraft in takeoff attitude, off the ground.

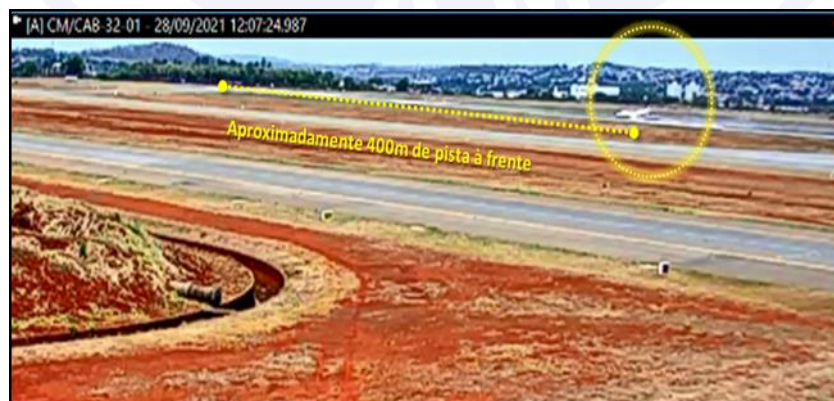
Nine seconds later, the sound of a probable touchdown and return to the runway was heard (Figure 15).

Figure 15 - Video frame from the airport administration, allowing view of the aircraft returning to the ground, with approximately 400 m of runway ahead.

However, the prescribed procedure was to continue takeoff after reaching V1 since, as recommended by the manufacturer, successful results were more likely when takeoff was continued rather than rejected.

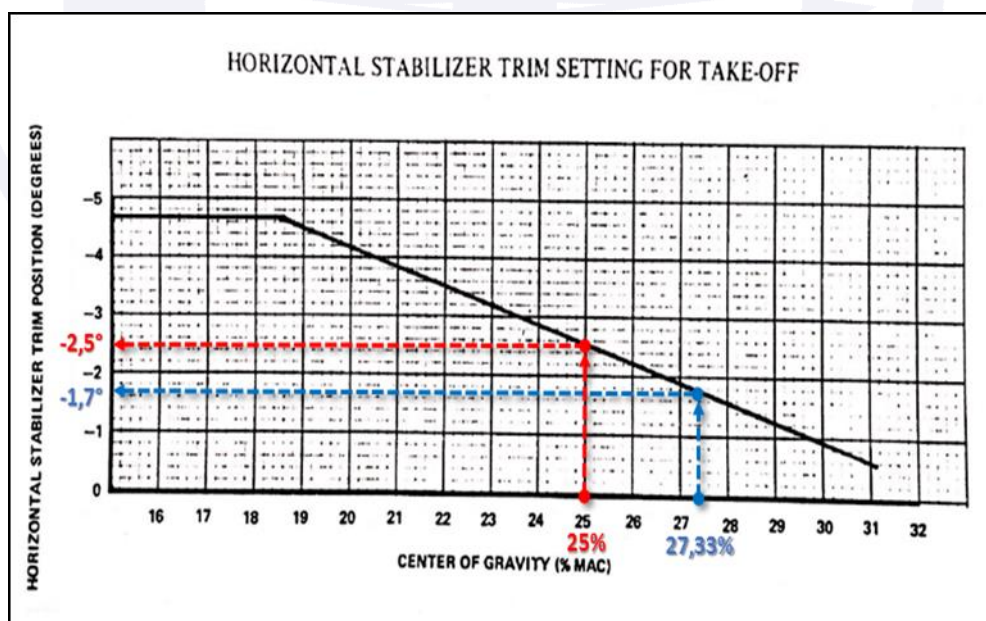
By means of the SSCVR, it was possible to identify the aircraft's "trimming", which was at 25% (red). However, for the calculated Center of Gravity (CG), the correct option would be 27.3% (blue) or -1.7°, as shown in Figure 16.

Figure 16 - "Trimming" diagram of the horizontal stabilizer for takeoff.

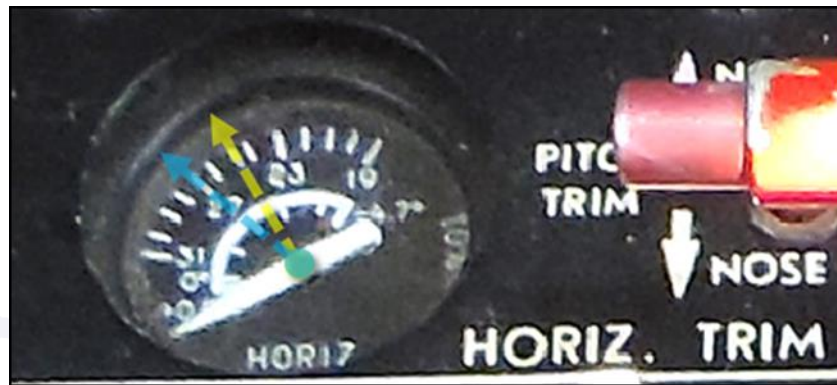
Figure 17 depicts the "trimming" display of the aircraft's horizontal stabilizer, with the external scale indicating the center of gravity in percentage values, with measures from 19% to 31% (one percentage-point variation). The internal scale has the indication in degrees, varying from 0° to -4.7° (1°-variation, with 4.7° being the last mark).

Figure 17 - Display of the Horizontal Stabilizer "trimming".

The yellow arrow highlights the pilot's view and the takeoff selection. The blue arrow highlights the correct selection for the calculated center of gravity.
