**FINAL REPORT**  
**A - 009/CENIPA/2020**

<b>OCCURRENCE:</b>	<b>ACCIDENT</b>
<b>AIRCRAFT:</b>	<b>PR-CJD</b>
<b>MODEL:</b>	<b>AS 350 B2</b>
<b>DATE:</b>	<b>18JAN2020</b>

This is the Final Report of the 18JAN2020 accident with the AS 350 B2 aircraft model, registration PR-CJD. The accident was classified as “[OTHR] Other/ Vehicle and Aircraft Collision”.

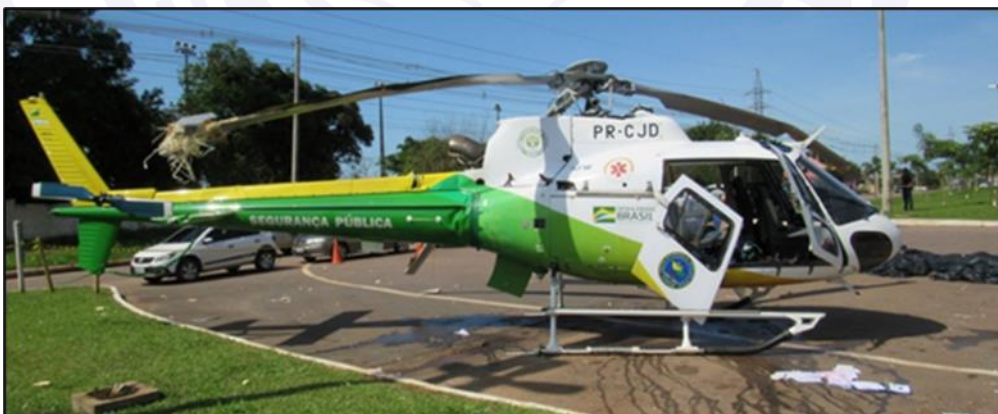
The aircraft had substantial damage to the main rotor, transmission, tail cone and right-side door.

Figure 1 - View of the aircraft after the collision and total rotor stop.

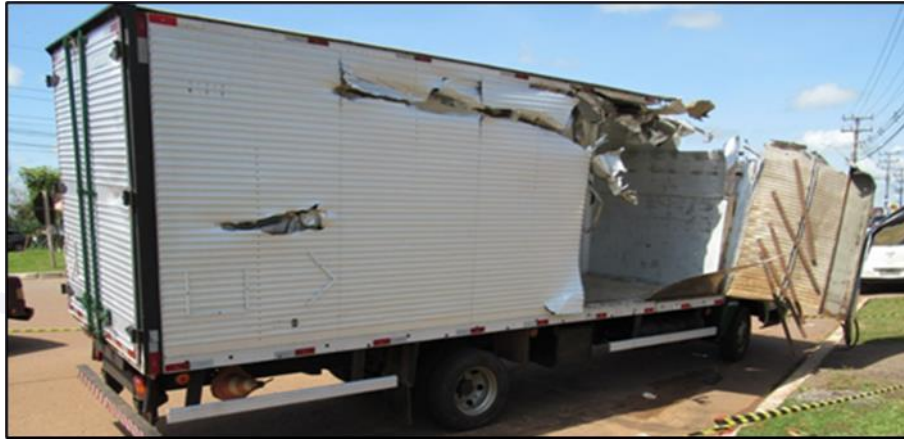
The truck had damage to the right front and right side of the trunk (Figure 2).

Figure 2 - Condition of the truck after the impact against the main rotor of the aircraft.

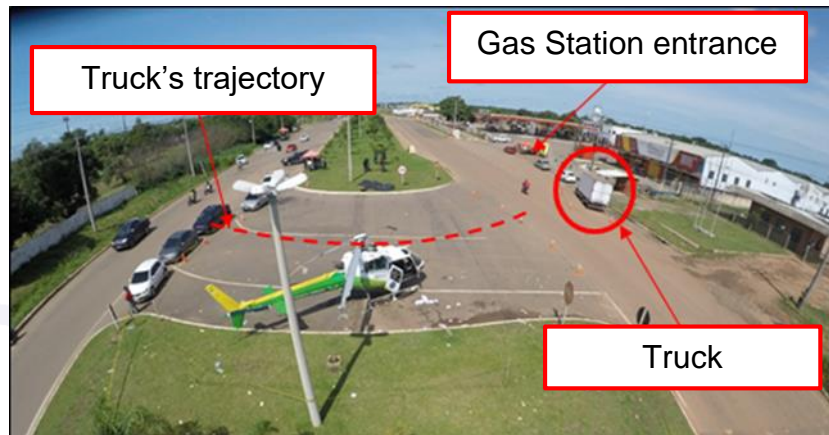
The truck collided with the aircraft's main rotor while it was making the turn on the BR-364's return and stopped 28 meters ahead. According to reports, the driver intended to access the gas station on the other side of the highway.

Figure 6 - Aerial view of the occurrence site.

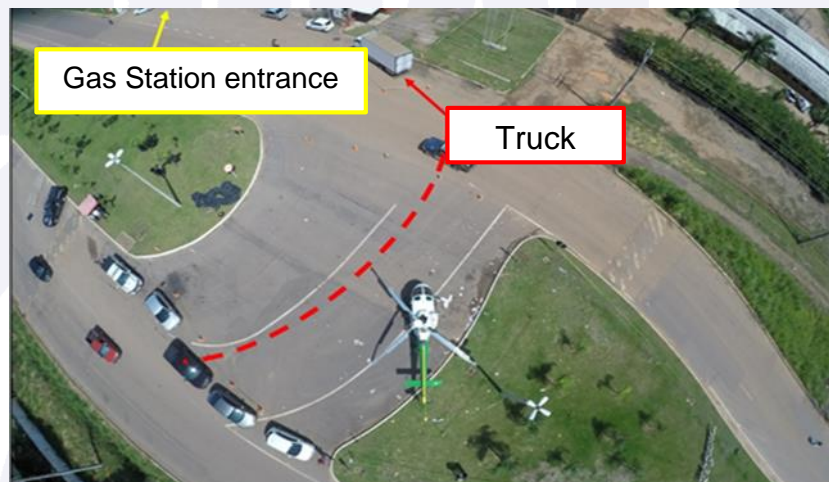
Figure 7 - Aerial view of the wreckage site. The red dotted line indicates the truck's trajectory. The yellow arrow indicates the entrance to the station.

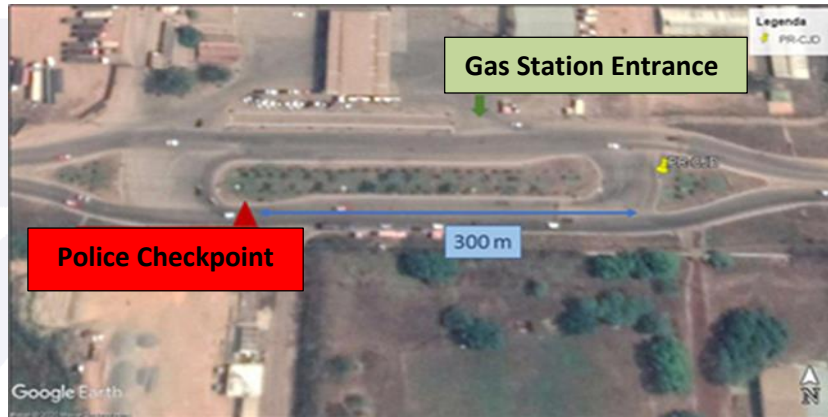
There was a police checkpoint 300 meters from the chosen landing site.

Figure 8 - Image illustrating the locations of the police checkpoint (red) and the landing of the helicopter (yellow). The blue arrow indicates the road and approximate distance.

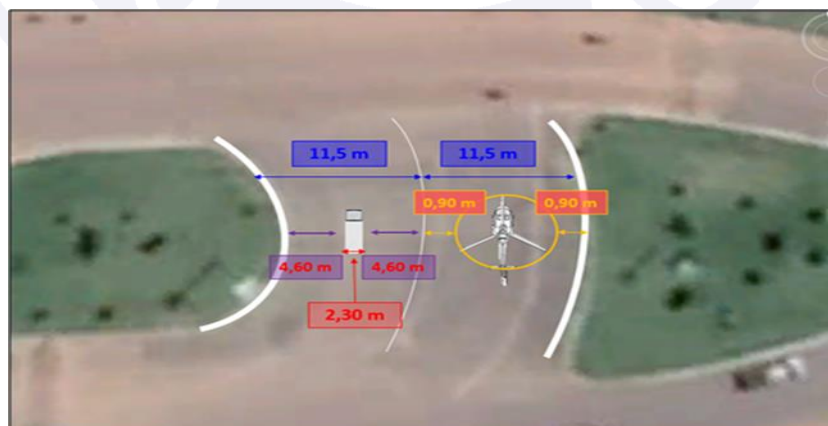
For landing on the day of the occurrence, the PIC instructed the aircraft to be closer to the return curb in relation to the position in which it had been placed the day before. The intention was to position the helicopter as shown in Figure 9.

Figure 9 - Sketch with the approximate dimensions of the helicopter landing site and free spaces for the passage of vehicles.

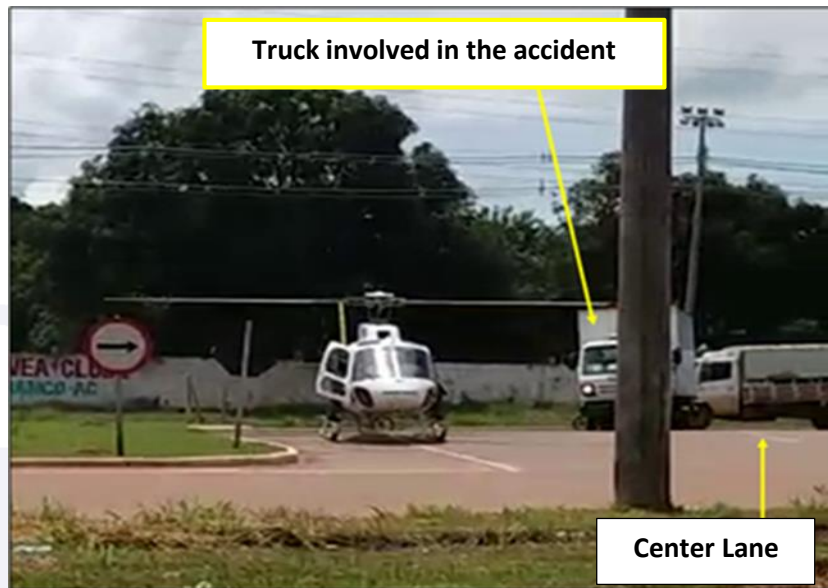
The analysis of the various available videos of the accident revealed that, during the performance of the procedures that would precede the take-off, none of the crew monitored the passage of vehicles on the road. In one of the videos, it was noticed that the truck entered the return, traveling through the middle of the lane, approximately over the white strip that divided it into two parts (Figure 10).

Figure 10 - Video image when the truck enters the return through the middle of the lane.  
Note the inexistence of beacons on the road.

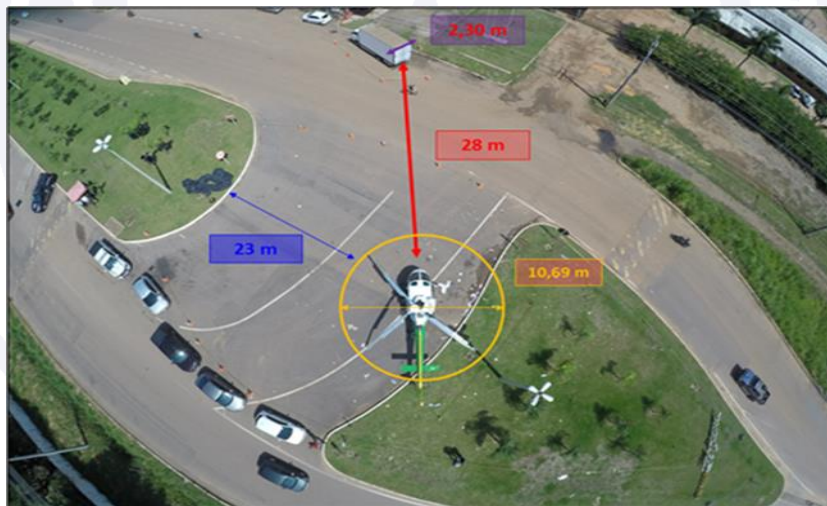
In this way, the truck's trunk entered the radius of the main rotor and was hit by it. The vehicle stopped 28 meters in front of the helicopter. The PR-CJD turned about 40° to the left before the rotors came to a complete stop.

Figure 11 - Aerial image taken after the accident, showing the final positions of the truck and the aircraft after the impact.
