**COMANDO DA AERONÁUTICA**  
**CENTRO DE INVESTIGAÇÃO E PREVENÇÃO DE**  
**ACIDENTES AERONÁUTICOS**

**FINAL REPORT**  
**A-064/CENIPA/2022**

<b>OCCURRENCE:</b>	<b>ACCIDENT</b>
<b>AIRCRAFT:</b>	<b>PR-CTD</b>
<b>MODEL:</b>	<b>PA-25-235</b>
<b>DATE:</b>	<b>17MAI2022</b>

This Final Report pertains to the accident involving the PR-CTD aircraft, model PA-25-235, which occurred on May 17, 2022, and was classified as “[LOC-I] Loss of Control In-flight.”

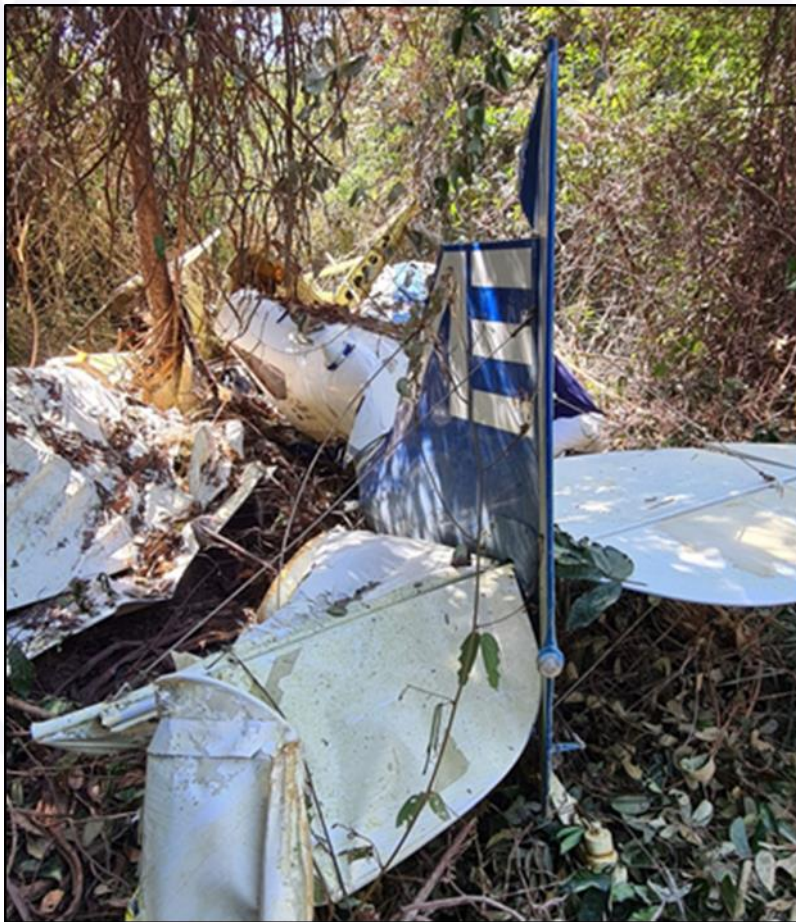
Figure 1 – General view of the aircraft at the accident site.

The aircraft sustained separation of the right wing and severe damage throughout its structure, with significant deformation to the forward section and wrinkling on the underside of the fuselage.

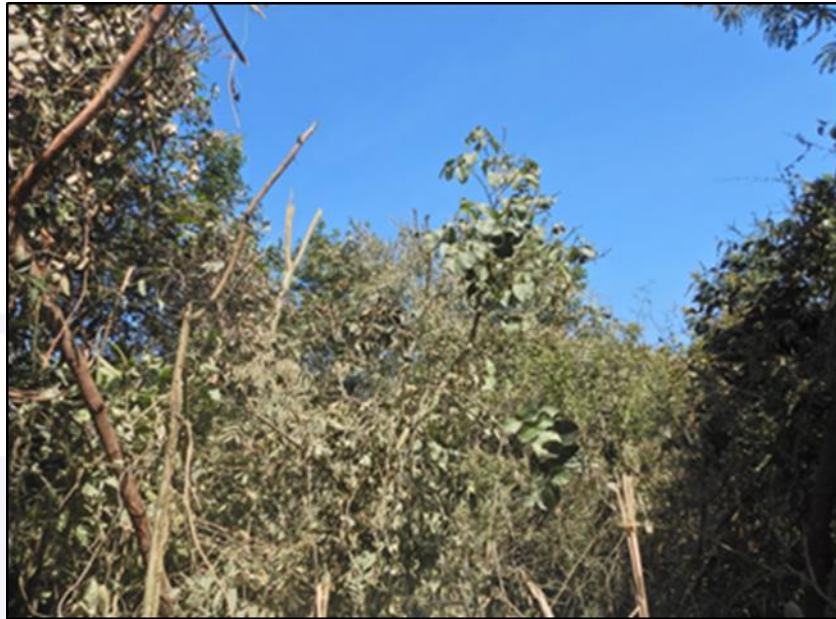
Impact marks on the trees extended for about 20 meters in the direction of the aircraft's approach (Figure 2).

Figure 2 – View of the PR-CTD aircraft's impact marks in a direction opposite to its movement.

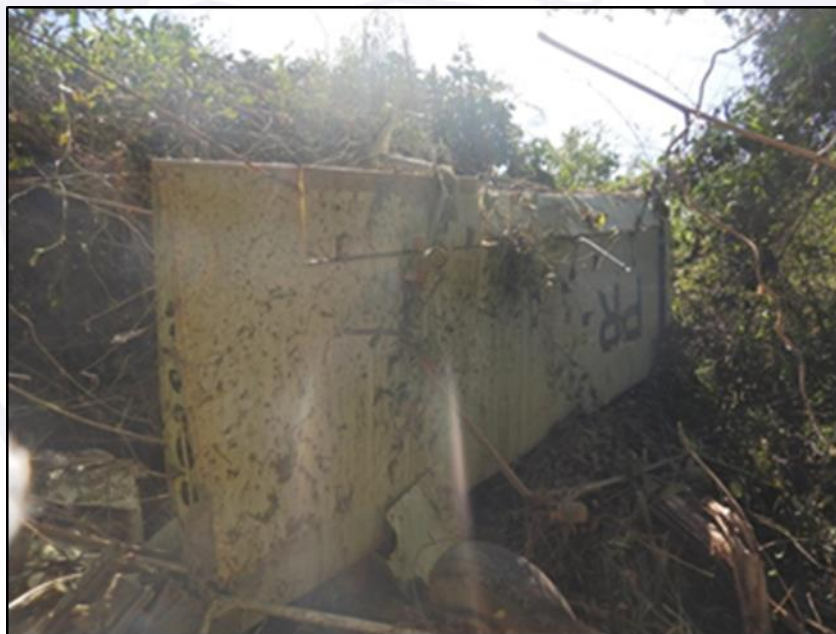
The right wing had separated from the fuselage at its root, and rested near the wreckage. The left wing sustained severe damage but remained attached to the aircraft. The flaps were in a retracted position.

Figure 3 – View of the right wing separated from the aircraft, near the wreckage.

Although the right wing was found separated from the fuselage, it was located near the wreckage concentration point, indicating that this complete separation did not occur in flight.

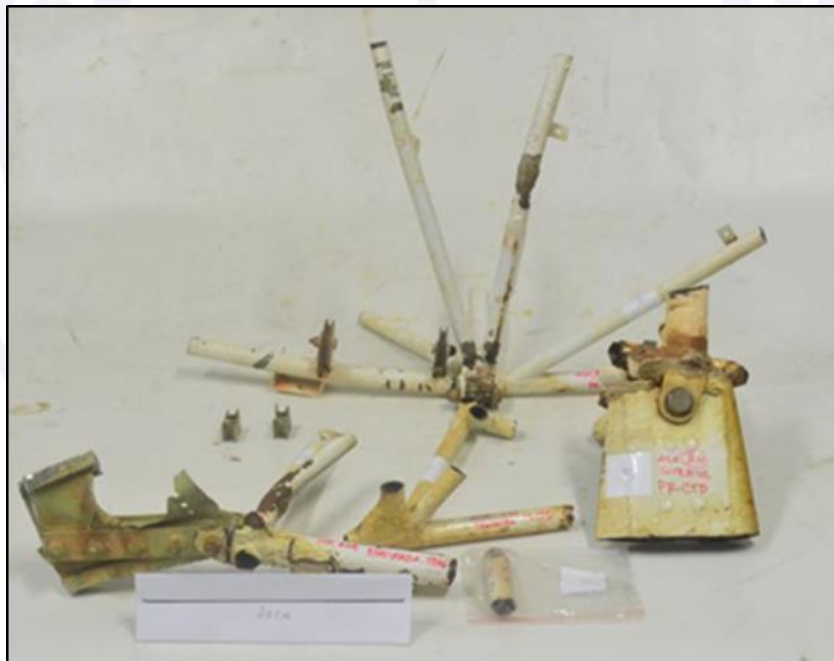
Considering the condition of the right wing-to-fuselage attachment fittings, the trusses from both wings were sent for analysis at the Institute of Aeronautics and Space (IAE) of the Department of Science and Aerospace Technology (DCTA).

Figure 4 – View of the material sent for analysis.

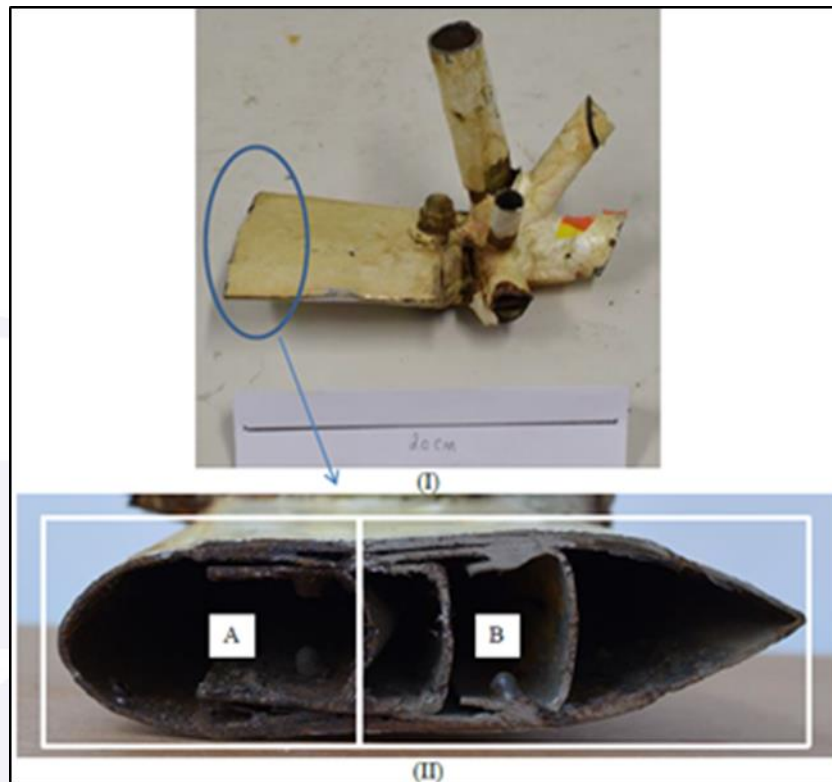
In Figure 5, it is possible to observe the upper truss component of the right wing, along with a detail of its fracture surface. The surface in question exhibited widespread corrosion.

Figure 5 – View of the upper truss of the right wing.

Component examinations performed on both wings showed that the upper truss of the right wing exhibited a fracture with a surface showing widespread corrosion. Examination of the lower fitting of that same wing revealed a fracture with typical characteristics of failure due to overload.

These pieces of evidence indicated that there was weakening of the right wing's upper truss, initiating a structural failure (partial separation) that prevented the maintenance of the aircraft's flight path and led to loss of control. With the impacts sustained during the aircraft's descent, the lower fitting of that same wing failed due to overload, resulting in the complete separation of that part of the airplane.

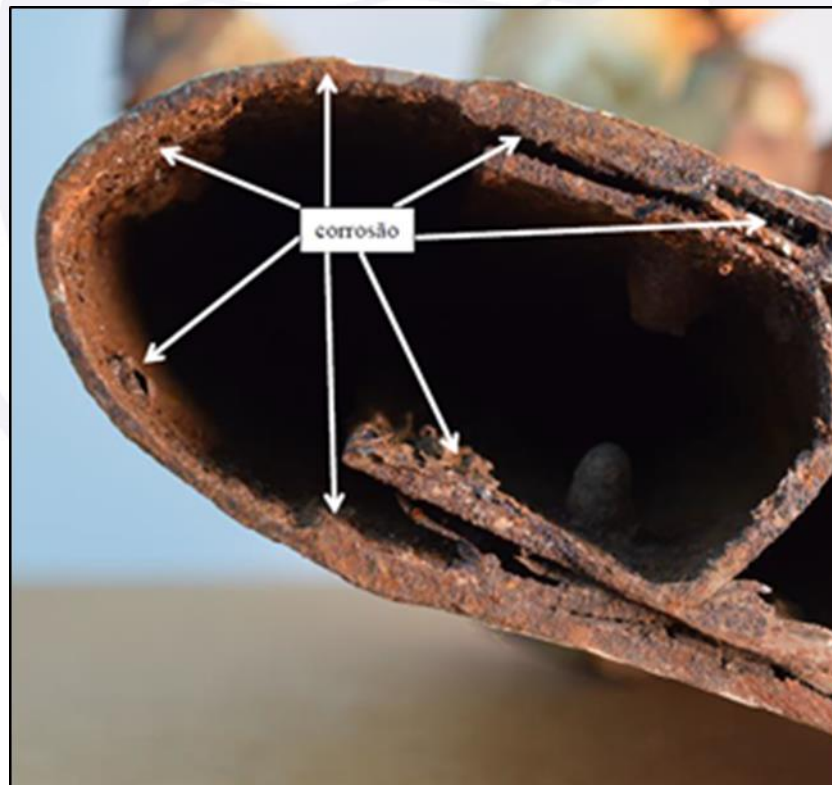
Figure 6 shows a detailed view of the corroded surface (A), which appeared to predate the accident due to the extent of the damage. Corrosion on the internal side of the structure indicated the passage of fluids – liquid or gaseous – from the external to the internal area.

Figure 6 – Close-up view of region (A) shown in Figure 5.

The widespread corrosion observed in the analyzed components indicated that the aircraft's structure had already been compromised well before the most recent maintenance activities. This condition weakened the material and could have led to imminent failure.

These findings demonstrated that the maintenance personnel failed to identify or correct the corrosion process that had already been affecting the aircraft, a circumstance that may have contributed to the structural failure.

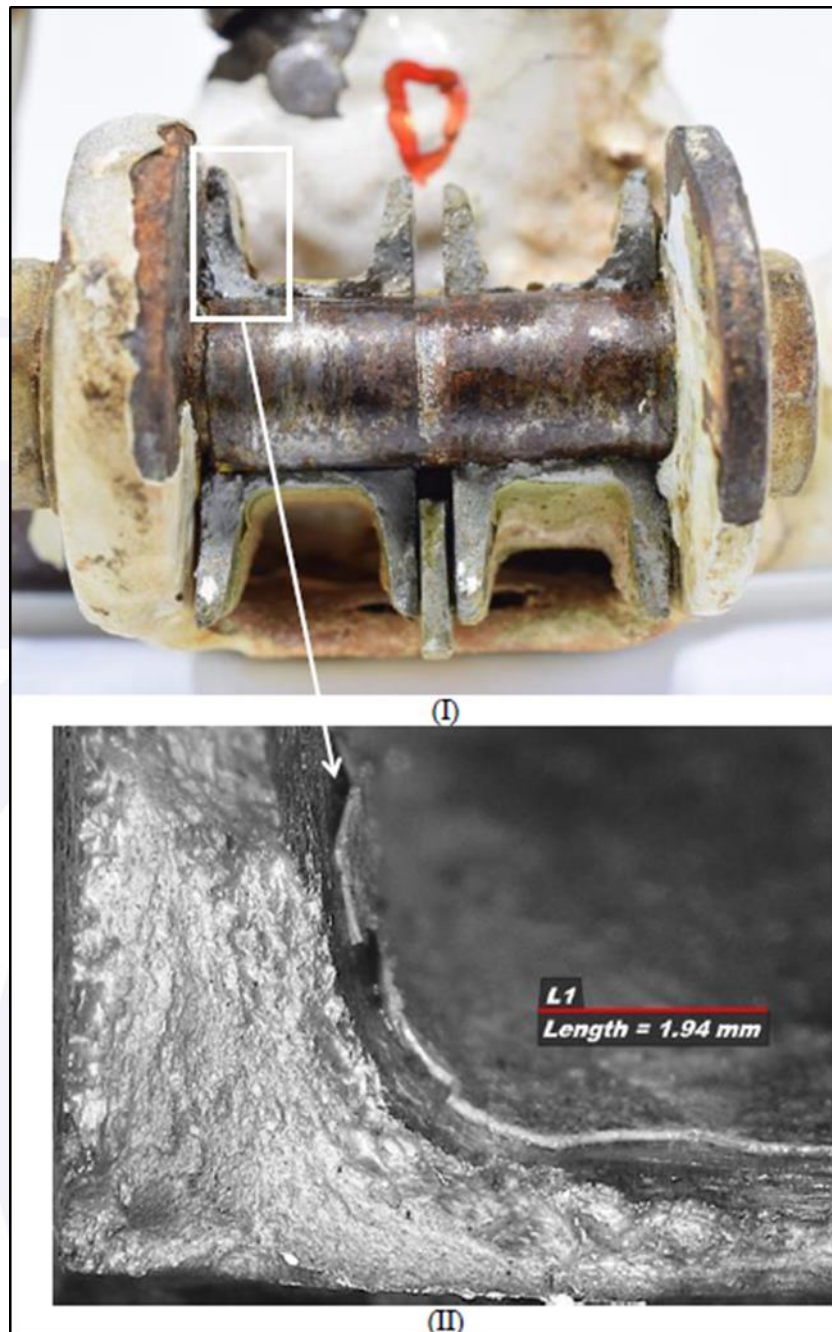
Examination of the lower right wing fitting revealed a fracture with typical characteristics of failure due to overload (Figure 7).

Figure 7 – View of the lower truss and the lower fitting of the right wing.

Welds were also observed on the lower truss of the right wing, where overlapping tubes of different thicknesses had been applied and welded. No entries were found in the aircraft's airframe logbook that could be associated with this condition, referring either to acceptable technical data with repair instructions or to the execution of the service itself.

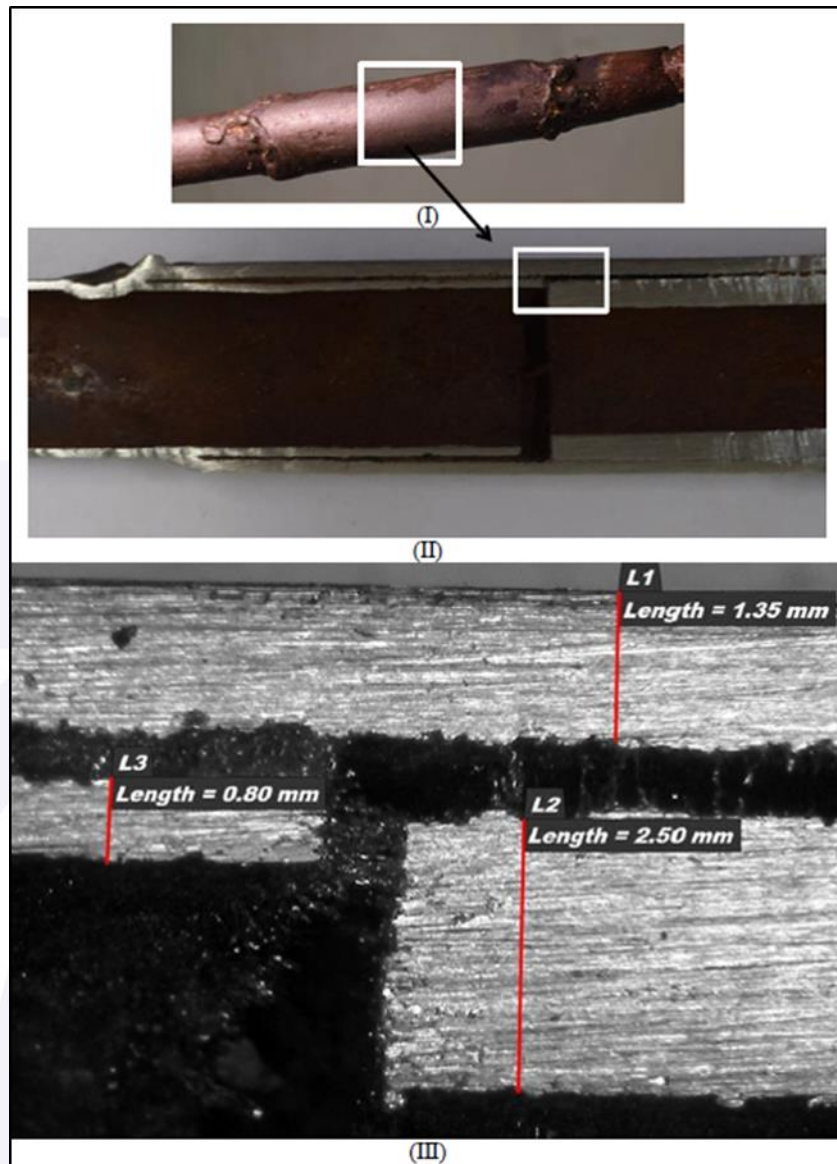
A longitudinal cut allowed for the measurement of differences in thickness between the welded tubes (Figure 8).

Figure 8 – Internal view of the right lower truss tube showing the thickness of the welded tubes.

The presence of welds and the use of tubes with different thicknesses in the lower truss of the right wing also suggested that the wing structure had previously undergone repairs. Combined with the corrosion, this may have contributed to the partial structural collapse in flight.

The presence of widespread corrosion in the aircraft's wing structural components, as well as the presence of welds and overlapping tubes of different thicknesses on the lower truss of the right wing, evidenced the performance of inadequate maintenance services that contributed to the in-flight structural failure.

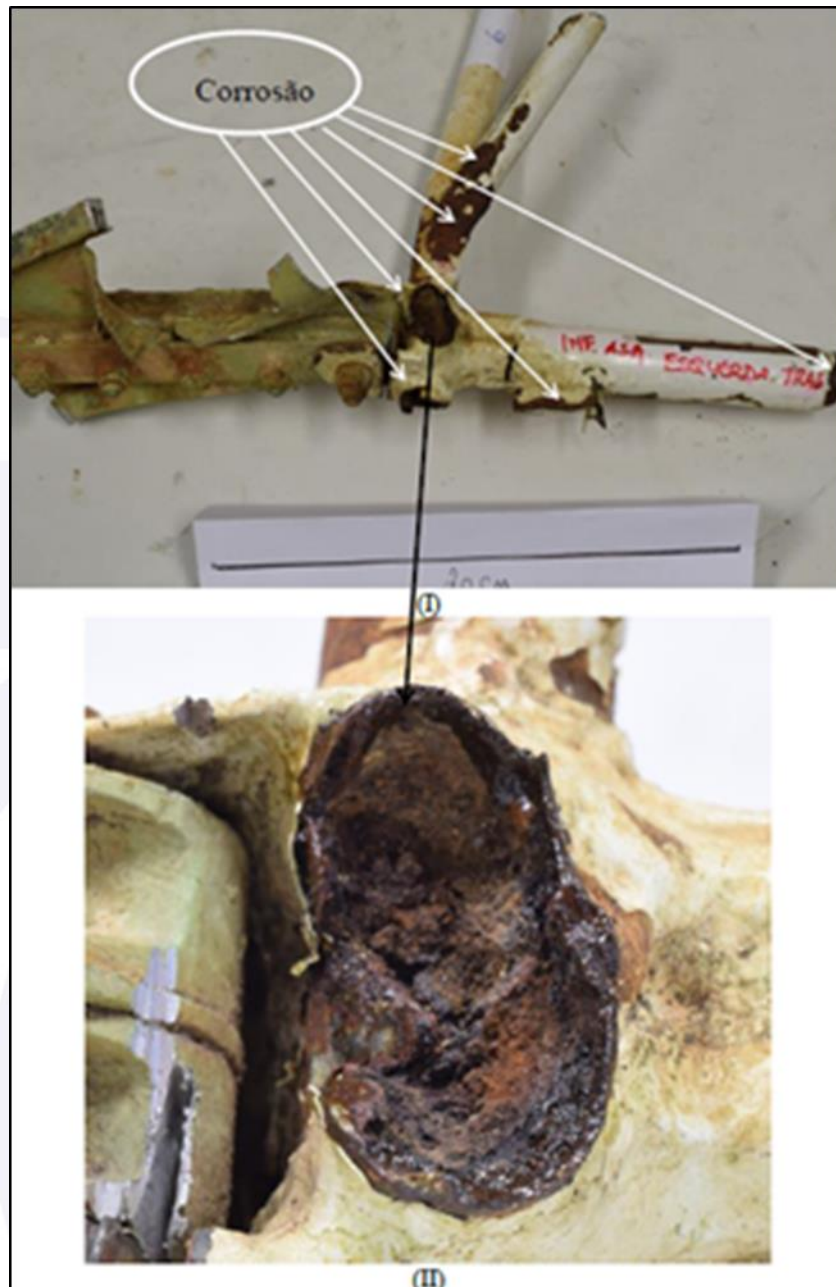
On the lower truss of the left wing, widespread corrosion with material loss was also observed (Figure 9).

The advanced stage of the observed corrosion indicated that the corrosive process had been ongoing for a significantly long period prior to the most recent maintenance activities.

Figure 9 – View of the lower truss of the left wing showing widespread corrosion.

Liaise with *Elo Forte Aviação Agrícola Ltda.*, to ensure that the operator demonstrates that its managerial oversight mechanisms ensure the quality of maintenance services performed on its aircraft, particularly with regard to the identification of corrosion processes affecting the airplanes it operates and the application of recommended corrective actions for this issue.

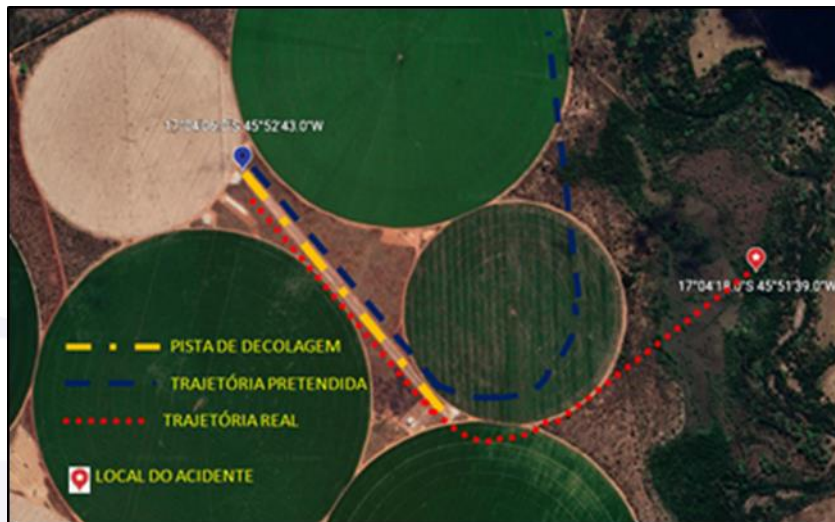
At around 11:00 UTC, during the takeoff in which the accident occurred, the PR-CTD was seen by witnesses flying a trajectory that differed from the usual profile and at a lower altitude than in previous flights. Shortly afterward, the sound of the aircraft striking the trees was heard.

Based on the information collected and the indications observed regarding the dynamics of the occurrence, it was estimated that the airplane followed the trajectory shown in Figure 10 below.

Figure 10 – Sketch of the aircraft's trajectory. The dashed blue line shows the usual profile. The dotted red line shows an estimate of the trajectory during this accident.

Reports from witnesses indicating that the aircraft followed an unusual trajectory at a lower altitude than in previous flights suggest that an abnormal condition may have been present before the collision with the ground.
