FINAL REPORT
A - 052/CENIPA/2020

OCCURRENCE:	ACCIDENT
AIRCRAFT:	PR-DTY
MODEL:	PA-25-260
DATE:	18APR2020

This is the Final Report of the 18APR2020 accident with the PA-25-260 aircraft model, registration PR-DTY. The accident was classified as “[LALT] Low Altitude Operation”.

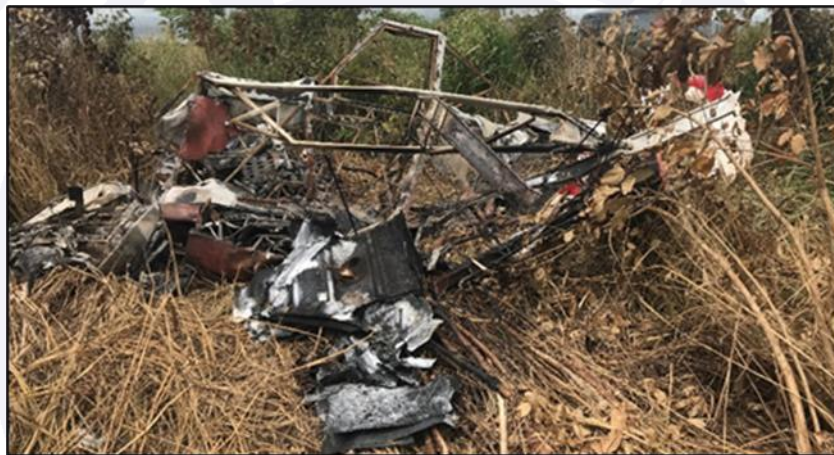
The aircraft caught fire upon impact and was destroyed.

Figure 1 - General view of the PR-DTY wreckage.

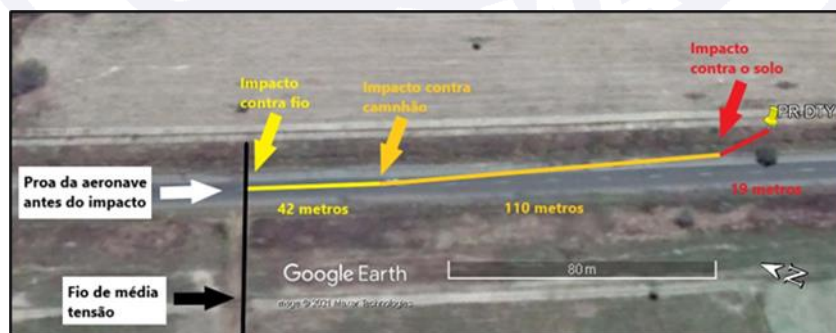
The first impact occurred against a single-phase medium voltage cable, with the aircraft heading at approximately 176°. The second impact occurred when the left wing collided with a truck traveling on the highway.

After the second impact, the aircraft traveled approximately 110 meters and hit the ground near the shoulder of the highway, dragging and leaving the road, stopping at 90° in relation to the axis of the BR-135 (Figure 2).

Figure 2 - Sketch of the accident. Source: adapted from Google Earth.

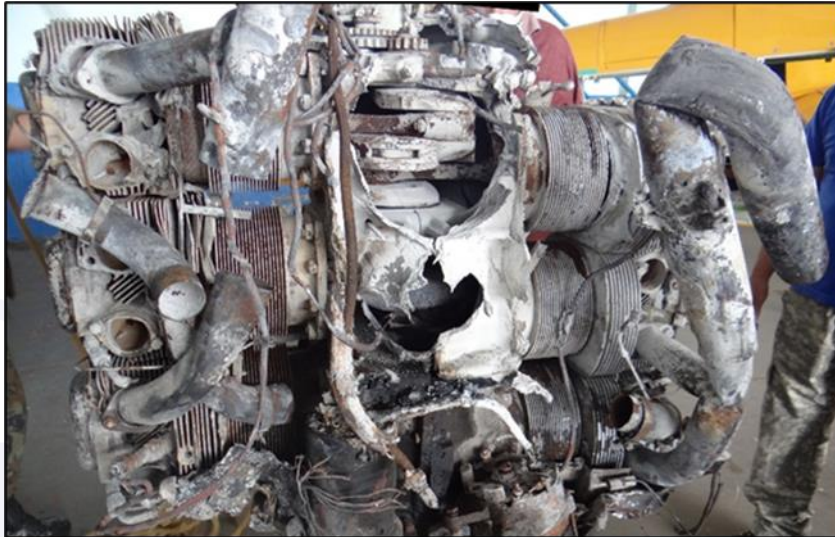
The analysis showed that the engine was exposed to temperatures above 820°C, leading components of the lubrication systems, fuel supply, cylinders, pistons, and semi-casings to be consumed in their entirety or in part.

Initially, it was found that the engine had severe damage as a result of the fire that followed the collision of the aircraft with the truck, on the BR-135. It was also observed that a large part of the engine was consumed by the fire (Figure 3).

Figure 3 - Aircraft engine overview.

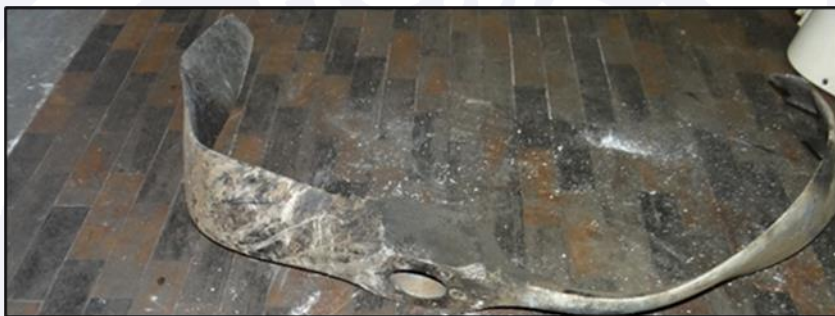
The propeller was the component that provided evidence that the engine was not stationary at the instant of the aircraft collision. Figure 4 shows an overview and the backward-facing bending in both blades.

Figure 4 - General view of the propeller with the blade tips facing backwards.

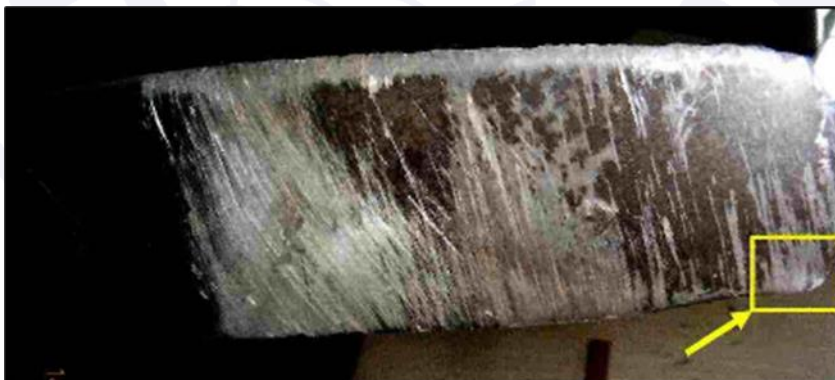
Figure 5 shows a propeller blade with transverse scratches. It can be seen, in the highlight, a small bend facing forward, at the end of the blade.

Figure 5 - View of a propeller blade showing transverse scratches, impact marks and forward-facing bending.

The investigation regarding the aircraft's powertrain system concluded that the engine was not stopped the moment the plane impacted the ground, and signs were observed that it was at medium to low power.
