FINAL REPORT
A - 002/CENIPA/2013

OCCURRENCE:	ACCIDENT
AIRCRAFT:	PR-DUB
MODEL:	R66
DATE:	03JAN2013

Aircraft	Model: R66 Registration: PR-DUB Manufacturer: Robinson Helicopter	Operator: Private
Occurrence	Date/time: 03JAN2013 - 1715 UTC Location: Serra do Mar Lat. 23°31'57"S Long. 045°20'34"W Municipality – State: Caraguatatuba – SP	Type(s): "[UIMC] Unintentional IMC" Subtype(s): NIL

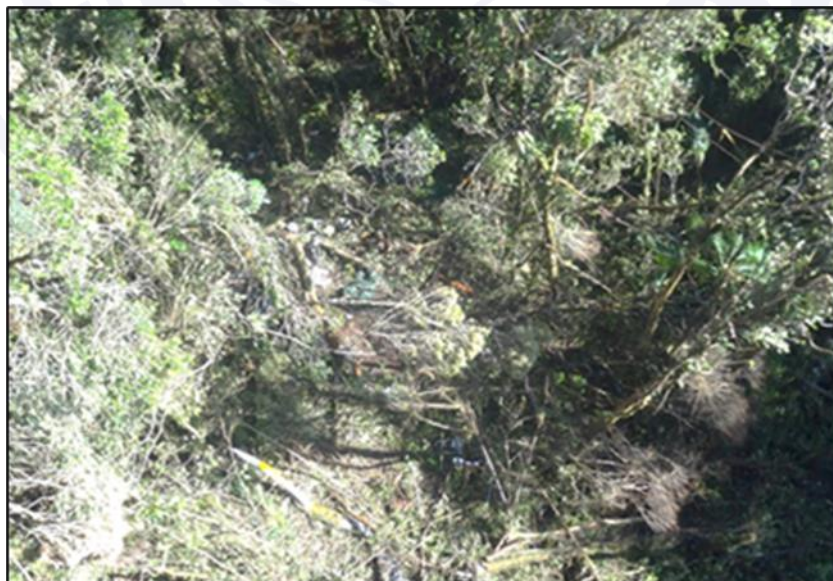
The aircraft was destroyed. The transmission assembly, blades and engine were separated from the helicopter's fuselage structure and were severely damaged by the impact (Figure 1).

Figure 1 - Overview of the helicopter site and wreckage.

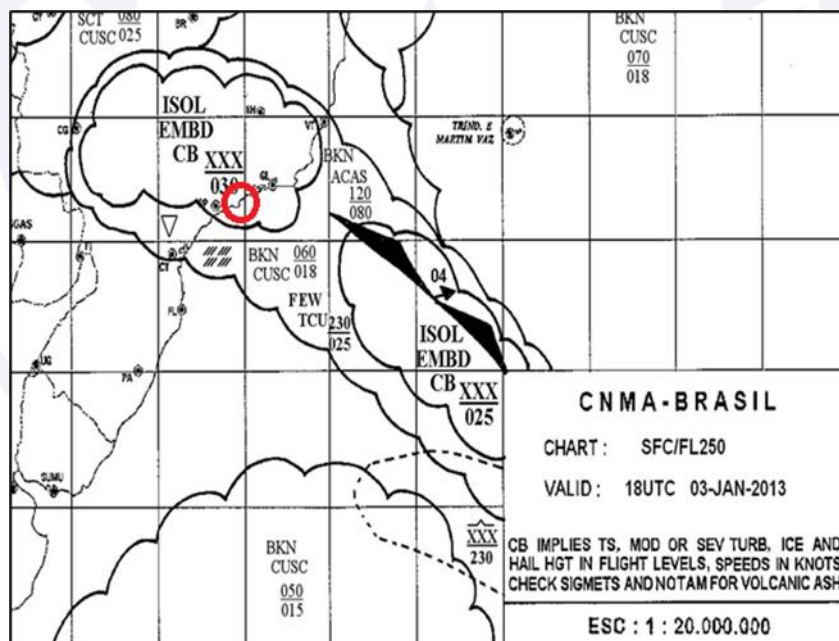
The SIGWX chart from the surface to FL250, valid until 1800 UTC on 03JAN2013, indicated the presence of isolated/embedded cumulonimbus (CB) clouds from level FL030, rain showers, cumulonimbus clouds and cloud from 1,800 to 6,000 ft (Figure 2).

Figure 2 - SIGWX chart valid until 1800 (UTC).

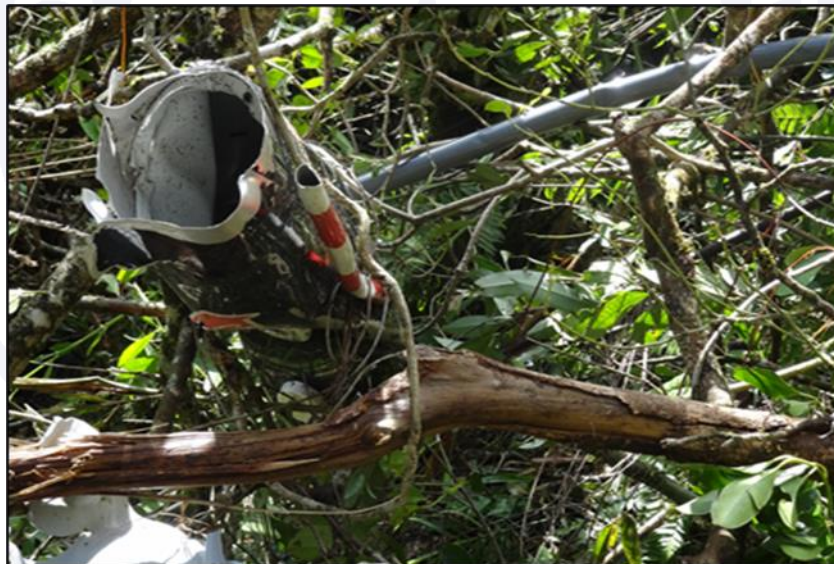
The characteristics of the wreckage (high degree of destruction and separation of most components and parts of the aircraft from the fuselage structure) indicated that the impact against the vegetation occurred with great energy.

The cabin, engine and main transmission were destroyed and separated. The shaft that drives the tail rotor has been sectioned. The rear transmission separated, as well as the main rotor blades. The skis also separated and buried in the ground (Figure 3).

Figure 3 - View of the separate tail cone.

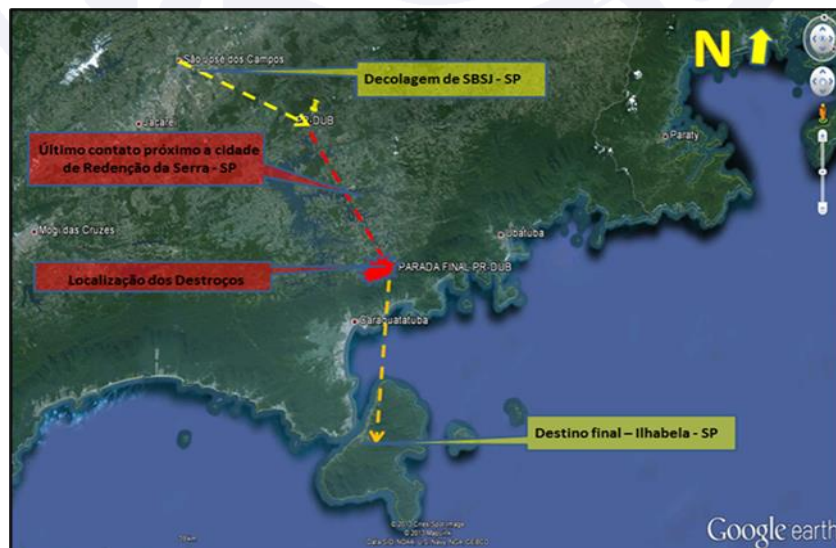
Figure 4, below, describes the intended route and the location of the PR-DUB wreckage.

Figure 4 - Route and location of the PR-DUB wreckage.
