FINAL REPORT
A - 081/CENIPA/2019

OCCURRENCE:	ACCIDENT
AIRCRAFT:	PR-DVR
MODEL:	T210N
DATE:	18MAY2019

This is the Final Report of the 18MAY2019 accident with the T210N aircraft model, registration PR-DVR. The accident was classified as “[SCF-PP] System/Component Failure or Malfunction Powerplant – Engine Failure in Flight”.

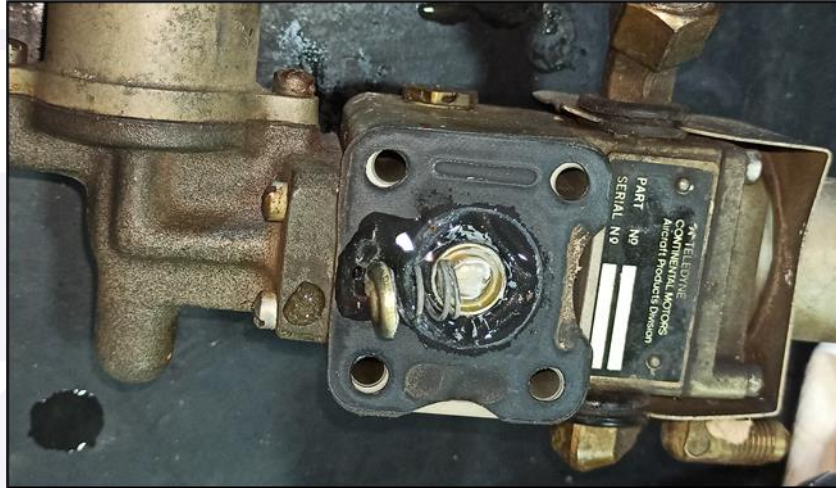
Figure 6 - View of the disassembly of the mechanical fuel pump.

It was verified, in the partial disassembly and analysis of the items, that the mechanical fuel pump had an internal leak in the retainer of the aneroid capsule, flooding its housing, a fact proven by hydrostatic test.

Thus, evidence was found that the aforementioned bomb could have shown abnormal functioning in the period prior to the accident.

However, the technical analysis of the mechanical fuel pump identified that there was a leak in the retainer of the aneroid capsule of this component.

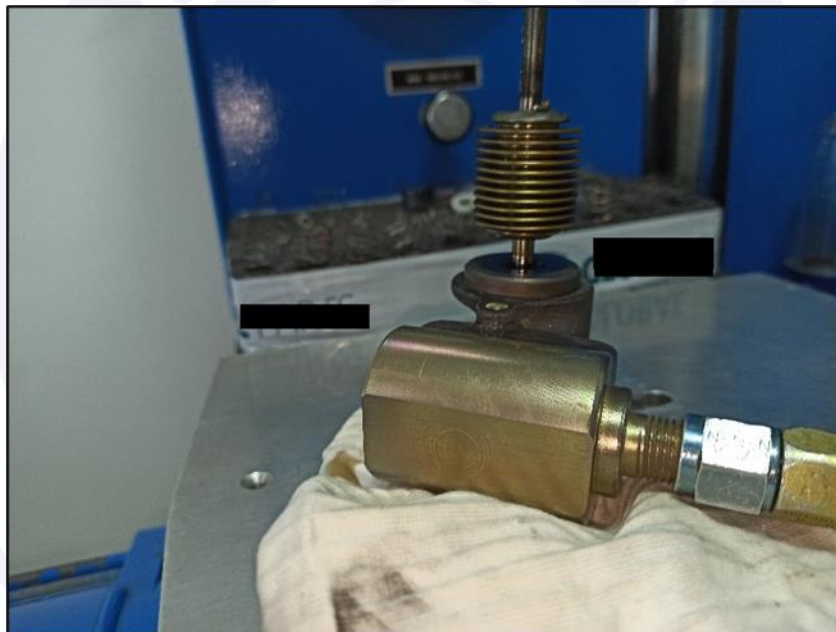
Figure 7 - View of the aneroid capsule in the hydrostatic test.

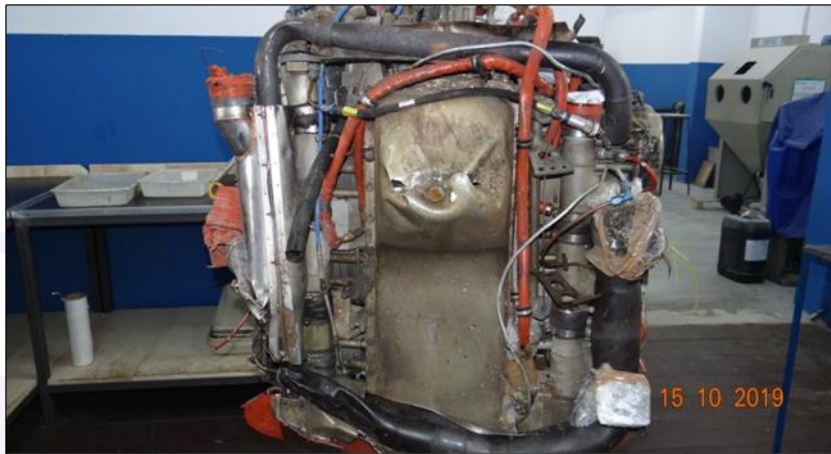
It was noted that the engine had severe impact damage (Figure 8).

Figure 8 - View from the bottom of the engine.

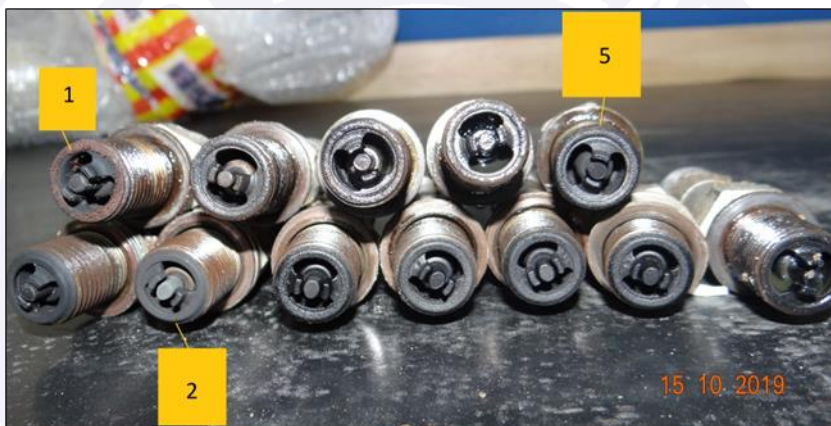
The spark plugs in cylinders 1, 2 and 5 showed a dark color (soot) on the central electrode (Figure 9).

Figure 9 - General view of the engine spark plugs. On the spark plugs of cylinders 1, 2 and 5, the presence of black soot was evident.

This possibility is reinforced by the presence of black soot on spark plugs 1, 2 and 5, which is associated with burning a very rich mixture (with excess fuel).

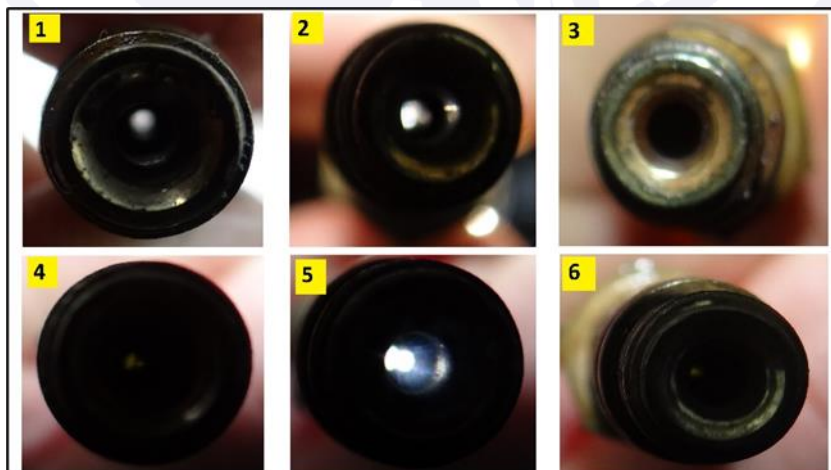
The fuel supply system was inspected and obstructions were found in the fuel through holes of the nozzles of cylinders 3, 4 and 6 (Figure 10).

Figure 10 - View of the engine injector nozzle orifices.

In fact, while the spark plugs in cylinders 1, 2 and 5 had a typical coloration when operating with rich mixture, due to leakage in the seal of the aneroid pump cap and the inefficiency of air supply by the turbocharger, the spark plugs in cylinders 3, 4 and 6 had typical coloration when operating with a lean mixture (greater amount of air), due to obstruction of the injector nozzles.

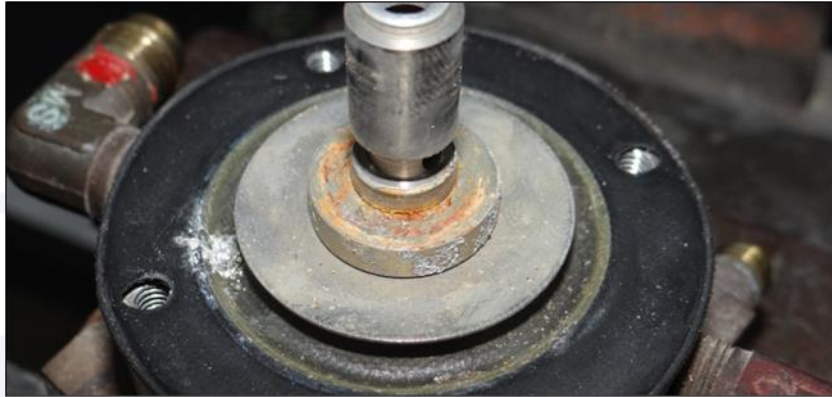
The fuel distributor diaphragm piston was stuck. After removing that one, corrosion was found in its housing and in the distributor filter. (Figures 11 and 12).

Figure 11 - View of the diaphragm piston stuck by corrosion.

It was also verified that the fuel distributor (spider) had the diaphragm cylinder stuck. When this component was removed, the presence of oxides in the fuel chamber was observed.

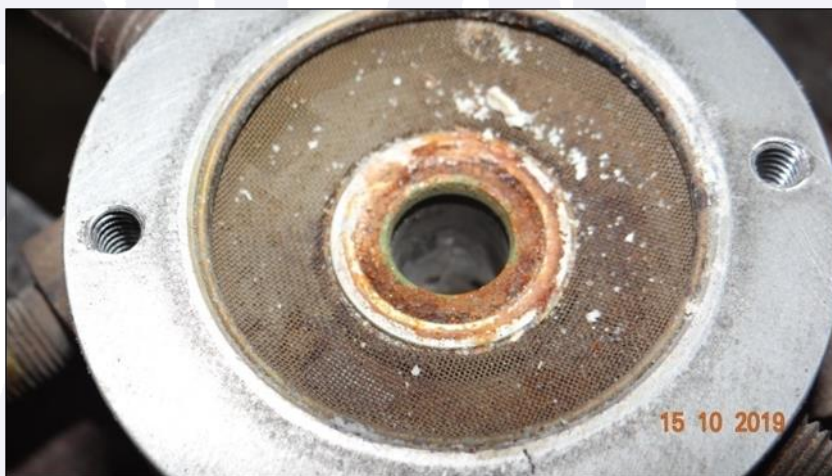
Figure 12 - View of corrosion in the distributor's internal fuel filter.

Oxides were found inside the fuel chamber of the distributor; however, it was not possible to establish the origin of these inorganic substances, and their occurrence is likely due to water contamination.

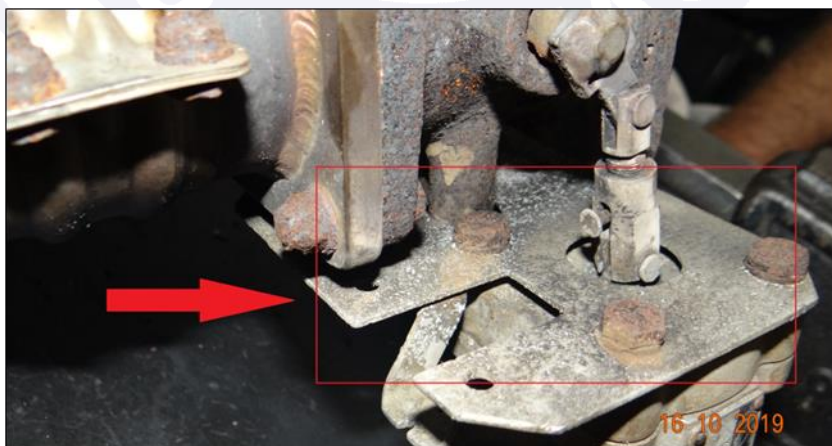
The component analysis also made it possible to verify evidence of exhaust gas leakage through the throttle body, which reached the hydraulic actuator of the waste gate valve, in addition to cracks and holes in the throttle, caused by severe corrosion. (Figures 13, 14 and 15).

Figure 13 - Evidence of the actuator affected by the leakage of exhaust gases from the throttle body.

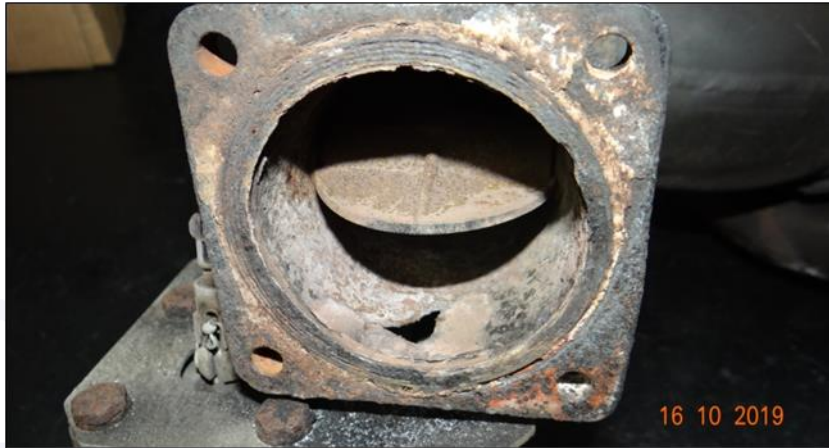
Figure 14 - View of severe corrosion on the inside of the throttle body.

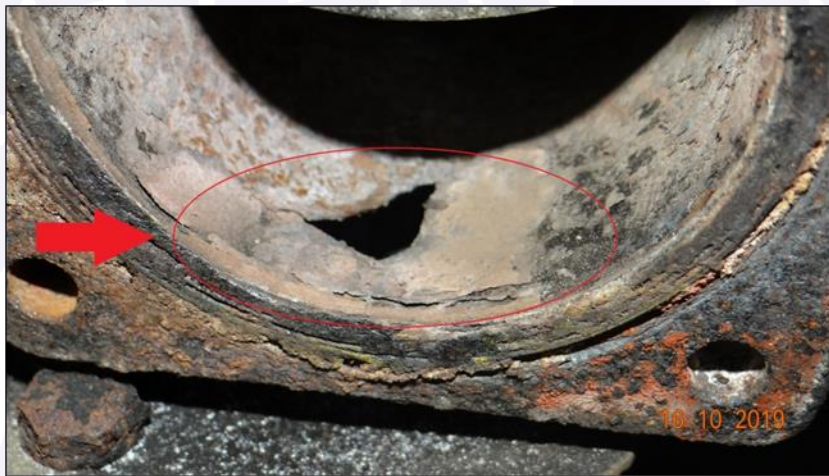
Figure 15 - View of the crack and hole observed inside the throttle body, caused by severe corrosion.

The crack and hole found in the throttle body of the waste gate bypass system, caused by severe corrosion, allowed the exhaust gases to leak into the atmosphere, reducing the efficiency of the turbocharger, due to the reduction in the air mass that should be forced into the cylinders.

This condition caused a rich mixture with a consequent loss of engine power, in addition to causing the black soot seen both on the spark plugs and in the black smoke noticed by people who observed the take-off.

Another fact that contributed to the unbalance of the air/fuel mixture was the inefficiency of the turbocharger, which had a hole in the throttle body and a crack in the waste gate.

These conditions, caused by severe corrosion, allowed the exhaust gases to leak into the atmosphere, making the turbocharger inefficient.

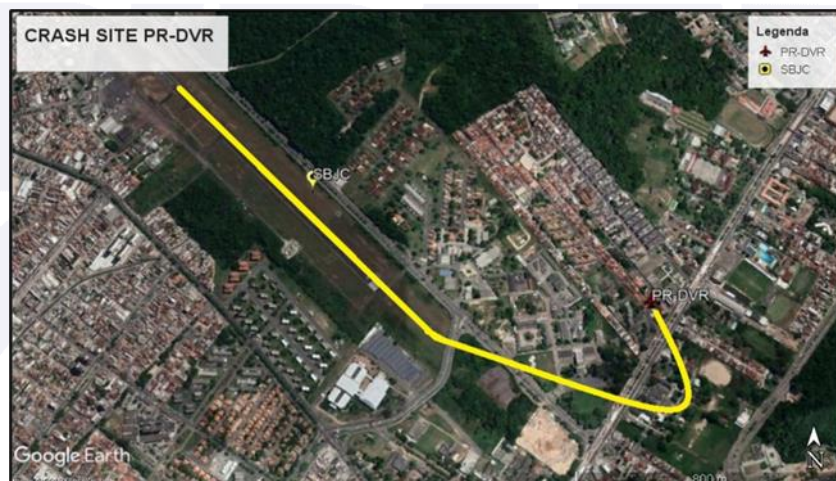
Shortly after the take-off, the pilot was alerted by observers that there was smoke coming from the aircraft. He then made a left turn in an attempt to return to the Aerodrome, but during this maneuver, the aircraft lost lift and collided with a residence (Figures 16 and 17).

Figure 16 - Sketch of the occurrence.

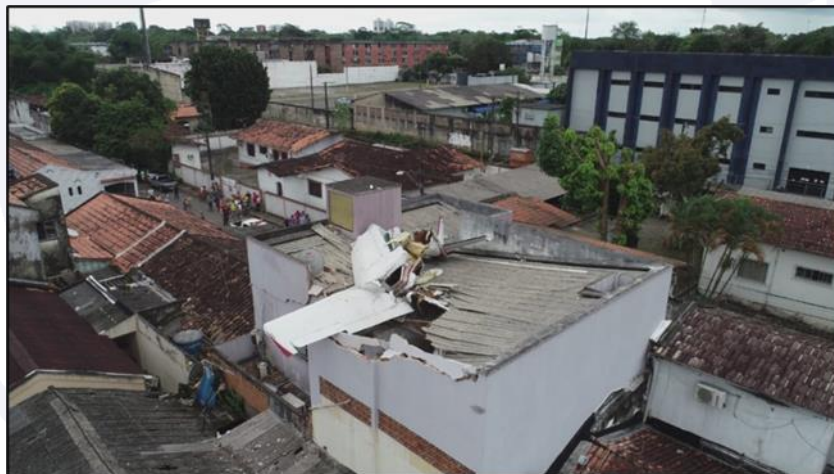
After a complete stop, the aircraft was left hanging in the stairwell of the residence. There was fuel leak, however there was no fire due to the swift action of public security agents and the people around.

Figure 17 - View of the aircraft after the impact.
