COMANDO DA AERONÁUTICA
CENTRO DE INVESTIGAÇÃO E PREVENÇÃO DE
ACIDENTES AERONÁUTICOS

FINAL REPORT
A - 117/CENIPA/2019

OCCURRENCE:	ACCIDENT
AIRCRAFT:	PR-EAM
MODEL:	AS350B3
DATE:	07AUG2019

This is the Final Report of the 07AUG2019 accident with the AS 350 B3 aircraft model, registration PR-EAM. The accident was classified as “[LOC-I] Loss of Control in Flight”.

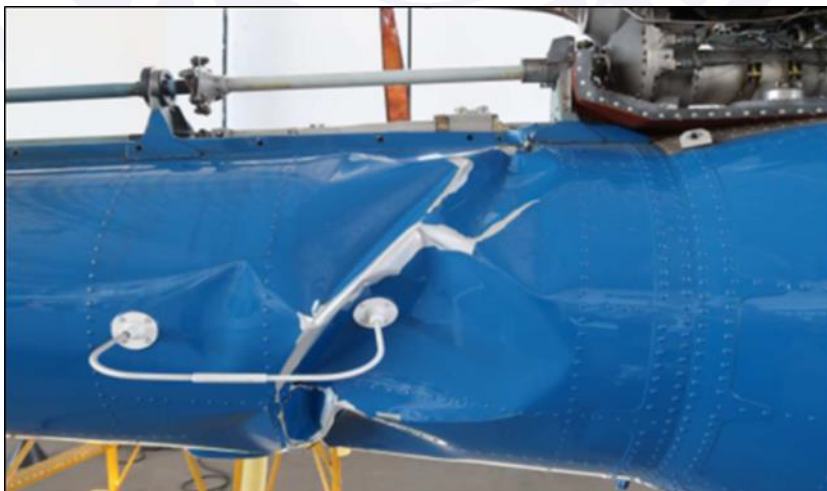
The aircraft had substantial damage to the tail cone and horizontal stabilizer, as well as light damage to the skis and tail rotor (Figure 1).

Figure 1 - Damage to the aircraft tail cone (seen from the right side).

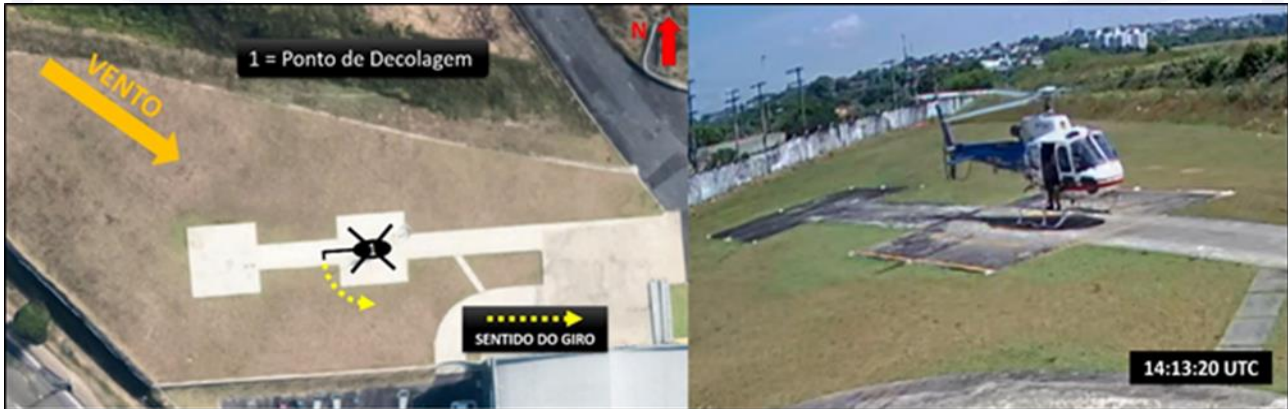
According to the images of a CCTV, it was possible to verify that the take-off took place at 14:13:20 (UTC). At that moment, before the aircraft left the ground, there was a left turn, causing the skis to drag on the ground (Figure 2).

Figure 2 - Moment when the aircraft starts the take-off.

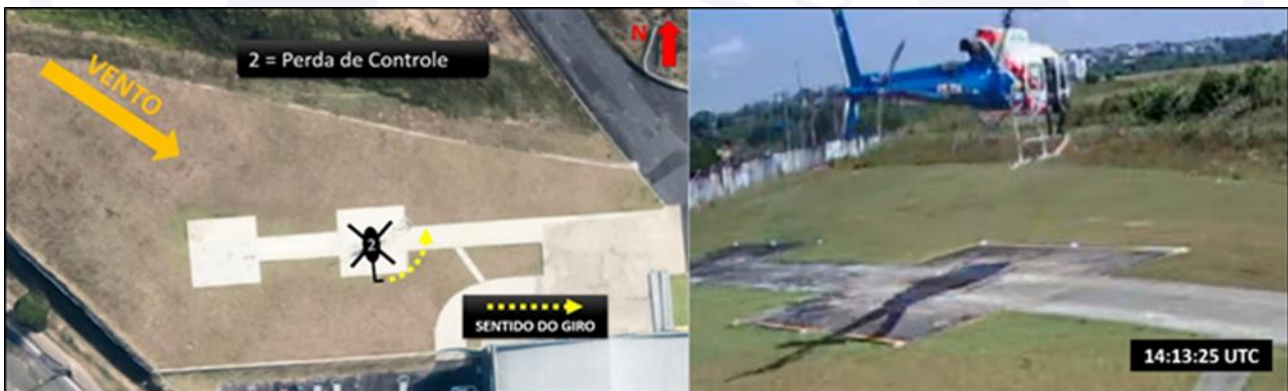
After leaving the ground, the aircraft continued to turn to the left while it began to gain height and accelerate the turn. At 14:13:25 (UTC), when reaching about 90° of turn and about 3m high, there was a sudden acceleration of the turn and the aircraft tilted laterally (Figure 3).

Figure 3 - First 90° turn to the left and loss of control.

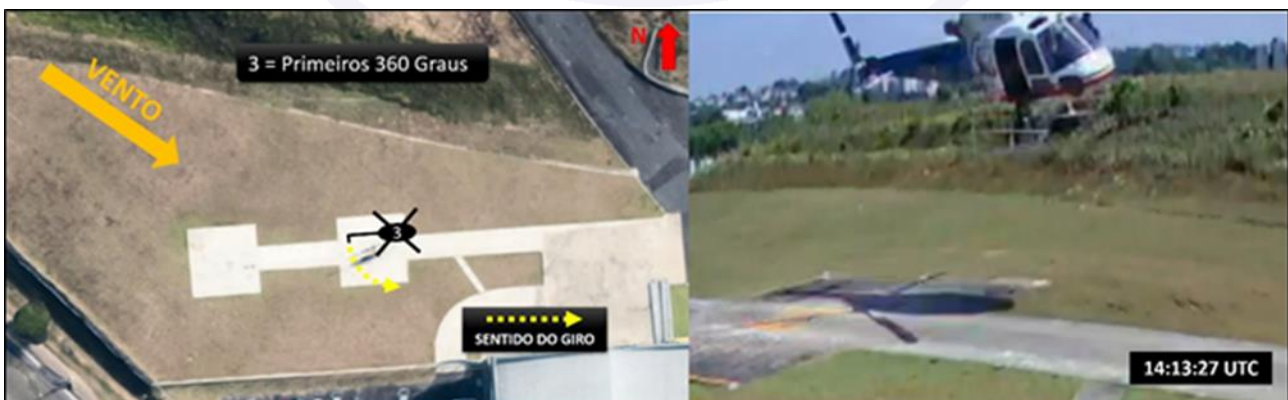
Two seconds later, at 14:13:27 (UTC), the aircraft completed the first 360° turn to the left, about the take-off position (Figure 4).

Figure 4 - First complete turn to the left (360°).

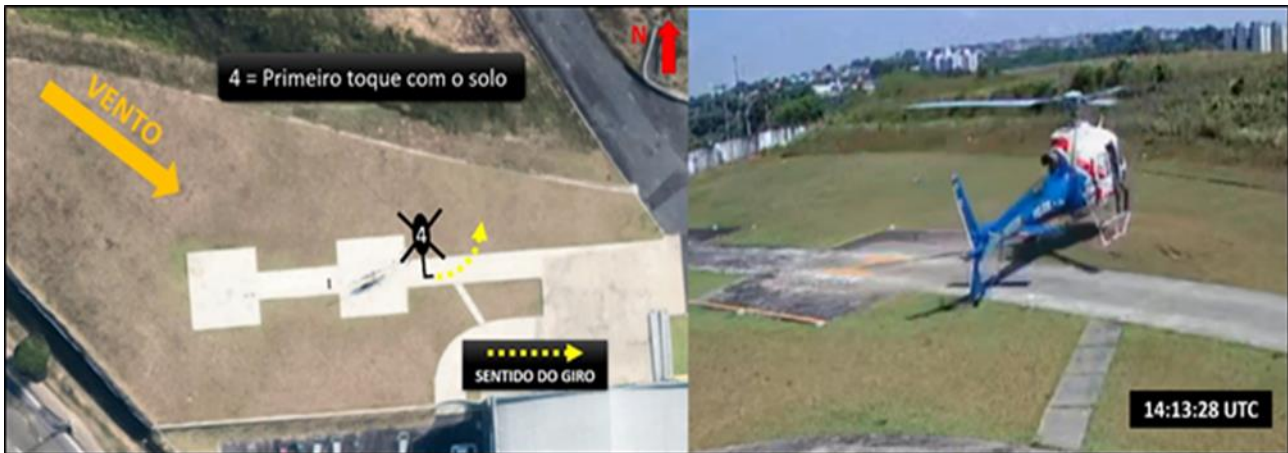
Then, the aircraft continued the left turn and quickly lost height, when at 14:13:28 (UTC) the impact with the ground occurred in a pitch up attitude of approximately 10° . At that moment, the tail of the aircraft and the rear portion of the skis collided (Figure 5).

Figure 5 - Touching the ground in a pitch-up attitude.

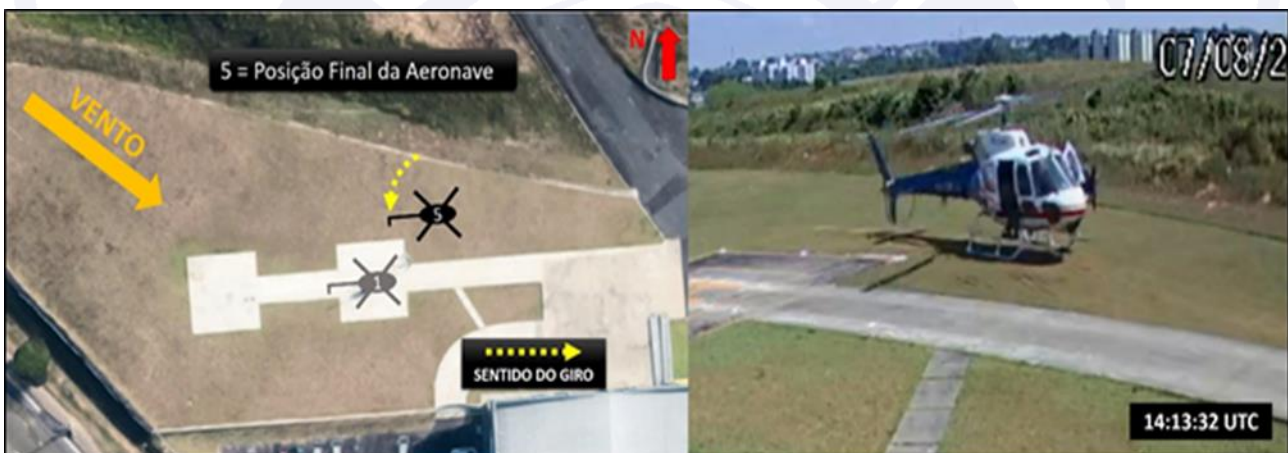
The aircraft continued the turn, however in deceleration, lowered the nose to about 10° pitch, continued the turn supported on the front part of the skis, but without leaving the ground, and completed another 270° turn. The stop took place at 14:13:32 (UTC), with the helicopter displaced about 10 m from the initial position (Figure 6).

Figure 6 - Final position of the aircraft, in which number 1 refers to the initial position (take-off) and number 5 refers to the final position.

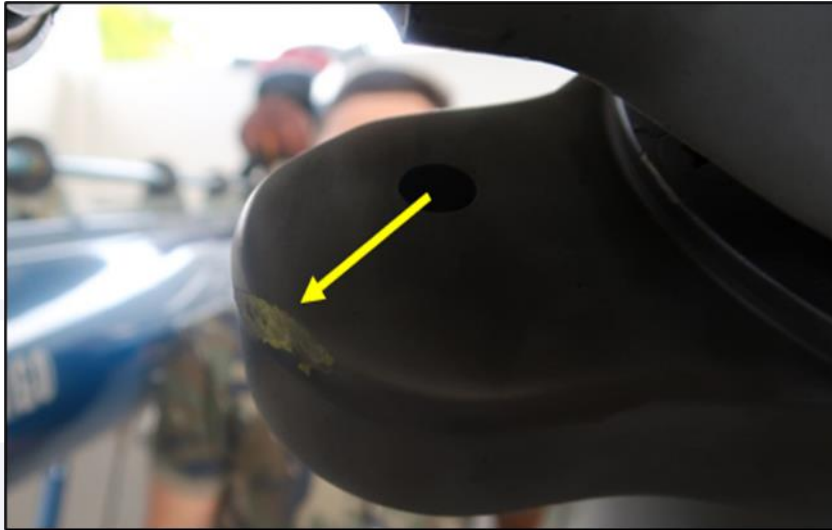
During the examination of the tail rotor, contact marks were observed between the counterweights of the tail rotor blades (Figure 7) and the end of the rotating control plate (Figure 8).

Figure 7 - Approximate view of the mark left on the counterweight, due to contact with the rotating control plate.

This analysis served to corroborate the marks observed in the counterweights of the tail rotor blades and the rotating plate, which were caused by the phenomenon known as tail rotor flapping.

The contact marks between the rotating control plate and the counterweights of the tail rotor blades indicated that the aerodynamic phenomenon known as flapping occurred, caused by the application of the left pedal command until close to the end of its course, which resulted in a tailspin at a rate greater than 60° per second. These findings were corroborated by the CCTV footage obtained and through the aerodynamic simulations performed by the manufacturer, which considered the conditions at the time of the occurrence.

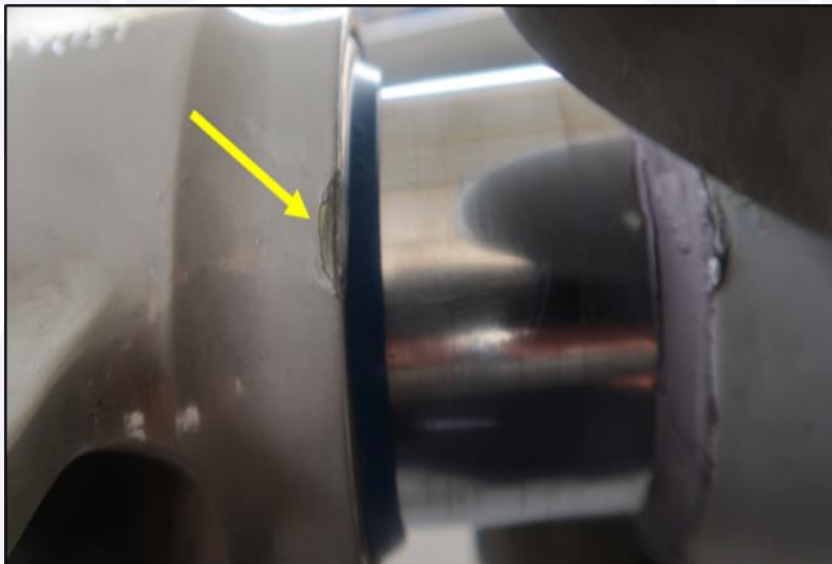
Figure 8 - Mark observed on the rotating control plate, caused by the contact of the tail rotor blade counterweight.

With the pedal applied to its left stop, there was an excessive increase in the turning speed and, consequently, the flapping effect, which made it possible for the counterweights to come into contact with the rotating plate.

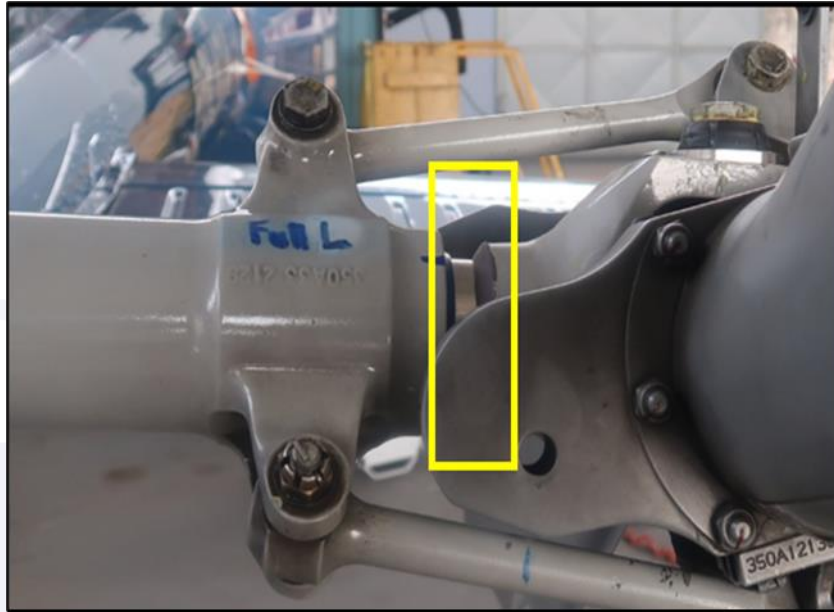
In order to make contact between the counterweight and the rotating plates possible, the left pedal should be applied to the end of its stop, since, in this condition, the rotating plate was in the position closest to the counterweights (Figure 9).

Figure 9 - Distance between the tail rotor blade counterweight and the rotating plate with the left pedal in the end-of-stroke position.

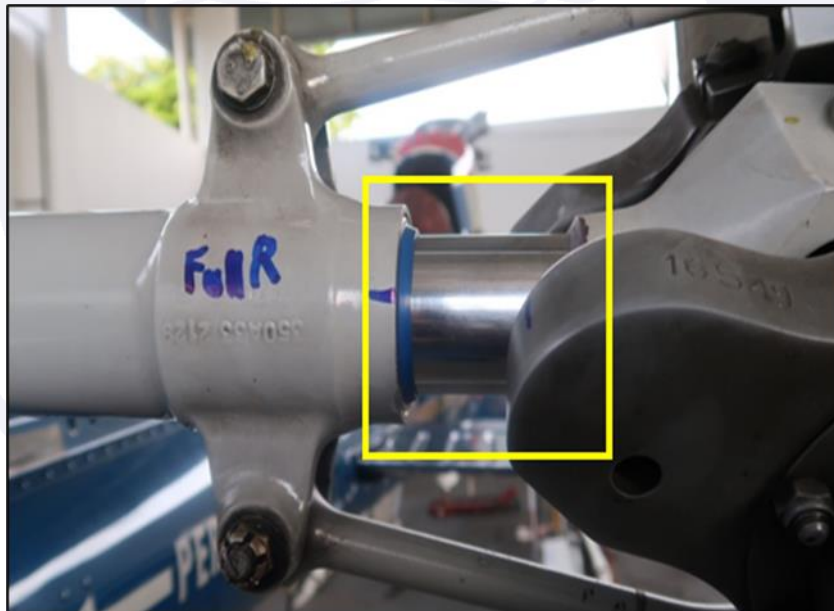
It is noteworthy that, when the right pedal is applied to its stop, the distance between the tail rotor blade counterweight and the rotating control plate does not allow contact between these parts (Figure 10).

Figure 10 - Distance between the tail rotor blade counterweight and the rotating plate with the right pedal in the end-of-stroke position.

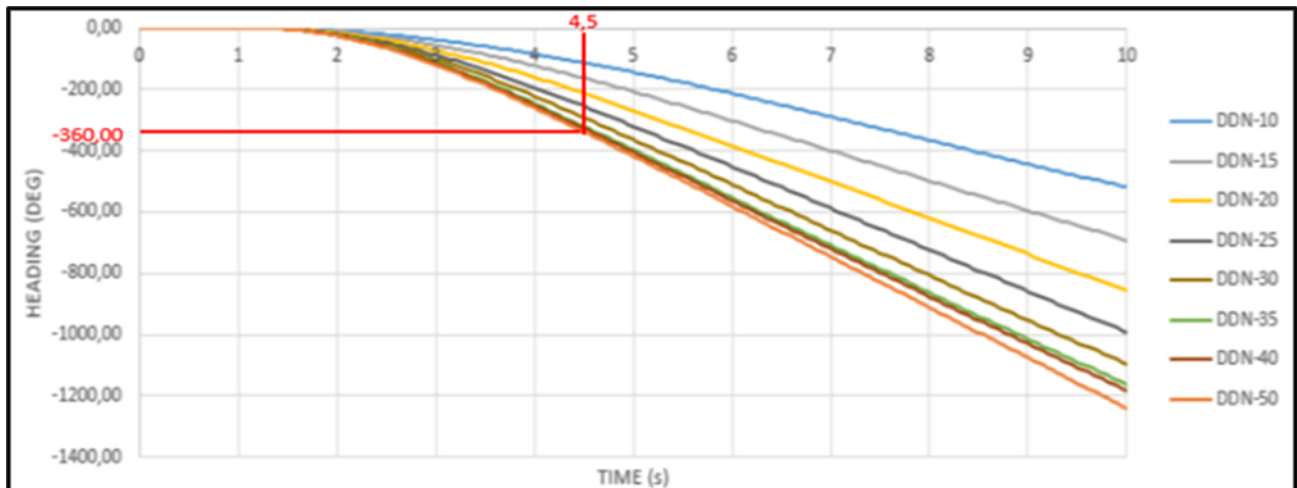
Figure 12 - Effect of left pedal application speed on aircraft heading variation as a function of time. Note that the DDN-50 Curve reaches a 360° turn in 4.5 seconds.

Considering the “DDN-50” curve (application in increments of 50% of the left pedal every half second) it is observed that in approximately 4.5 seconds the aircraft heading DEG is close to 360°.
