COMANDO DA AERONÁUTICA
CENTRO DE INVESTIGAÇÃO E PREVENÇÃO DE
ACIDENTES AERONÁUTICOS

FINAL REPORT
A-044/CENIPA/2022

OCCURRENCE:	ACCIDENT
AIRCRAFT:	PR-EFC
MODEL:	CABRI G2
DATE:	11ABR2022

This Final Report pertains to the April 11, 2022, accident involving the CABRI G2 helicopter of registration marks PR-EFC. The occurrence was typified as "[LOC-I] Loss of Control In-Flight."

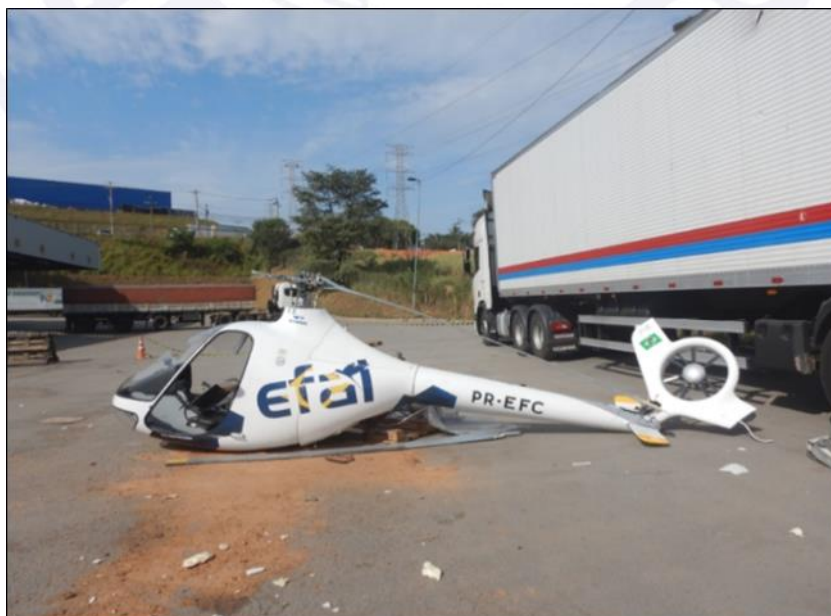
The aircraft sustained substantial damage throughout its entire structure. The skid landing gear detached from the airframe due to the impact with the ground.

Figure 1 – Side view of the helicopter after the accident.

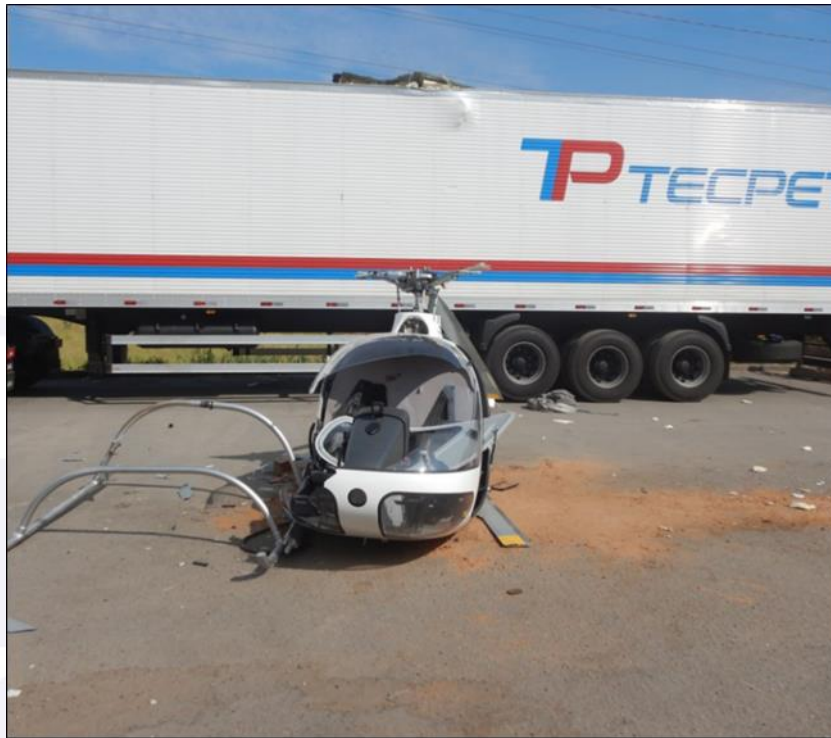
Two main rotor blades separated from the rotor head, and all three blades exhibited severe damage.

Figure 2 – Front view of the helicopter.

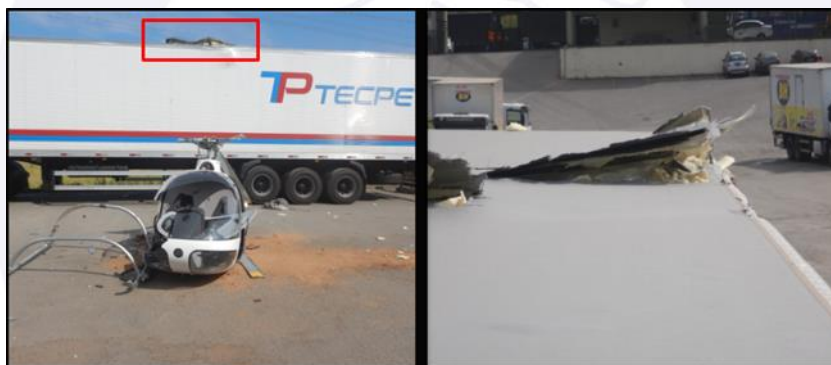
The aircraft collided with a truck that was parked in the cargo-loading area of *Hipermercado BH*, causing damage to the vehicle's cargo compartment.

Figure 3 – On the left, the point of impact on the truck; on the right, detail of the damage.

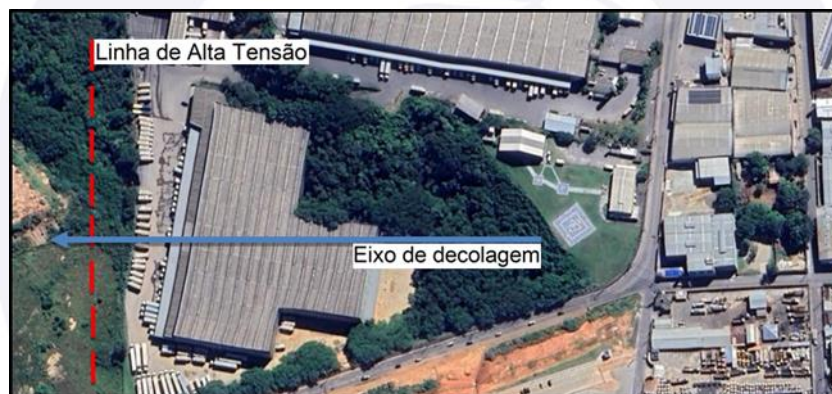
The area surrounding the helipad contained multiple terrain elevations, prompting the CIAC to standardize the 320° axis as the sole departure direction. However, along this axis, a high-voltage power line was positioned transversely, as illustrated in Figure 6.

Figure 6 – Departure axis and high-voltage power line.
Source: Adapted from Google Maps.

From an operational standpoint, a key factor at SNHN was the proximity of a high-voltage power line located directly along the takeoff trajectory.

The power line was in a position higher than the helipad; however, a properly executed takeoff would normally allow the aircraft to clear such obstacle.

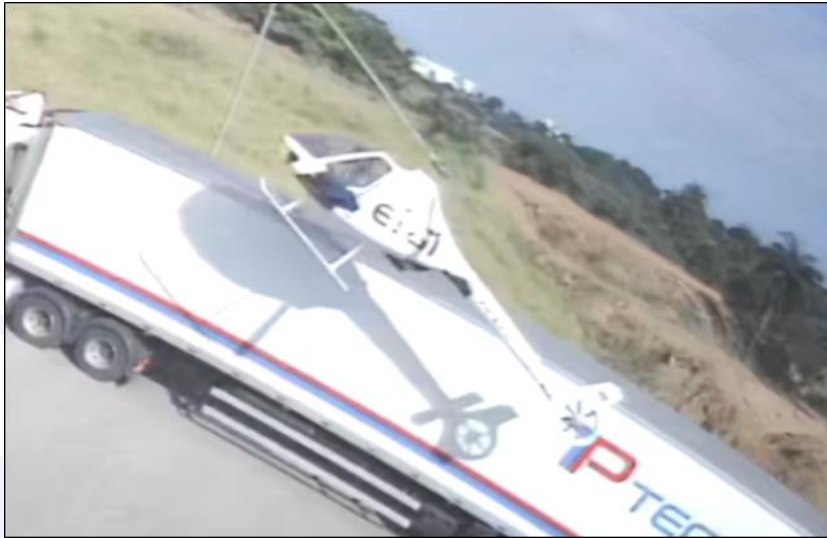
Security camera footage from the site captured the final moments before impact. It was observed that the aircraft sustained damage after colliding sequentially with a truck and the ground. Before the impact, the tail boom, main rotor blades, and the *Fenestron* were intact.

Figure 7 – Image of the aircraft moments before impact.
Source: *Hipermercado BH's* security camera footage.

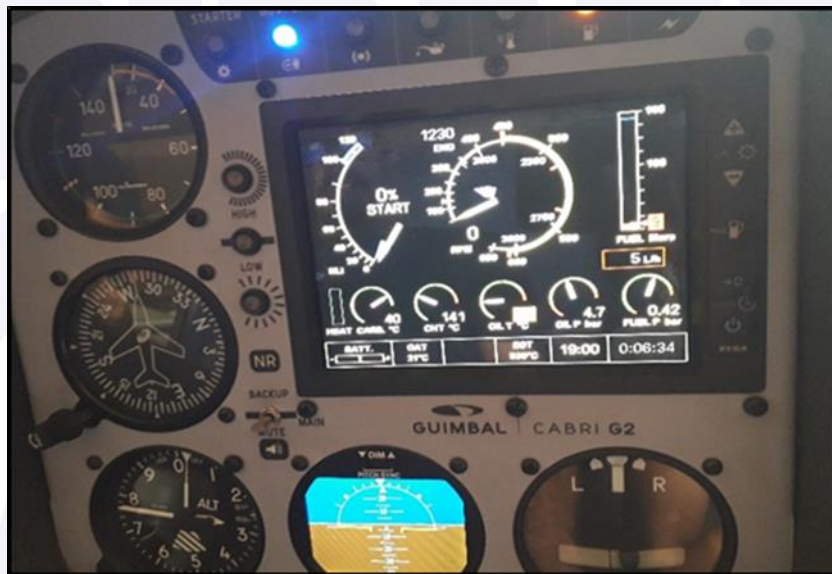
The engine was then test-run in the aircraft, following the parameters outlined in the Operator's Manual – Lycoming O-360, dated October 2005, 8th edition. During testing, the engine performed normally across different power settings, with no malfunctions or operational anomalies.

Figure 8 – Image of the instrument panel during engine run-up.

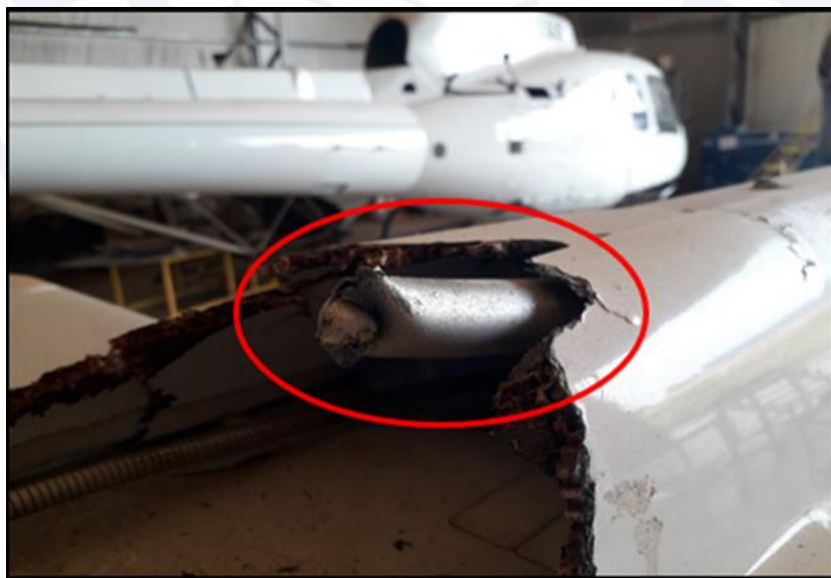
Furthermore, the Investigation Committee identified that fractures in the main rotor blades, as well as a torsional failure in the tail rotor drive shaft (Figure 9), indicated that the engine was operating normally at the time of the accident.

Figure 9 – Tail rotor drive shaft with torsional failure.
