**FINAL REPORT**  
**A-084/CENIPA/2022**

<b>OCCURRENCE:</b>	<b>ACCIDENT</b>
<b>AIRCRAFT:</b>	<b>PR-EGD</b>
<b>MODEL:</b>	<b>R44 II</b>
<b>DATE:</b>	<b>19JUL2022</b>

This is the Final Report of the 19 July 2022 accident with the R44 II aircraft, registration marks PR-EGD. The accident received the typification of “[UNK]] Undetermined”.

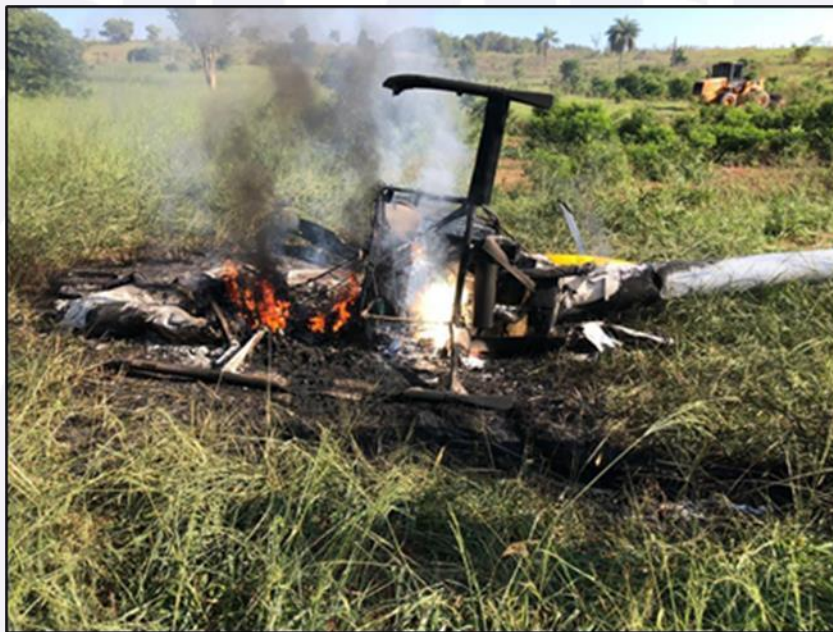
Figure 1 - View of the PR-EGD being consumed by fire shortly after the accident.

The fire probably started immediately after the impact. The combustion material was the fuel of the aircraft.

The degree of destruction and charring of the aircraft prevented the verification of components, equipment, instruments, and fuel of the helicopter.

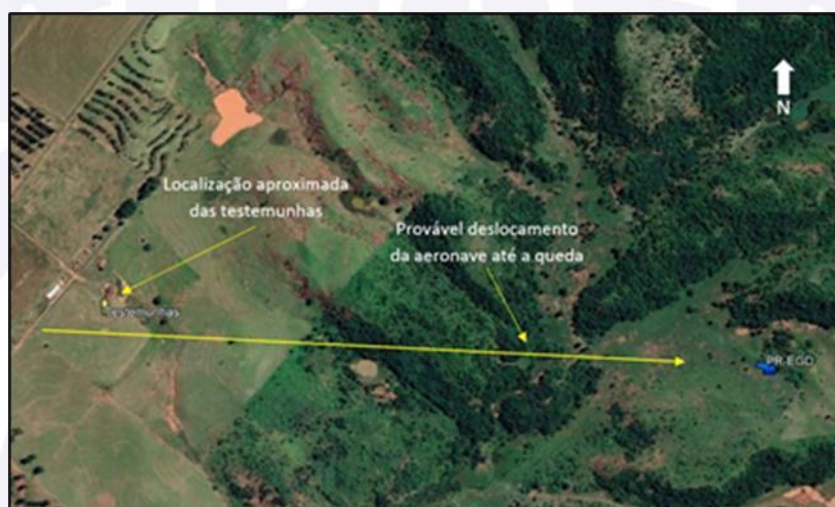
The Figure 2 shows the probable direction of movement of the PR-EGD toward the accident site.

Figure 2 - Probable direction of travel of the PR-EGD.
