COMANDO DA AERONÁUTICA
CENTRO DE INVESTIGAÇÃO E PREVENÇÃO DE
ACIDENTES AERONÁUTICOS

FINAL REPORT
A-084/CENIPA/2022

OCCURRENCE:	ACCIDENT
AIRCRAFT:	PR-EGD
MODEL:	R44 II
DATE:	19JUL2022

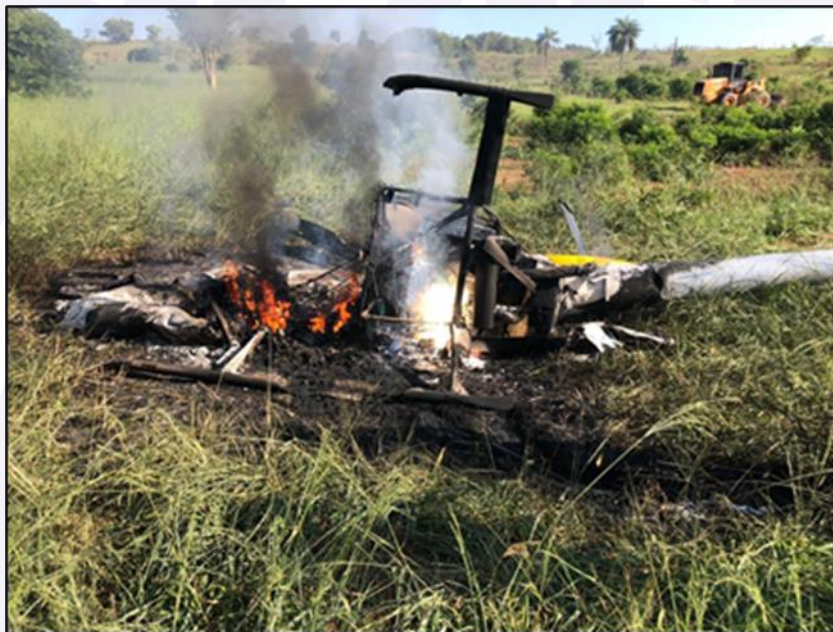
Figure 1 - View of the PR-EGD being consumed by fire shortly after the accident.

The fire probably started immediately after the impact. The combustion material was the fuel of the aircraft.

The degree of destruction and charring of the aircraft prevented the verification of components, equipment, instruments, and fuel of the helicopter.

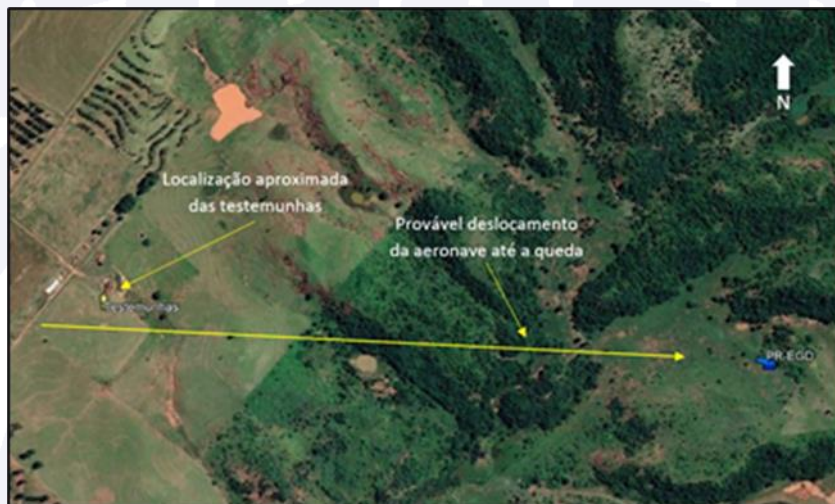
The Figure 2 shows the probable direction of movement of the PR-EGD toward the accident site.

Figure 2 - Probable direction of travel of the PR-EGD.
