FINAL REPORT
A - 140/CENIPA/2019

OCCURRENCE:	ACCIDENT
AIRCRAFT:	PR-ETJ
MODEL:	SR20
DATE:	21OCT2019

This is the Final Report of the 21OCT2019 accident with the SR20 aircraft model, registration PR-ETJ. The accident was classified as “[LOC-I] Loss of Control in Flight” and “[F-POST] Fire/Smoke (post-impact)”.

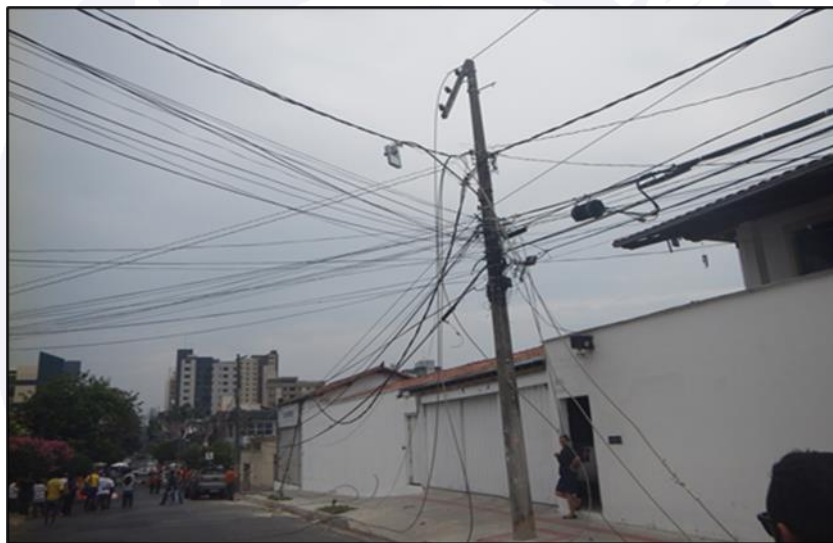
The first impact occurred in a pitched down attitude (approximately 10°) and with leveled wings, causing the right-wing tip to collide with an electrical power pole on the road (Figure 1).

Figure 1 - Point of the first impact of the aircraft.

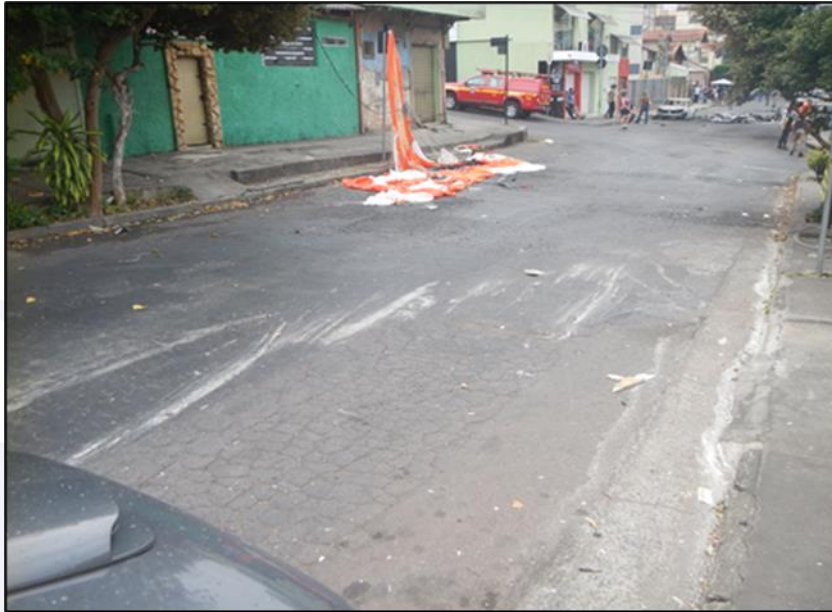
After the second impact, the aircraft collided with the asphalt of the same road, dragging for about 100 meters until it collided with the back of a vehicle that was circulating on the road (Figure 2).

Figure 2 - Marks on the asphalt from the aircraft collision.

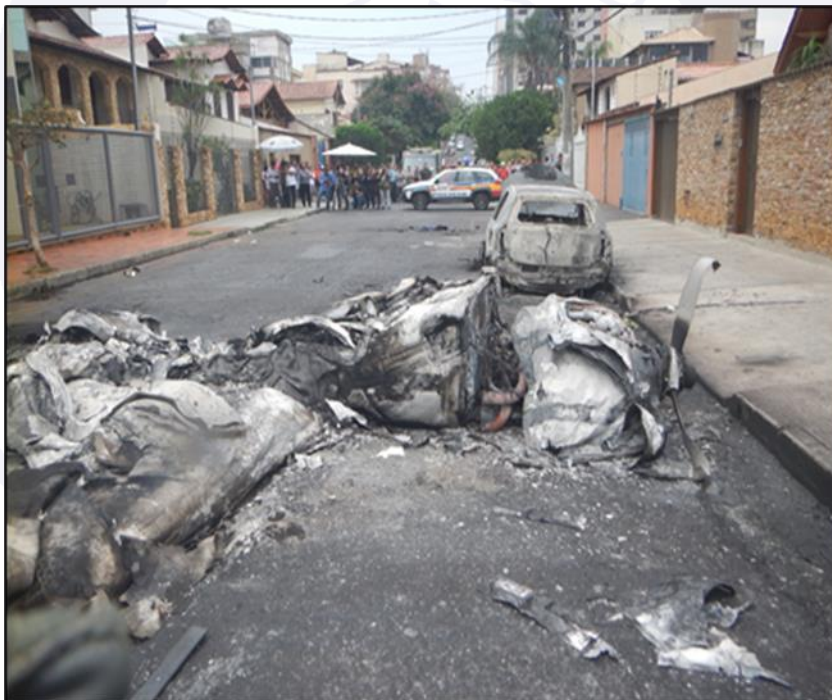
The degree of destruction and carbonization of the aircraft made it difficult to verify equipment and instruments (Figures 3 and 4).

Figure 3 - Aircraft wreckage after the fire was extinguished.

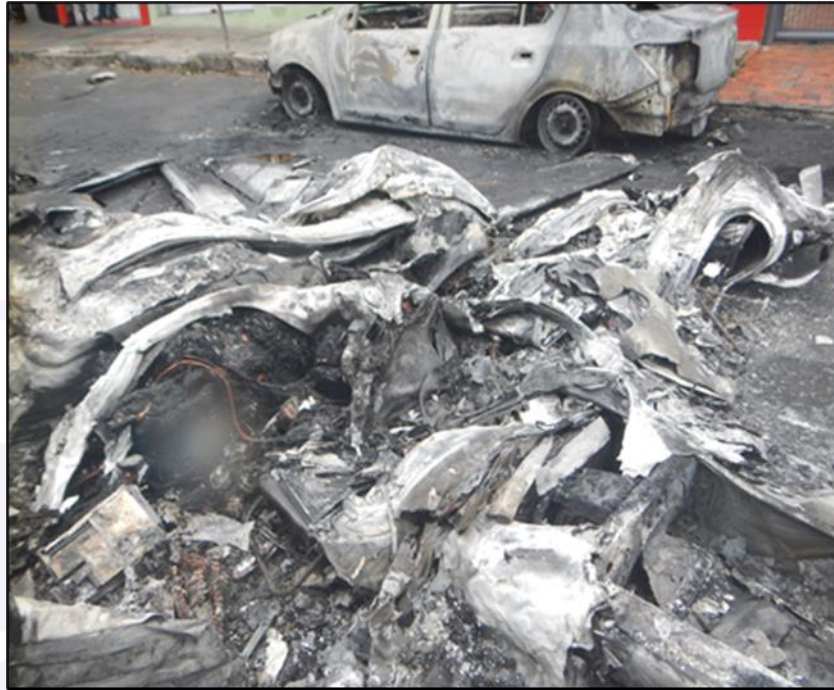
Figure 4 - Close-up view of the wreckage after the fire has been extinguished.

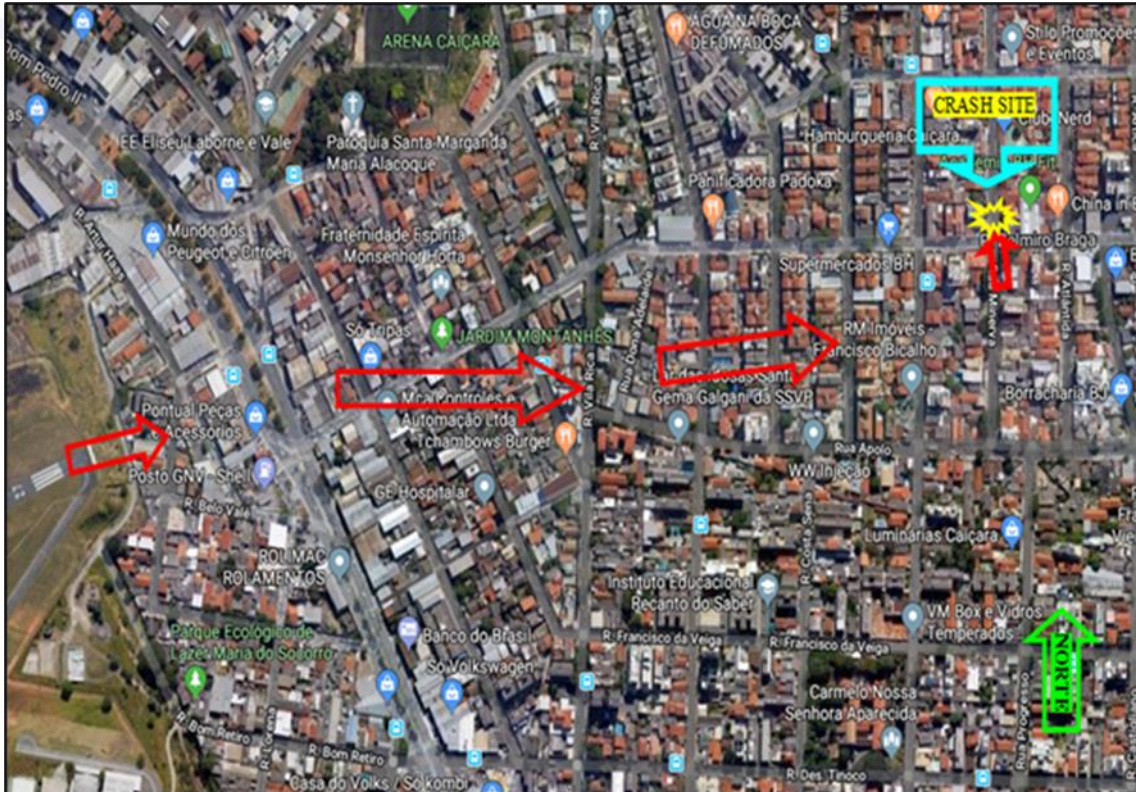
The trajectory of the aircraft can be seen in Figure 5, below:

Figure 5 - Sketch of the occurrence. Source: Google Earth.
