COMANDO DA AERONÁUTICA
CENTRO DE INVESTIGAÇÃO E PREVENÇÃO DE
ACIDENTES AERONÁUTICOS

FINAL REPORT
IG - 071/CENIPA/2020

OCCURRENCE:	SERIOUS INCIDENT
AIRCRAFT:	PR-FPM
MODEL:	EC-120B
DATE:	27MAY2020

This is the Final Report of the 27MAY2020 serious incident with the EC-120B aircraft model, registration PR-FPM. The serious incident was classified as “[LOC-I] Loss of Control in Flight”.

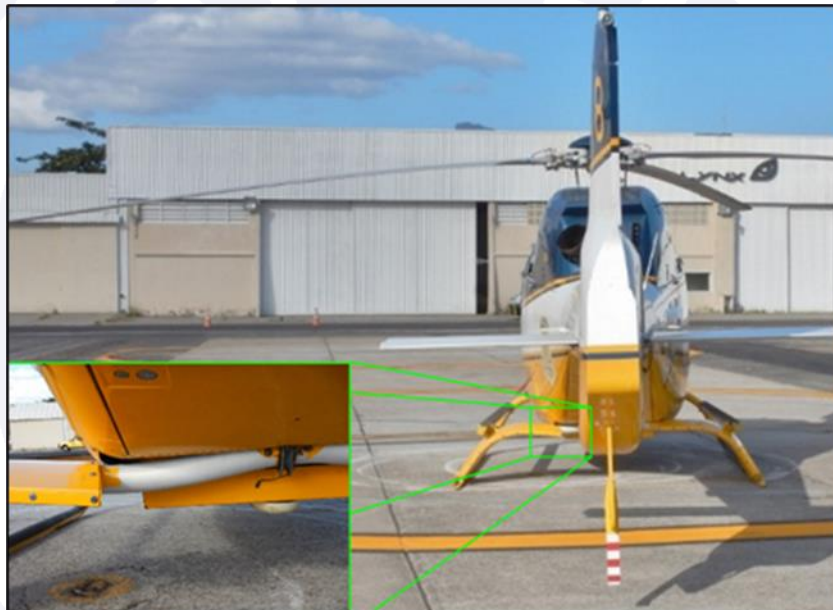
The aircraft had minor damage restricted to the skis.

Figure 1 - View of damage to the rear left side of the ski.

The damage was restricted to the ski due to the sharp touch against the ground. The aircraft returned to operation after completing inspections related to the hard landing.

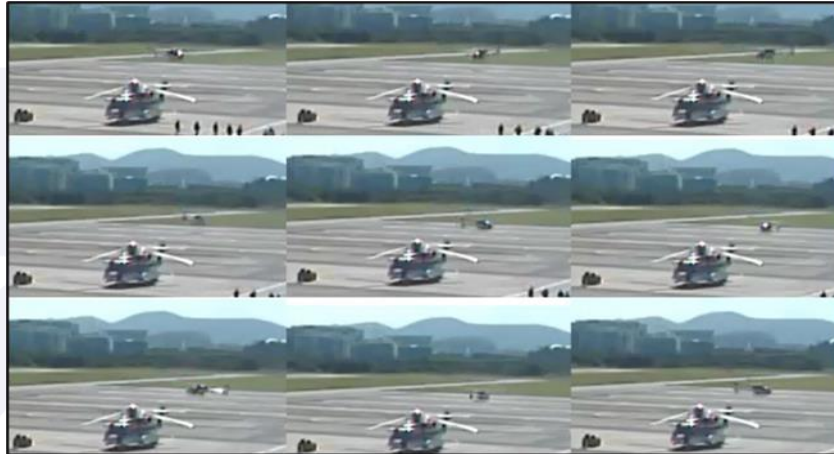
At that moment, the aircraft started an uncontrolled turn to the right, followed by a sharp touch against the ground, completing another turn by dragging the skis on the floor of the apron (Figure 2).

Figure 2 - Record of the PR-FPM trajectory during loss of control.
Source: SBJR apron monitoring cameras.

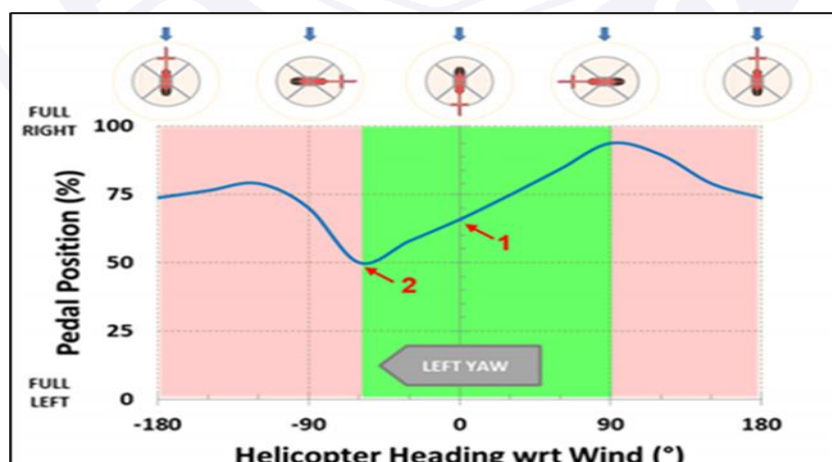
For the description of the phenomenon, a graph from the Safety Information Notice n° 3297-S-00 was used, which addresses the pedal position turn, as a function of the relative wind incidence direction of the helicopter, in a stabilized hovering condition. For each combination of weight, altitude, temperature, and wind speed, there is a corresponding turn (Figure 3).

Figure 3 - Stabilized Pedal Position as a Function of Relative Wind.

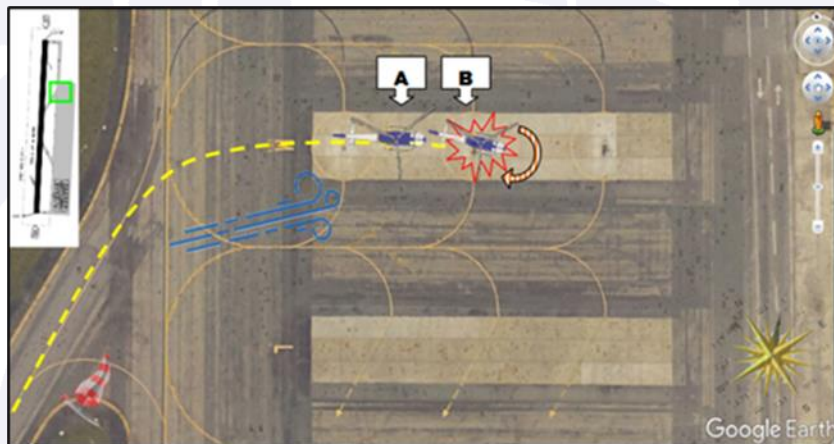
The blue symbol in Figure 4 indicates the direction of the 287° wind gust according to the INMET.

Figure 4 - PR-FPM trajectory, with the arrow indicating the aircraft's direction of rotation.

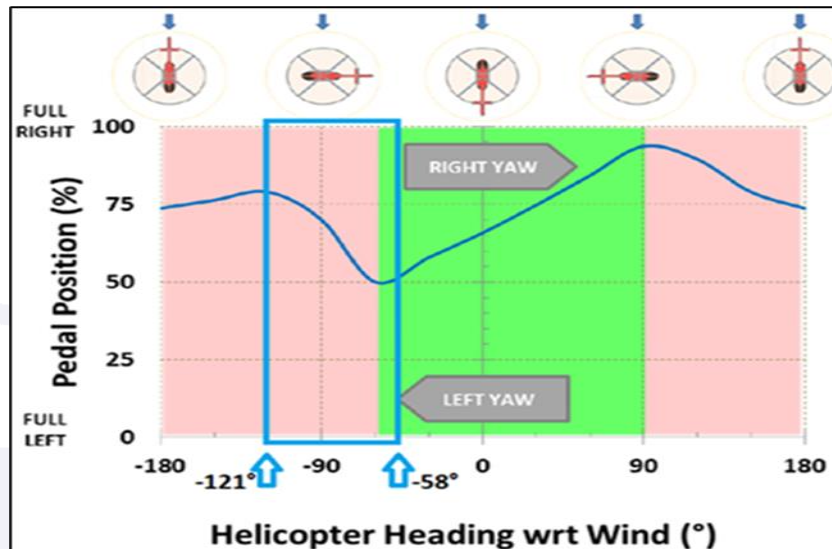
Taking into account that the aircraft's heading, on the occasion of the unexpected turn, was turned in the direction of 120°, the relative wind incident on the PR-FPM varied between -58° and -121° at these three moments (blue rectangle in Figure 5).

Figure 5 - Example of the pedal turn in hovering. Source: Safety Information Notice No. 3297-S-00.

The critical azimuth is considered the one in which there is the smallest margin for the application of the pedal, which corresponds, in the case of the graph in Figure 5, to the condition of $+90^\circ$, that is, crosswind coming from the left side in relation to the helicopter. In this condition, the helicopter tends to head the wind and, to counteract it, it is necessary to use the right pedal, which, in this situation, is at approximately 90% of its course.

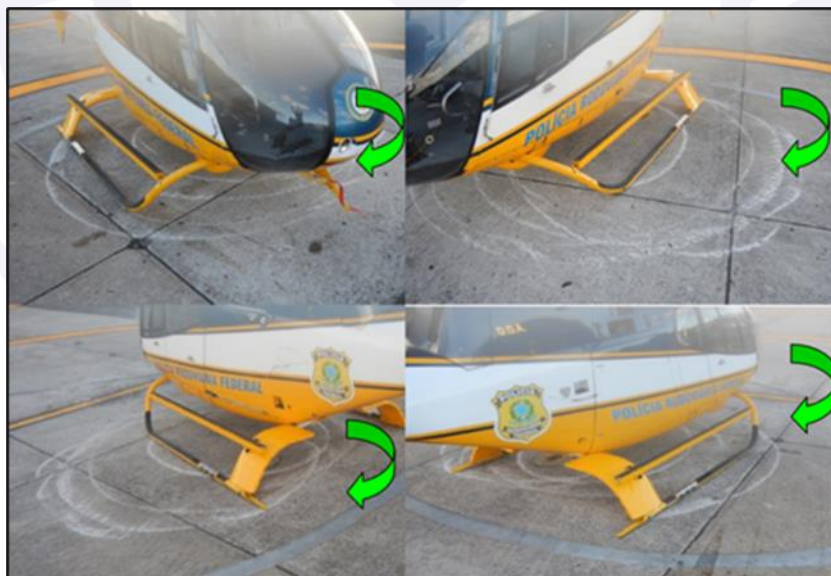
The PIC, who was sitting on the left chair, took over the controls of the aircraft and made the landing while still in a turning condition, dragging the skis on the ground for another 365° (Figure 6).

Figure 6- Details of the markings on the ground after the ground turn (the green arrow indicates the direction of rotation of the aircraft).
