FINAL REPORT
A - 064/CENIPA/2021

OCCURRENCE:	ACCIDENT
AIRCRAFT:	PR-FPR
MODEL:	210N
DATE:	06MAY2021

This is the Final Report of the 06MAY2021 accident with the 210N aircraft model, registration PR-FPR. The accident was classified as “[LALT] Low Altitude Operations”.

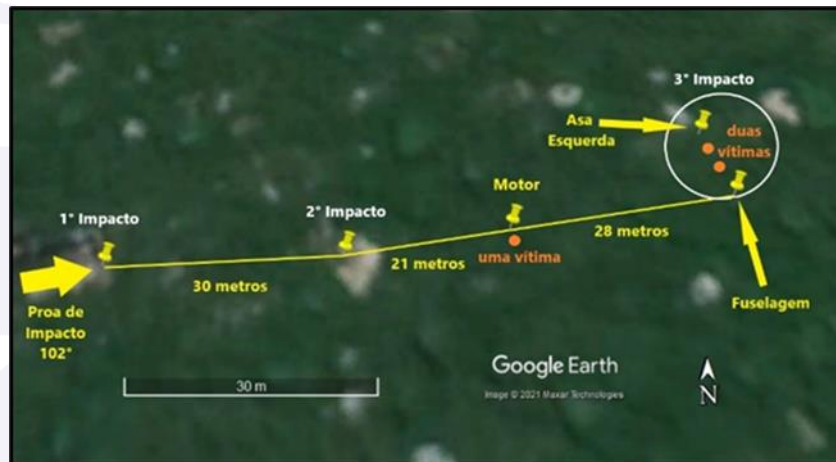
The first impact occurred approximately 650 meters from threshold 30, in a pitch up attitude (approximately 10°) and with leveled wings. There was no evidence of previous impact.

There was a trail of approximately 30 meters, where small paint chips and fragments of the aircraft's fuselage were found, indicating that it dragged on vegetation/ground.

The second impact occurred with a lot of energy against a pile of sand. At that moment, the plane broke apart, and the engine was thrown forward.

The fuselage was concentrated at the site of the third and final impact.

Figure 1 - Sketch of the occurrence. Source: Adapted from Google Earth.

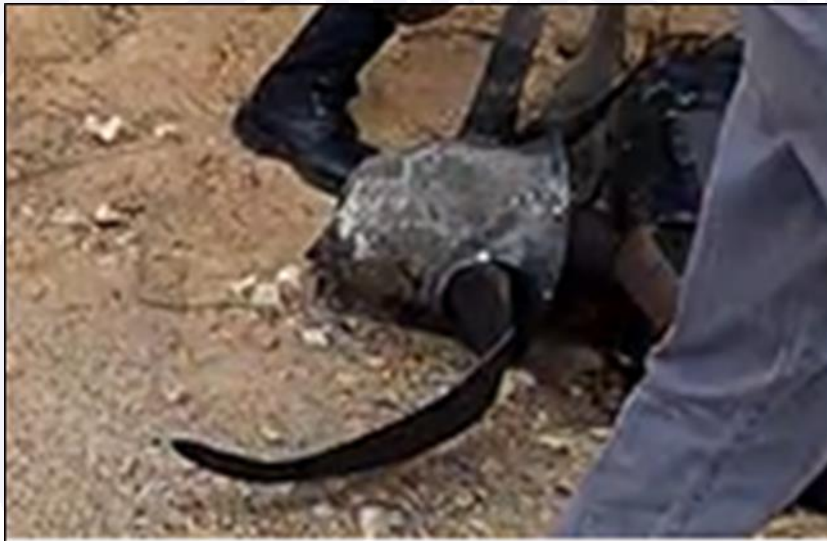
During the field investigation, it was observed that at least one propeller blade presented forward deformations, compatible with an impact in which the engine developed power at the moment of collision with the ground (Figure 2).

Figure 2 - Image of the PR-FPR propeller assembly.

The deformations observed in the wreckage indicated the occurrence of impacts with high energy.

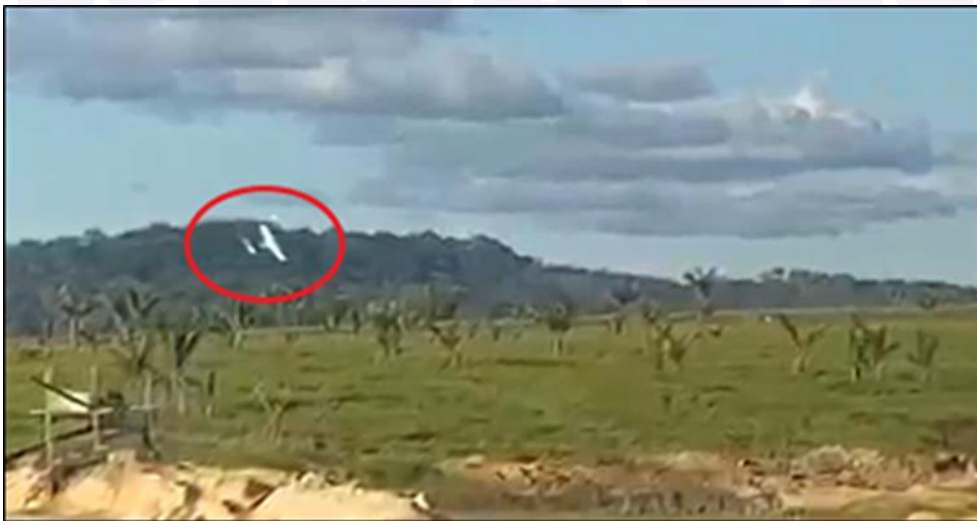
Through the footage of the accident made by observers, it was possible to notice that the aircraft was performing a flight at low altitude, with turns to the right, in the moments before the collision with the ground.

Figure 3 - Image of the flight extracted from the video provided by observers.

Then, after leveling the wings, the plane “sank” and disappeared behind the relief.

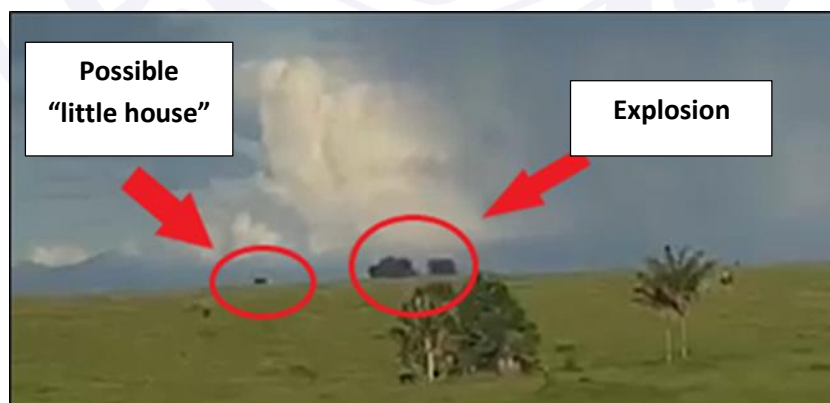
The audio of this footage describes the expected trajectory of the low pass, mentioning identifiable references in the footage when the aircraft disappears from the video behind the terrain, such as “it will lift up ahead, near that little house” indicating that the observer was used to seeing this type of flight (Figure 4).

Figure 4 - Image of the flight extracted from the video provided by observers, showing the mentioned reference and the explosion after the plane hit the ground.

According to the reports collected, flying at low altitudes in the mining area was a common practice.
