FINAL REPORT
IG - 055/CENIPA/2016

OCCURRENCE:	SERIOUS INCIDENT
AIRCRAFT:	PR-GOV
MODEL:	737-76N
DATE:	28MAR2016

This is the Final Report of the 28MAR2016 serious incident with the 737-76N aircraft model, registration PR-GOV. The accident was classified as “[SCF-NP] System/Component Failure or Malfunction Non-Powerplant – Unintentional/Explosive Decompression”.

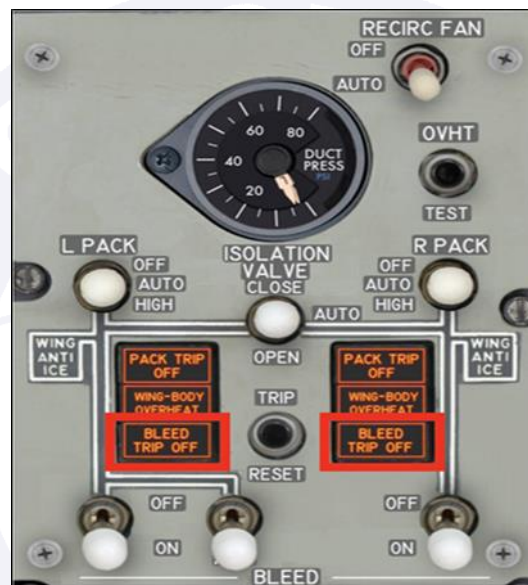
There were no abnormalities during the takeoff, climb and leveling phases. During the cruise flight, with the aircraft leveled on the FL380, the BLEED TRIP OFF lights in the pressurization panel were switched on, first from the left Bleed Valve and then from the right Bleed Valve (Figures 6 and 7).

Figure 7 - Pressurization panel, with emphasis on the BLEED TRIP OFF lights.
Source: FCOM.

According to the FCOM, the amber BLEED TRIP OFF light came on when there was excessive temperature or pressure in the bleed air from the engines. When this happened, the respective valve closed automatically.

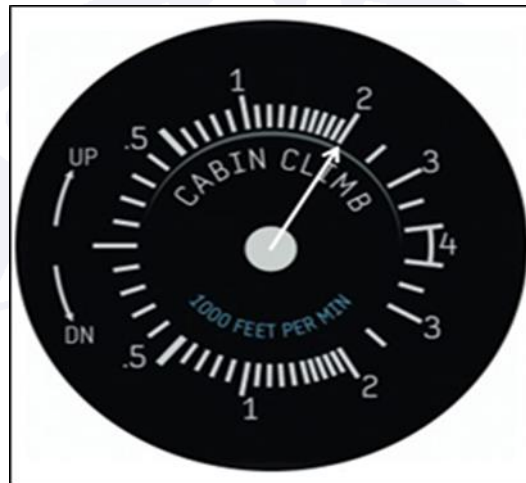
After the BLEED TRIP OFF lights were turned on, the pilots observed that the cabin's climb/descent ratio indicator had a positive ratio in the order of 2,000ft/min (Figures 8 and 9).

Figure 9 - Representation of a cabin climb marking 2,000ft/min positive.
Source: Adapted from FCOM.

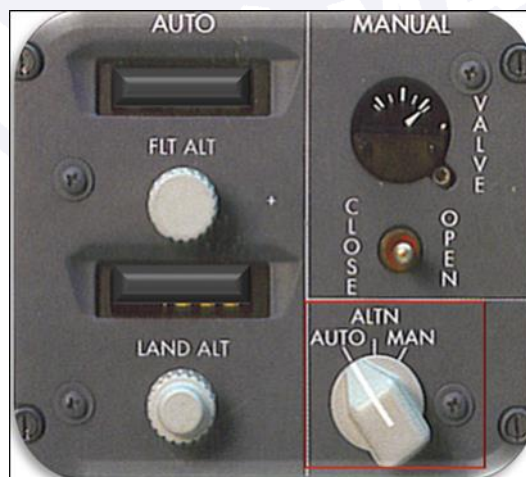
Given the situation, the pilots tried to control the cabin altitude by switching the pressurization system from automatic control mode (AUTO) to alternate mode (ALTN) and manual mode (MAN). However, they were not successful (Figure 10).

Figure 10 - Pressurization control modes.
