COMANDO DA AERONÁUTICA
CENTRO DE INVESTIGAÇÃO E PREVENÇÃO DE
ACIDENTES AERONÁUTICOS

FINAL REPORT
IG - 146/CENIPA/2017

OCCURRENCE:	SERIOUS INCIDENT
AIRCRAFT:	PR-GXW
MODEL:	737-8EH
DATE:	18NOV2017

This is the Final Report of the 18NOV2017 serious incident with the 737-8EH aircraft, registration PR-GXW. The serious incident was classified as “[RE] Runway Excursion / Overshoot”.

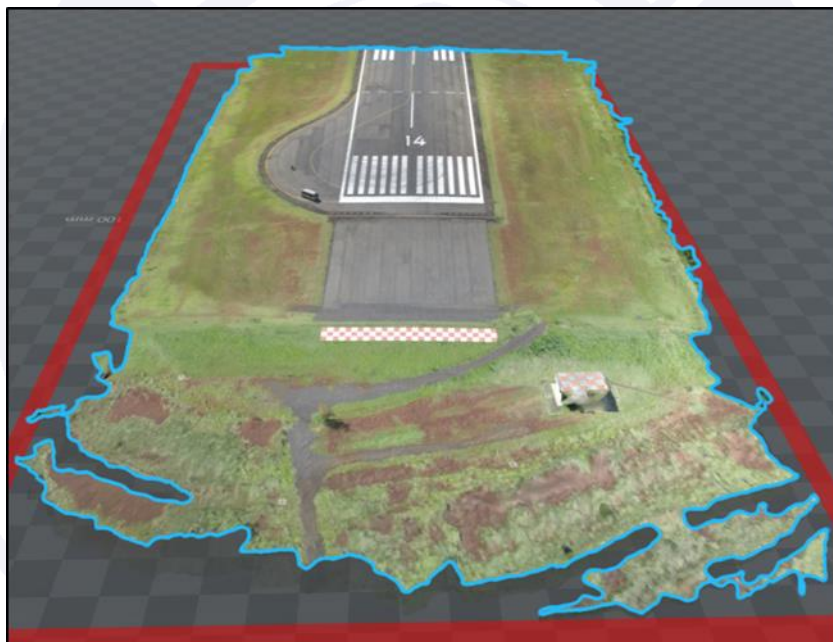
Figure 1 - 3D mapping of the stopway located after threshold 14.

The aircraft overpassed the limits of runway 32, crossing the opposite threshold (14) and stopping at the stopway (50m x 45m).

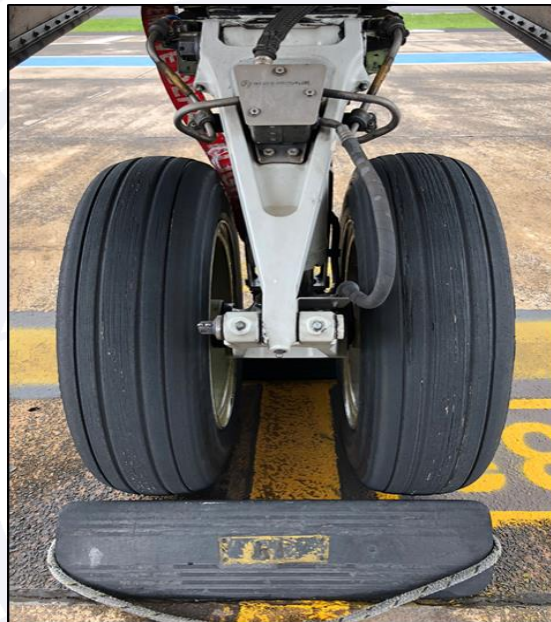
Figure 2 – Tires of the aircraft's nose landing gear.

All tires on the aircraft were inspected. They had a good state of preservation, with deep grooves, with no accentuated wear on the rubber and no apparent plies. No marks were found on the tires that indicated the occurrence of hydroplaning.

The aircraft's tires were in good condition, with deep grooves, no sharp wear, no apparent plies and no hydroplaning marks. The wear check parameters of the main landing gear brake assemblies indicated that the aircraft brakes had normal operating conditions.

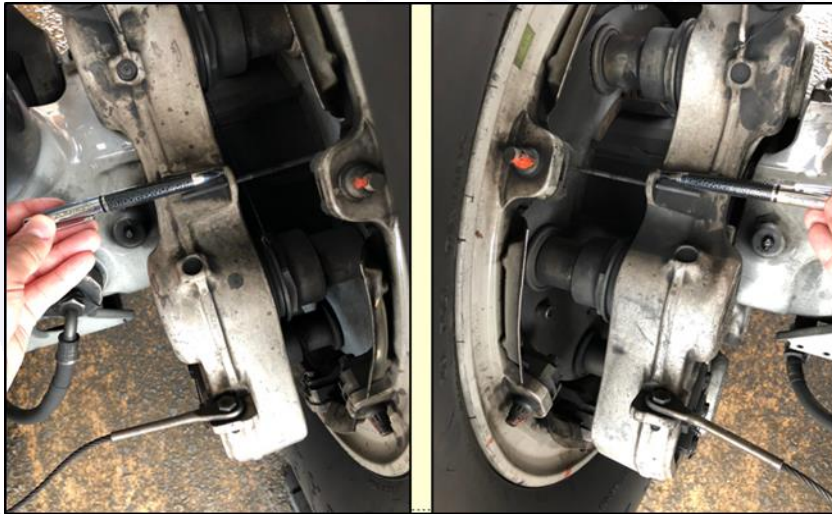
Figure 5 - Brake assembly of the right main landing gear (internal and external).

The brake sets of the two main aircraft landing gears were checked. The wear check parameters of both brake sets were far from the maintenance limit.
