COMANDO DA AERONÁUTICA
CENTRO DE INVESTIGAÇÃO E PREVENÇÃO DE
ACIDENTES AERONÁUTICOS

FINAL REPORT
A-151/CENIPA/2016

OCCURRENCE:	ACIDENTE
AIRCRAFT:	PR-IDR
MODEL:	AS 350 B3
DATE:	19NOV2016

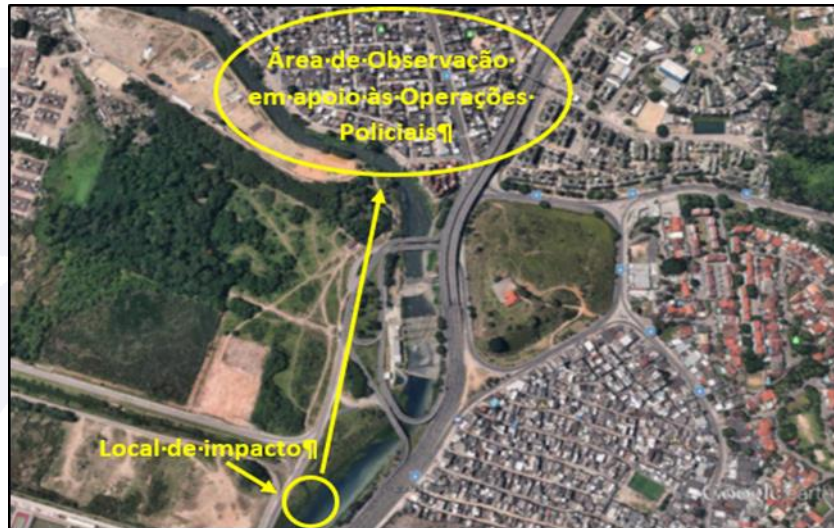
The aircraft crashed on soft terrain on the banks of a river, near the land area where police actions were being executed. The angle of impact and vertical speed were high.

Figure 1 – Crash-site on the banks of a river, close to the area of police operations.

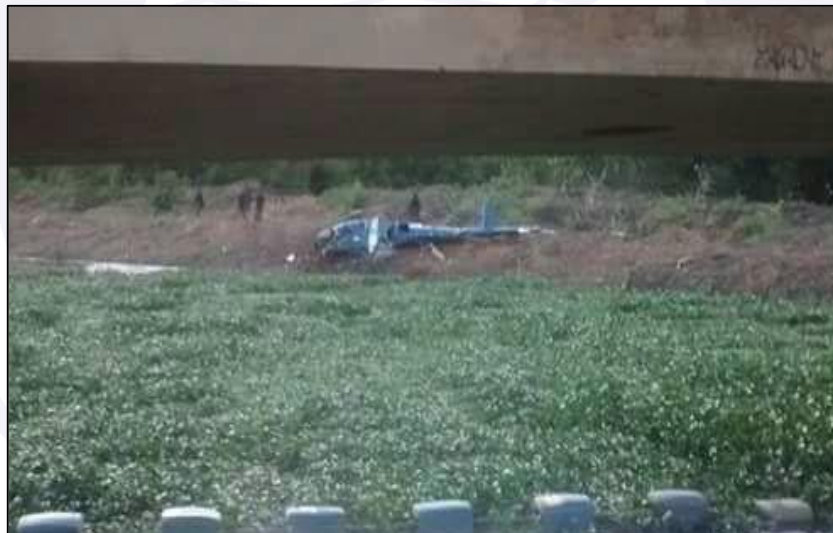
Figure 2 – View of the aircraft after the crash on the river bank.

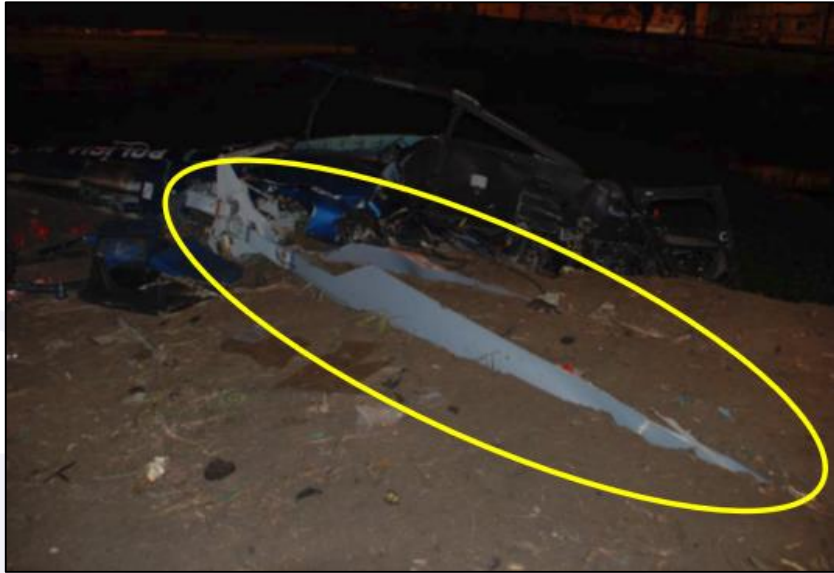
Figure 3 – Wreckage seen from above, highlighting two of the main rotor blades partially buried in the terrain.

The main rotor blades sustained significant damage, with delamination on the spar and deformations on both the leading and trailing edges of the blades, typical characteristics of impact while the main rotor was rotating.

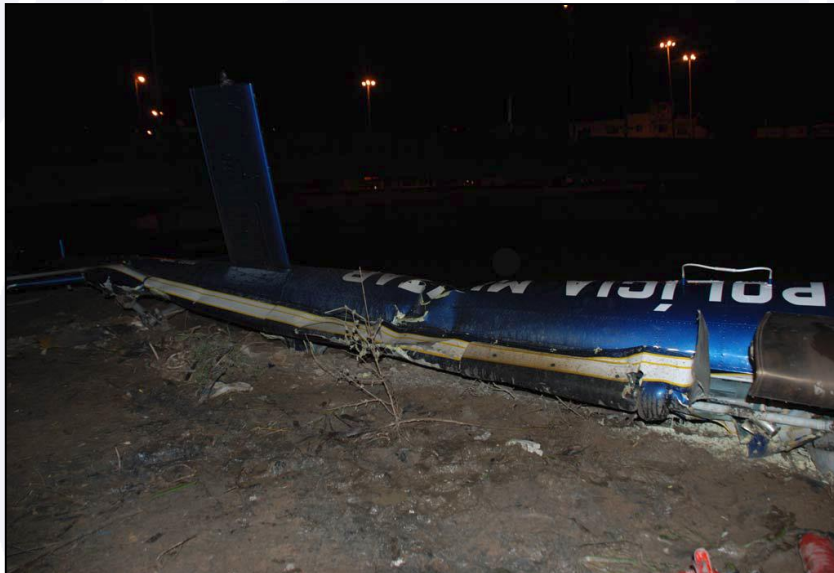
Figure 4 – View of part of the aircraft tail boom.

The tail boom was still aligned with the structure, although disconnected in consequence of the complete shearing of the coupling.

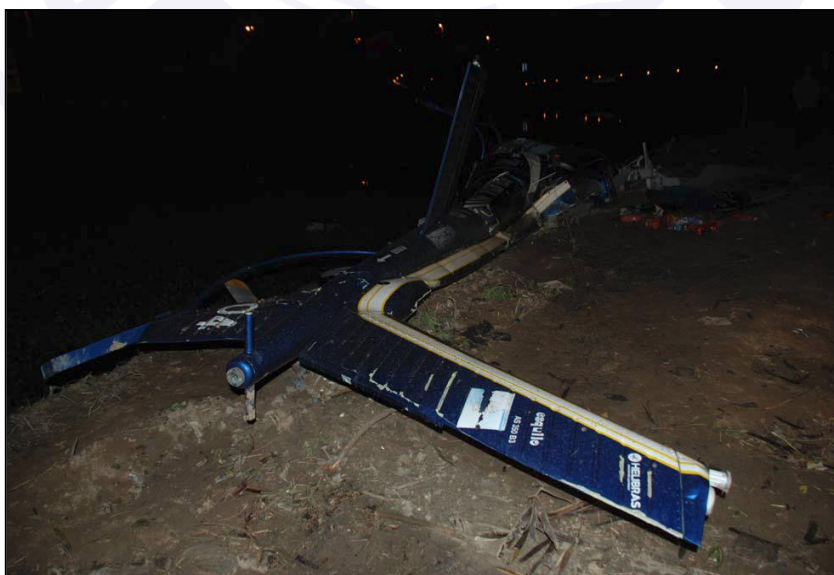
Figure 5 – Rear view of the aircraft.

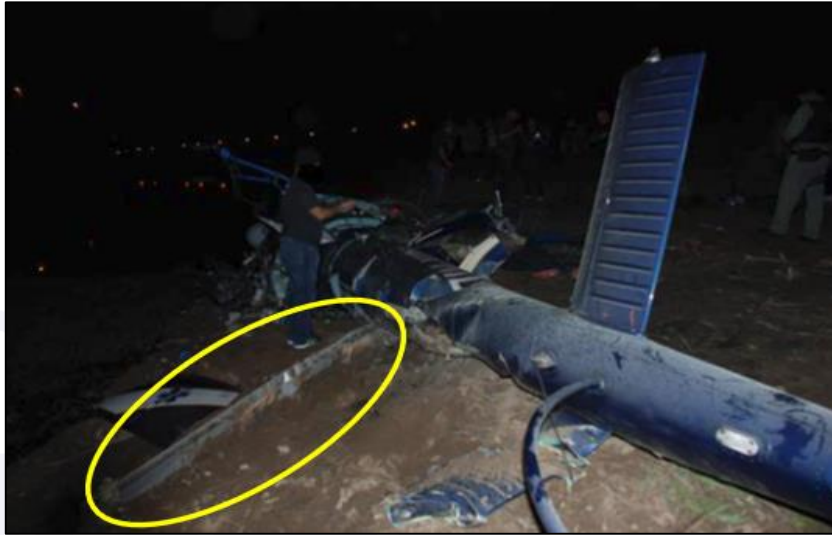
Figure 6 – Rear of the aircraft (left side) with the third blade of the main rotor in highlight.

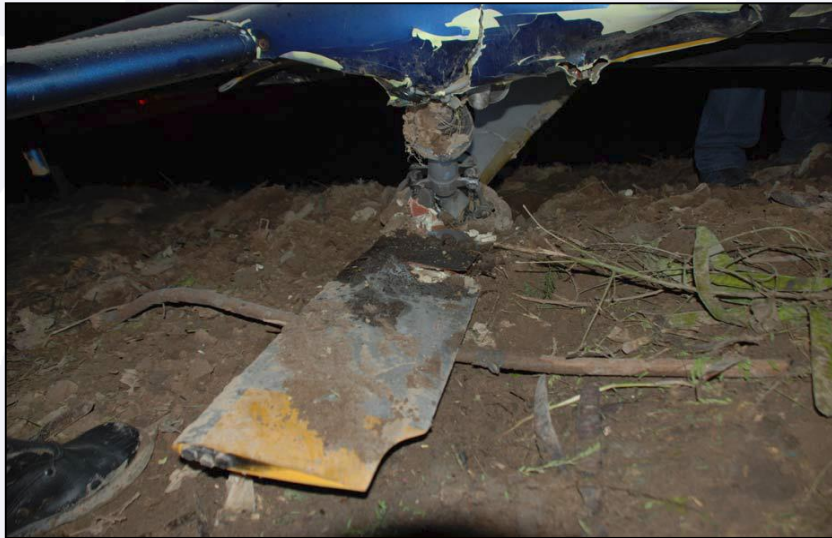
Figure 7 – Tail-rotor of the aircraft.

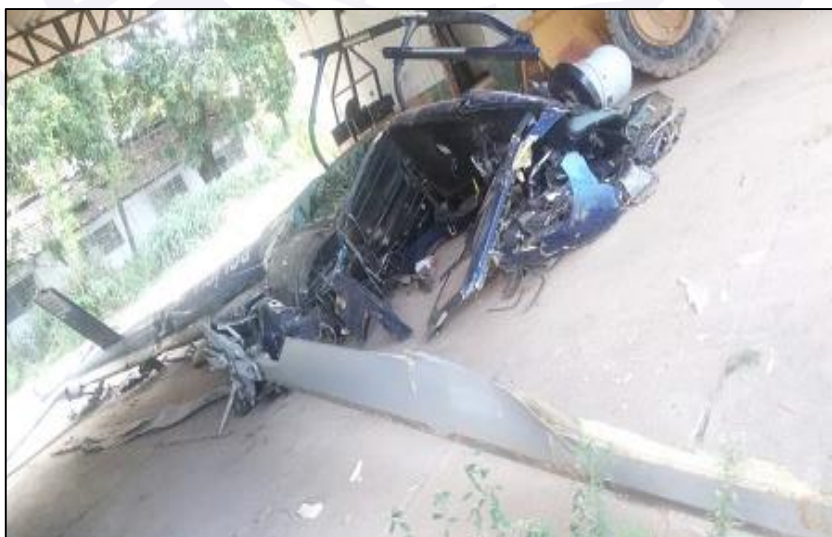
The right-hand side of the fuselage, including the cabin, the underside structure and the tail boom, had significant damage, with flattening caused by the impact forces (Fig. 8).

Figure 8 – Greater damage to the right side of the aircraft with characteristics of flattening.

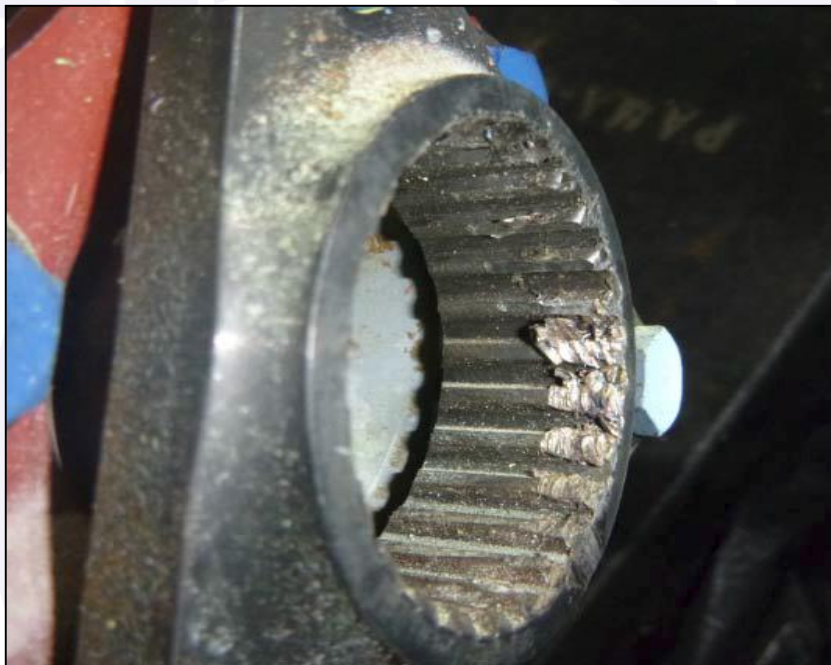
Damage with rotational characteristics was identified in the coupling assembly between the engine and the MGB. The damage was compatible with a shaft that was rotating at the moment of impact (Figures 9 and 10).

Figure 9 - Evidence of rotational damage on the inner splines of the engine shaft flange.

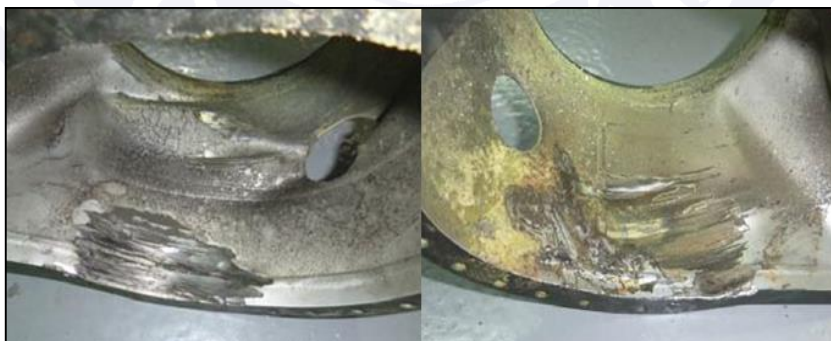
Figure 10 - Evidence of rotational damage between the engine connection tube and the engine output shaft (freewheel assembly).

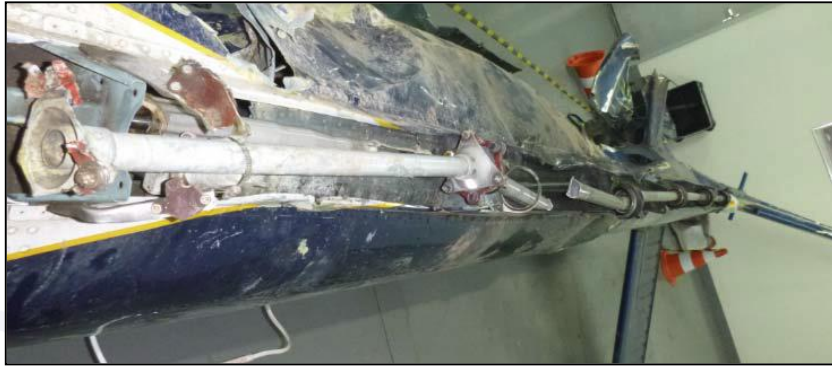
The Tail Rotor Drive Shaft assembly showed significant damage and overload-related deformations (Figures 11 and 12).

Figure 11 - General view of the tail rotor drive shaft assembly.

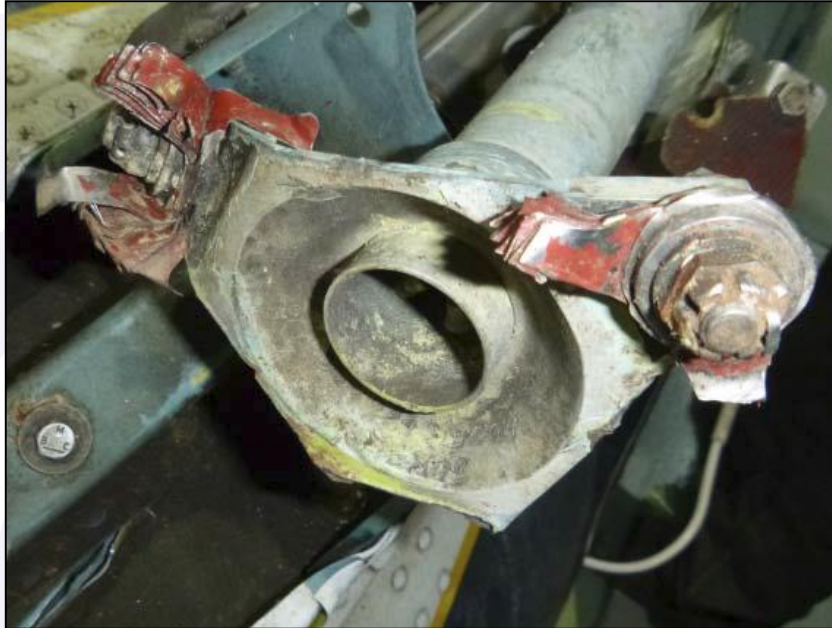
Figure 12 – Evidence of overload-induced damage to the remaining parts of the flexible coupling of the tail-rotor drive shaft.

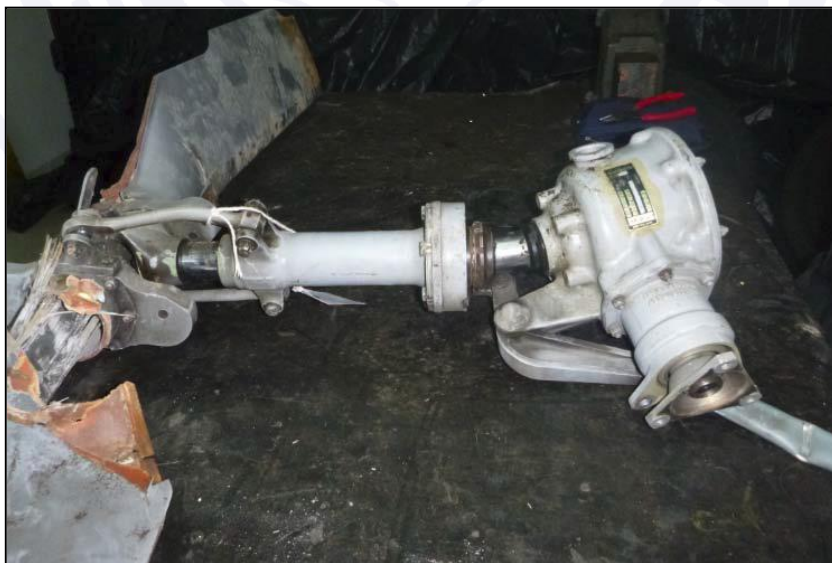
The Tail Rotor Gear Box and the Tail Rotor Head showed damage consistent with deformation caused by the impact of the aircraft with the ground (Figures 13 and 14).

Figure 13 – Tail rotor gear box: damage compatible with impact of the aircraft with the ground.

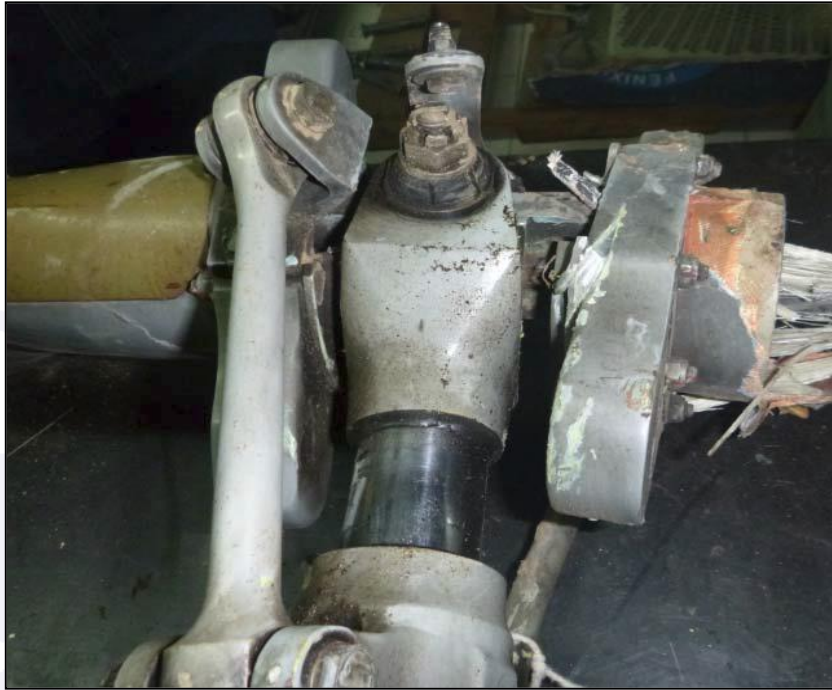
Figure 14 – Tail rotor head: damage compatible with aircraft impact with the ground.

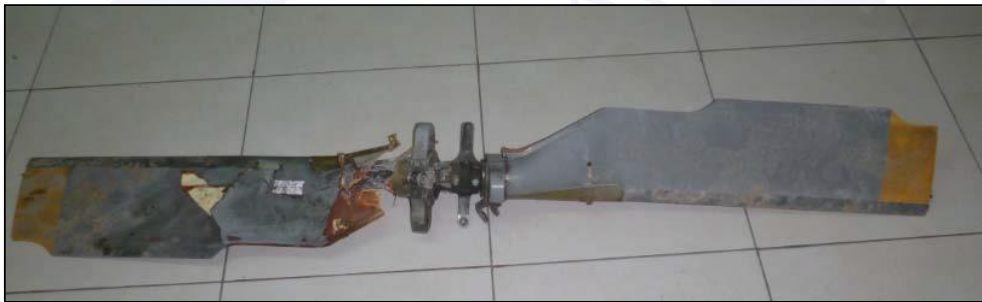
The Tail Rotor blades showed damage compatible with the impact (Figure 15).

Figure 15 – Tail rotor blades: damage compatible with impact of the aircraft with the ground.

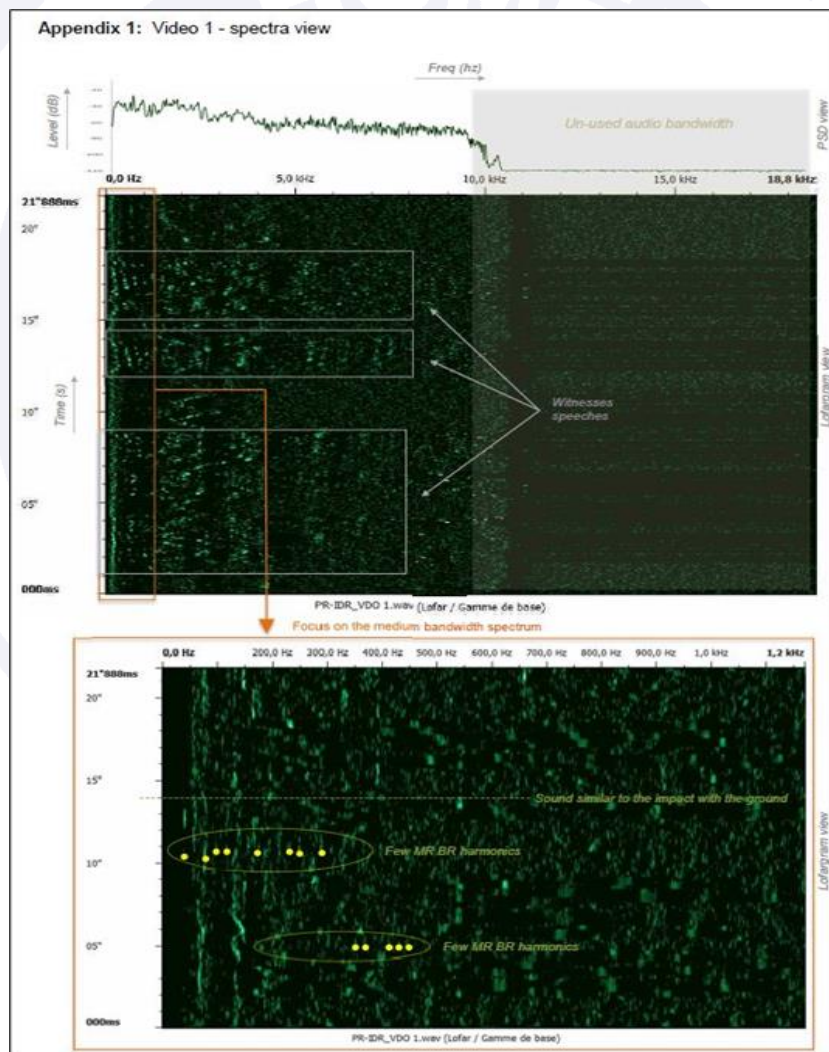
Figure 16 – Spectral analysis of the audio of the number 1 video related to the accident. Source: BEA.

In the videos, it was possible to notice that, during the last thirteen seconds of the flight, the helicopter was rapidly descending in a state of continuous left rotation.

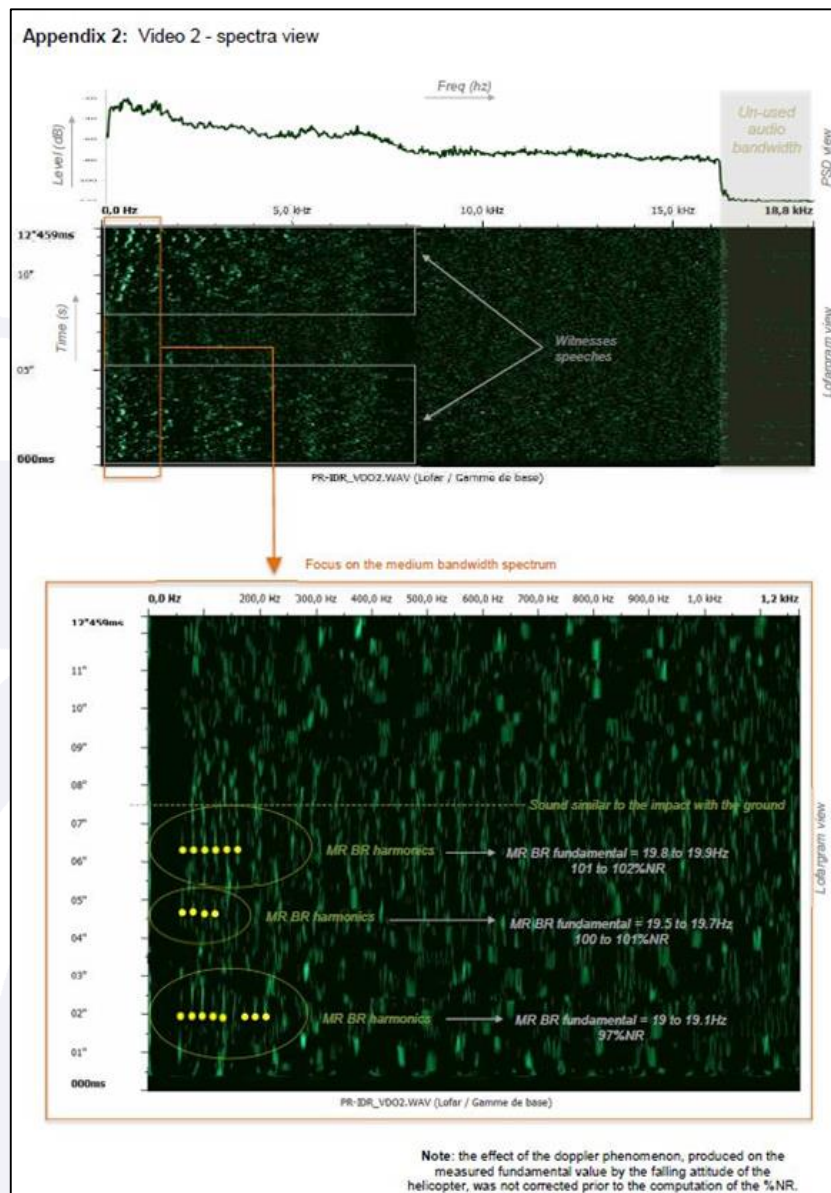
Figure 17 – Spectral analysis of the audio of the number 2 video related to the accident.
Source: BEA.
