COMANDO DA AERONÁUTICA
CENTRO DE INVESTIGAÇÃO E PREVENÇÃO DE
ACIDENTES AERONÁUTICOS

FINAL REPORT
A-008/CENIPA/2022

OCCURRENCE:	ACCIDENT
AIRCRAFT:	PR-JGV
MODEL:	Baron 58
DATE:	19JAN2022

This Final Report pertains to the 19 January 2022 accident involving the Beechcraft Baron 58 aircraft, registration marks PR-JGV. The occurrence was typified as “[SCF-PP] Engine failure or malfunction”.

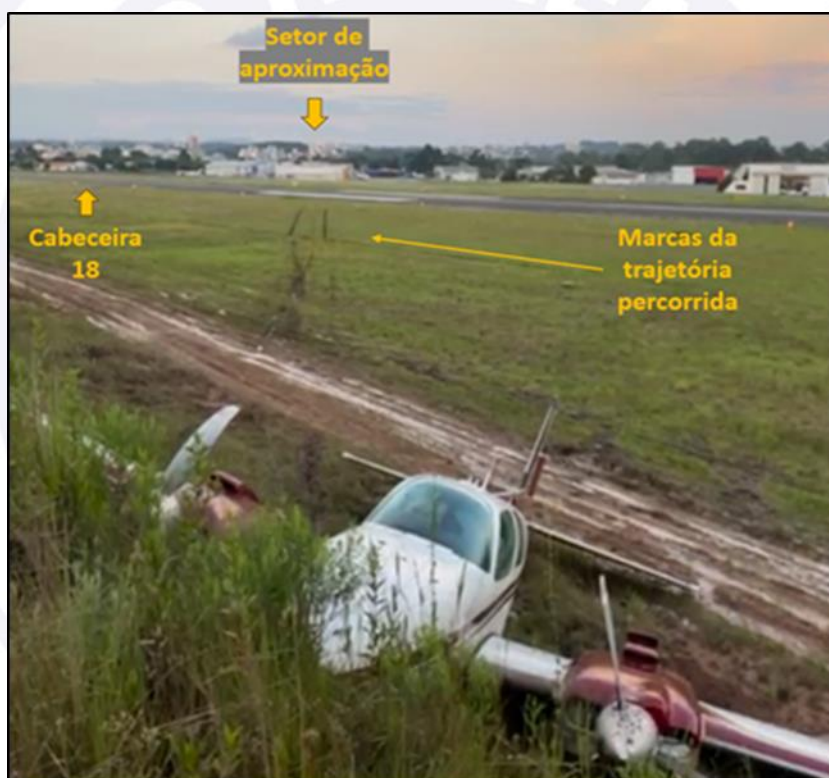
Figure 1 - Final position of the aircraft and displacement marks on the grassy area.

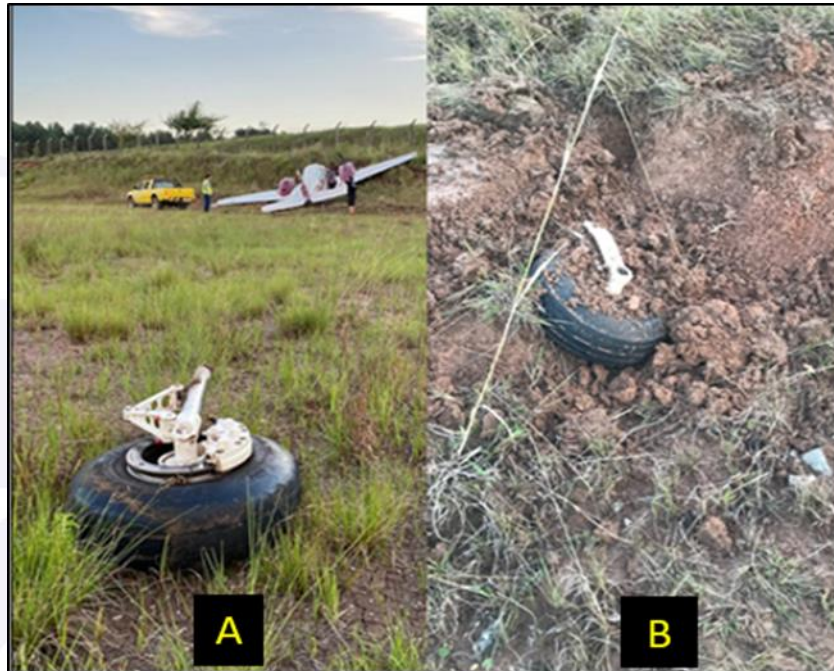
The off-runway landing on a grassy area caused substantial damage to the landing gear, with the left main gear and the nose gear detaching from the aircraft (Figure 2).

Figure 2 - Left main landing gear (A) and nose landing gear (B).

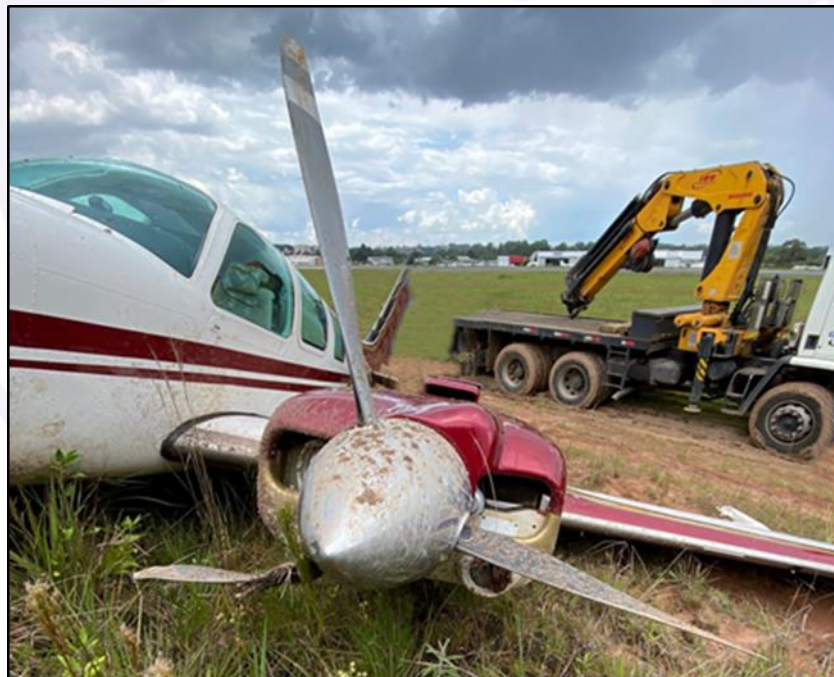
The blades of the left engine propeller were found in the feathered position, with only one blade showing longitudinal damage (Figure 3).

Figure 3 - Left engine's propeller blades in the feathered position showing longitudinal damage to one of the blades.

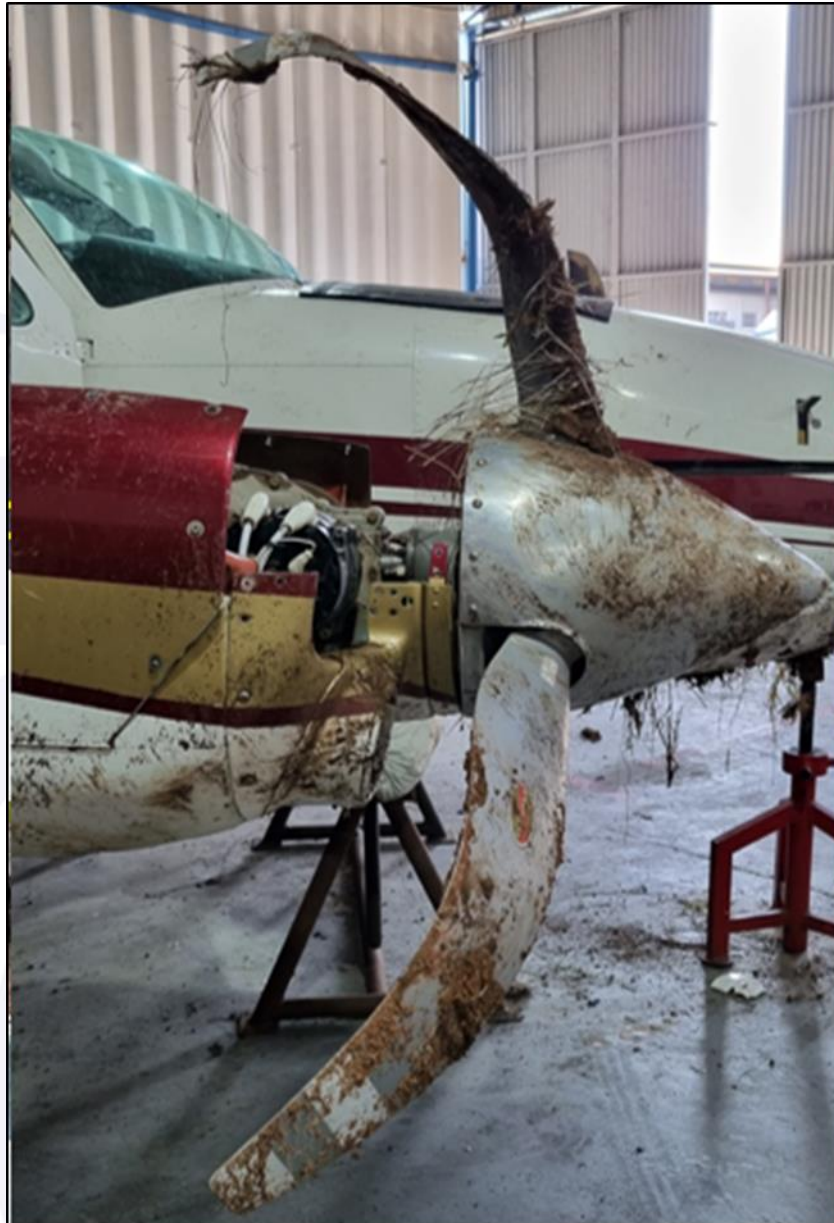
The blades of the right engine propeller were found in a position other than feathered, and all of them exhibited longitudinal damage, bending backward (Figure 4).

Figure 4 - Right engine propeller blades not feathered, exhibiting longitudinal damage.

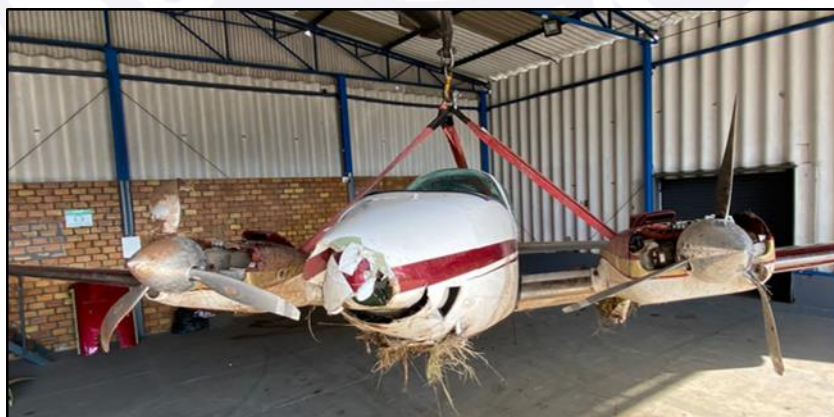
The cowling of both engines and the forward section of the fuselage remained relatively preserved, with significant denting concentrated in the front part (Figure 5).

Figure 5 - View of the damage sustained by the propeller blades and fuselage.

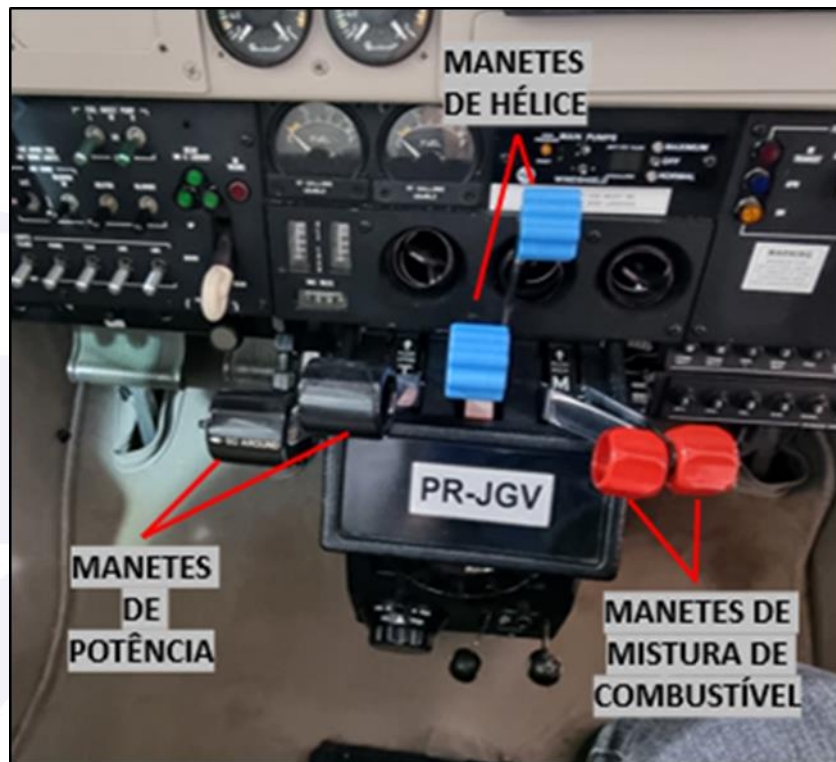
Figure 6 - Image of the throttle, propeller, and fuel lever positions after the accident.

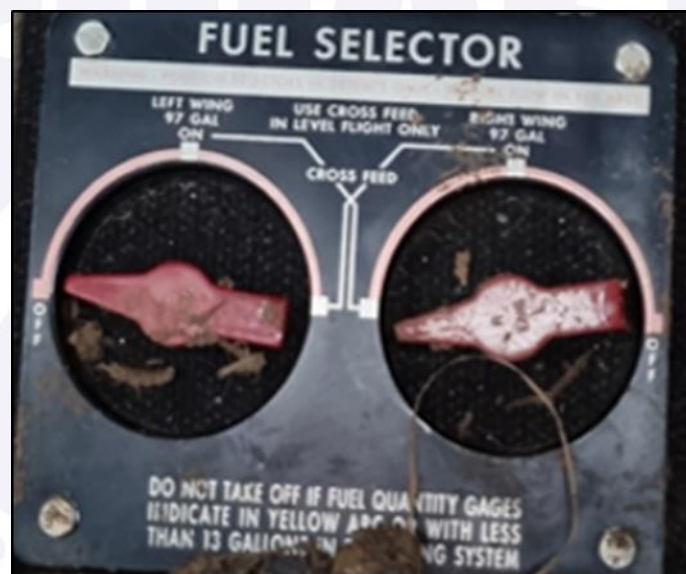
The left fuel selector was in the OFF position, while the right fuel selector was in the CROSS FEED position. These positions were consistent with the cross-feed configuration, as shown in Figure 13.

Figure 13 - Position of the left fuel selector in OFF and the right fuel selector in CROSS FEED.

Additionally, the fuel selector on the left side was found in the OFF position, while the right selector was in the CROSS FEED position, indicating cross-feed fuel supply to the left engine.

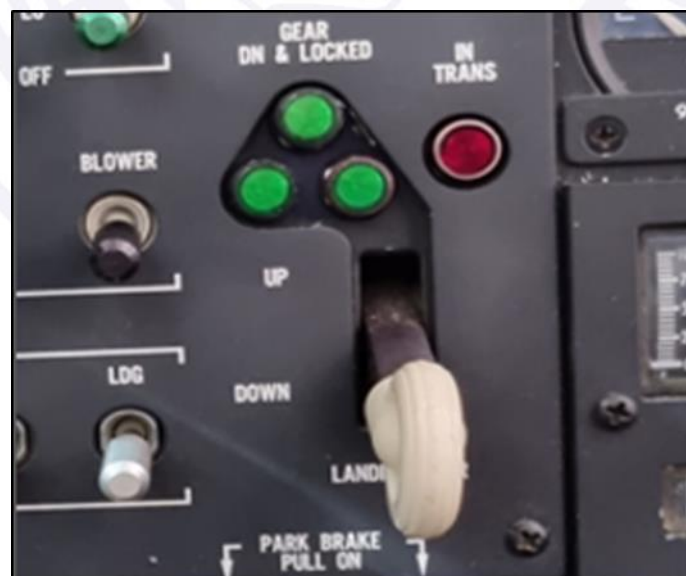
The landing gear control lever was in the DOWN position, consistent with the landing gear being extended and locked (Figure 14).

Figure 14 - Landing gear lever in the DOWN position.

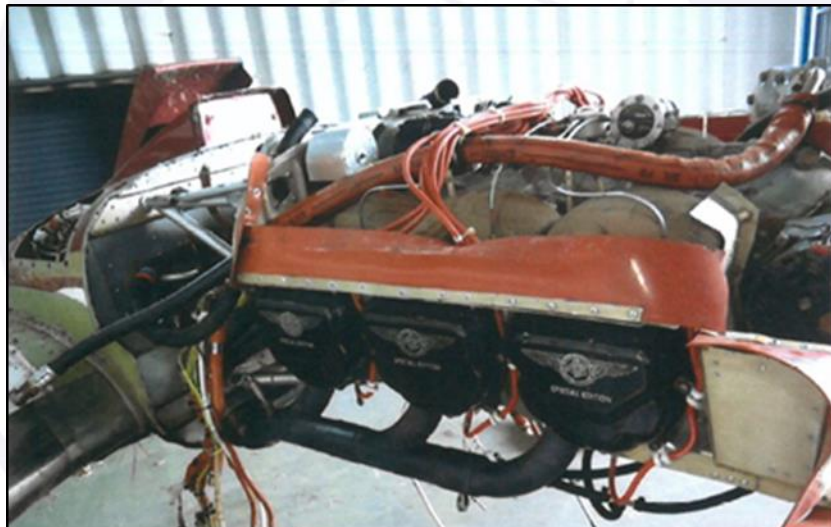
Externally, the engine displayed an intact appearance in its components and accessories, with no apparent damage resulting from the emergency landing (Figure 15).

Figure 15 - Left engine showing external integrity.

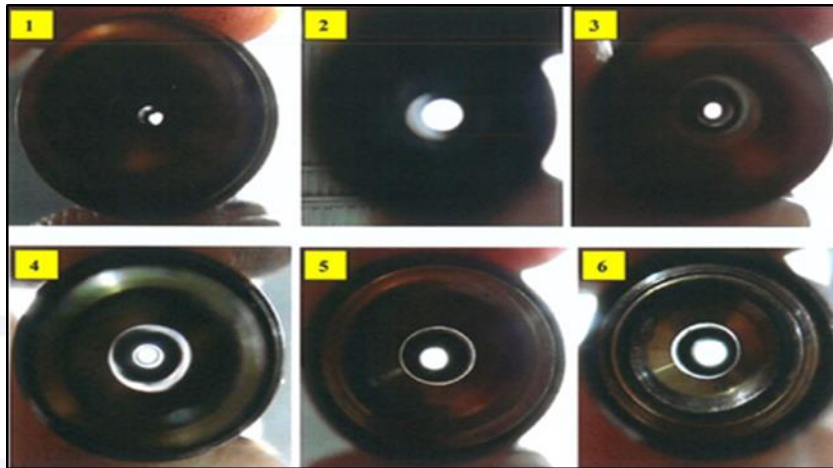
Examinations of the left engine's fuel injectors indicated that they were unobstructed (Figure 16).

Figure 16 – Unobstructed fuel injectors of the left engine.

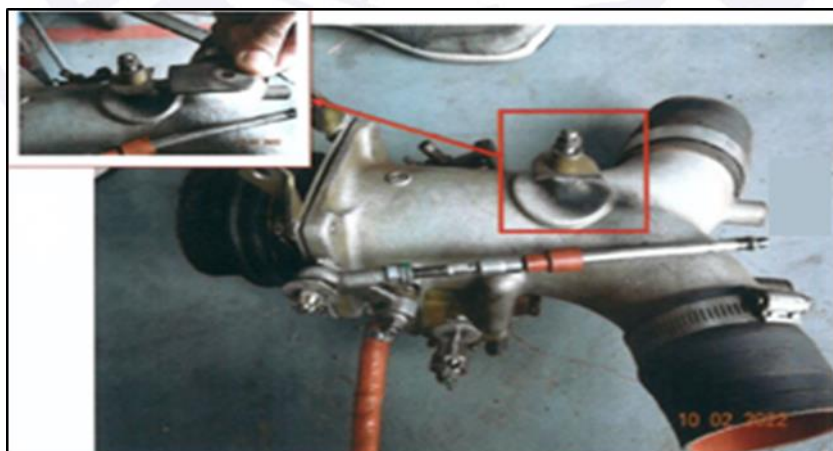
During the engine analysis conducted by members of the Investigation Committee, it was identified that the throttle body assembly (THROTTLE ASM-AIR) had one of its mounting brackets (BRACKET-THR BODY SUPPORT) broken (Figure 17).

Figure 17 - General view of the throttle body assembly (THROTTLE ASM-AIR), highlighting the broken mounting bracket.

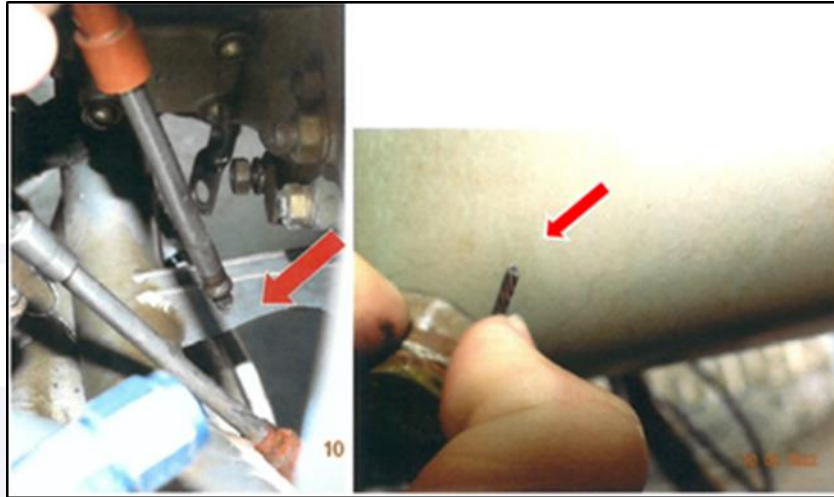
It was also noted that the throttle lever control cable was severed (Figure 18).

Figure 18 - Severed throttle lever control cable.

The control cable rupture showed characteristics of a fatigue failure mechanism. It was hypothesized that prolonged use may have subjected the cable to conditions that accelerated its structural degradation, or that it was manufactured with deviations from its design specifications.

Following the throttle lever control cable's rupture, control of the butterfly valve was lost, preventing the engine from responding to the pilot's commands. This situation was interpreted by the PIC as a left engine flameout, leading to the execution of the *Engine Failure in Flight* procedures, including shutting down the engine.

Evaluate, together with the type certificate holder of the Beech Baron 58 aircraft model, whether the current maintenance requirements are sufficient to ensure that the throttle control cables, PN - 102-389010-47, do not fail under conditions different from those specified in their design parameters.

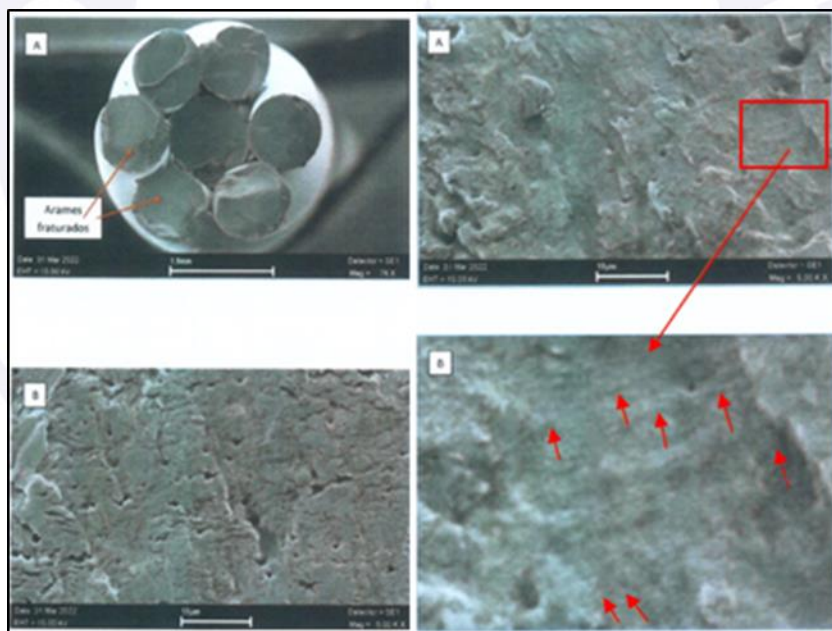
Electrophotographs of the fractured wires showed denting on the fracture surface and striations indicative of fatigue failure (Figure 19).

Figure 19 – Highlight of the fatigue mechanism on the fractured wire (red arrows).

A deficiency in the manufacturing process or assembly of the PN 102-389010-47 throttle control cable may have contributed to the premature degradation of its structure through the development of material fatigue. This ultimately led to its unexpected total failure during operation, resulting in the inability to control the left engine.

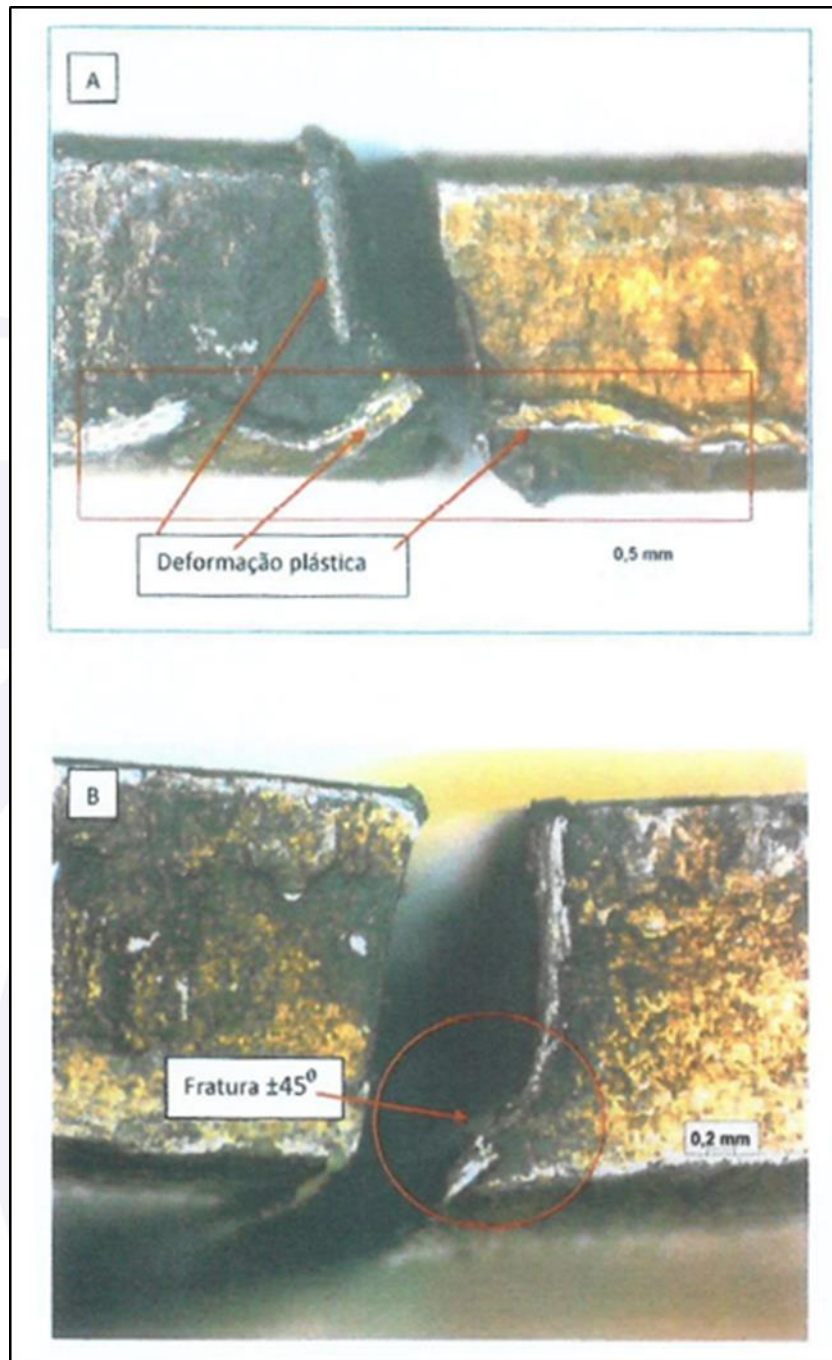
The throttle body bracket exhibited plastic deformation, warping, and a fracture at approximately 45°, indicating an overload on the throttle body assembly bracket (THROTTLE ASM-AIR).

Figure 20 - View of the fracture of the throttle body assembly bracket.

The throttle body bracket exhibited plastic deformation, warping, and fracture at approximately 45°, indicating overload stress. It was inferred that the bracket's fracture likely occurred during the aircraft's impact with the terrain.
