COMANDO DA AERONÁUTICA
CENTRO DE INVESTIGAÇÃO E PREVENÇÃO DE
ACIDENTES AERONÁUTICOS

FINAL REPORT
A-082/CENIPA/2022

| AIRCRAFT: | PR-JSM |
| MODEL: | AT-502 |

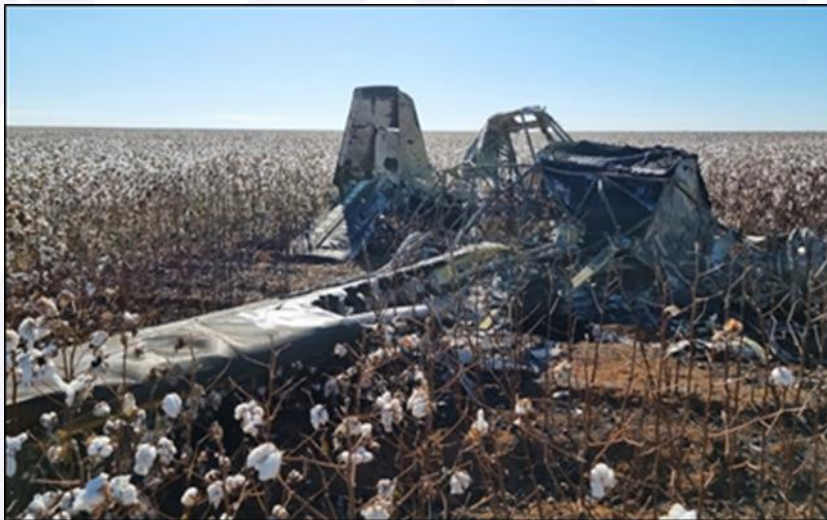
At the end of a turnaround maneuver, the spray boom touched the crop, causing the airplane to collide with the ground and subsequently catch fire.

Figure 1 - Final positioning of the aircraft after the occurrence.

The airplane was destroyed.

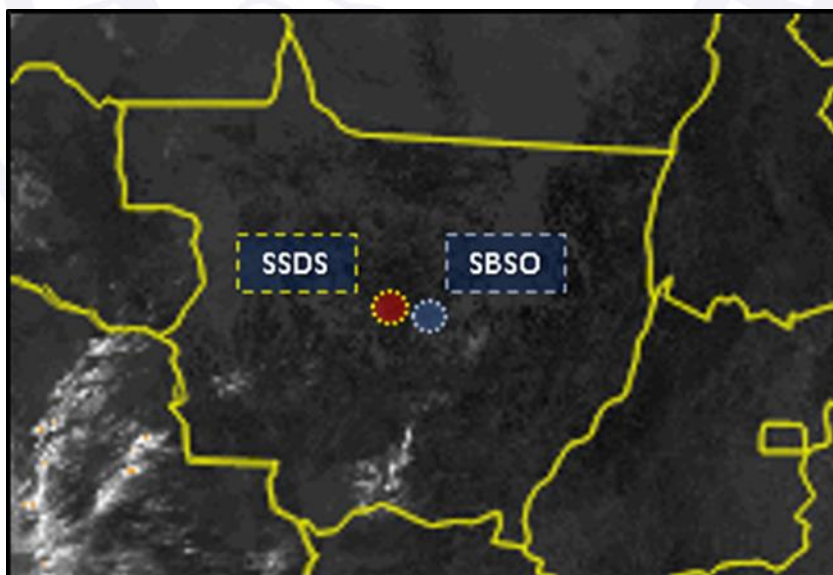
Figure 2 - Enhanced satellite image of the region at 13:10 UTC., highlighting SSDS and SBSO. Source: <https://www.redemet.aer.mil.br/>.

Thus, the Investigation Commission concluded that the meteorological conditions were above the minimum requirements for flight operations.

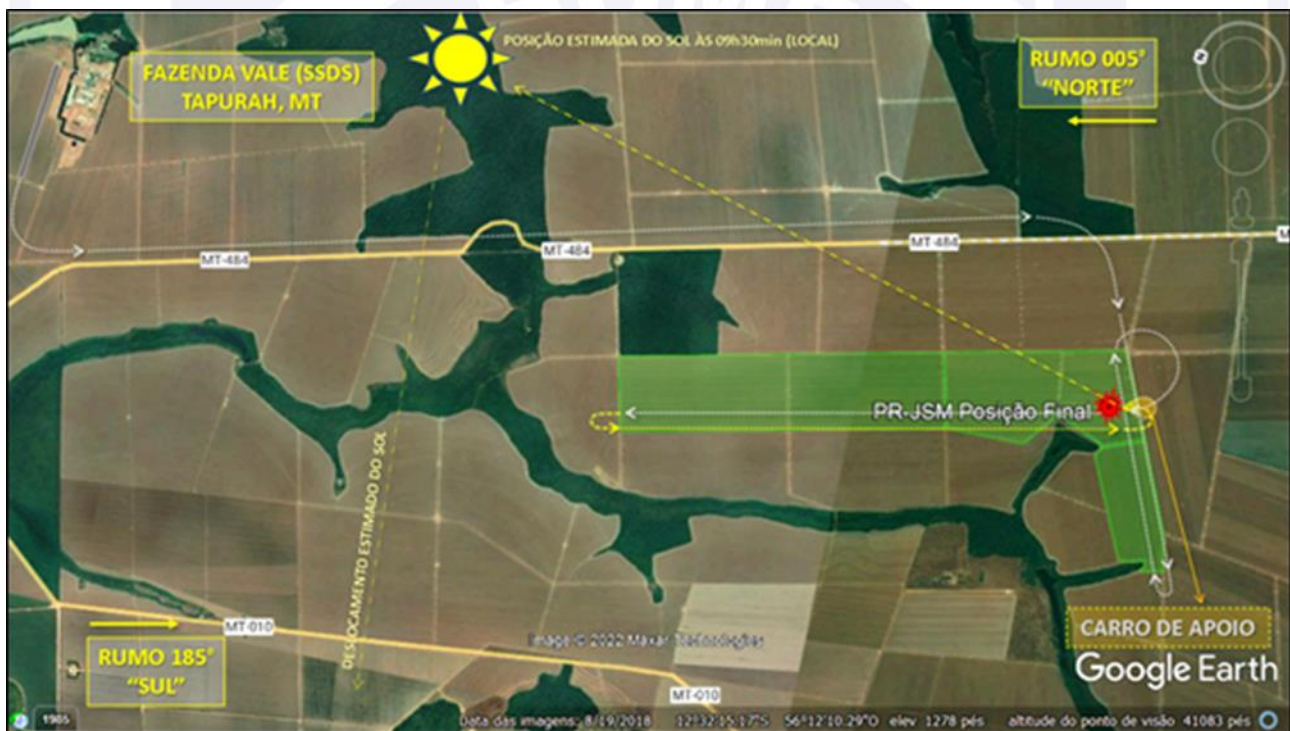
It was the fourth flight of the day, and the aircraft was executing its fifth repositioning turn for application, following a path consistent with the layout in areas 222 and 223 (highlighted in green) of *Fazenda Vale do Rio Verde*, as shown in Figure 3.

Figure 3 - Sketch of the trajectory flown by the aircraft.

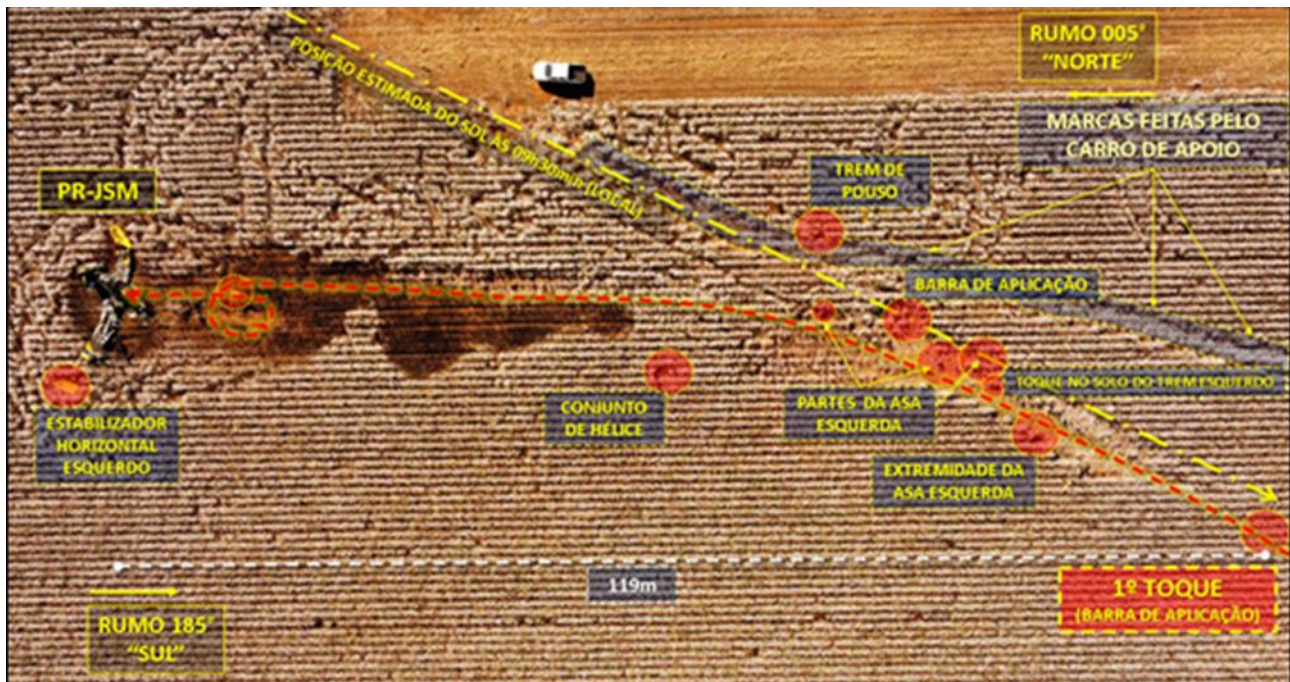
The aircraft impacted the plantation with high longitudinal energy. The area of the debris extended 119 meters in length and 36 meters in width, maintaining the direction of flight, indicating the final segment of a left reversal turn, consistent with observations made during the initial action of the investigation.

Parts of the aircraft detached upon initial contact with the cotton field, including the spray bar and the tip of the left wing, which were the farthest pieces of wreckage from the aircraft's final position.

The detachment of the left wing resulted in the release of fuel, which ignited upon contact with the aircraft's hot components, initiating the fire.

The fire was concentrated at the root of the right wing, consistent with the dynamics of the impact and the aircraft's final position, as illustrated in Figure 4.

Figure 4 - Dynamics of the occurrence and debris dispersion.
Source: Adapted from Google Earth, 2022.
