COMANDO DA AERONÁUTICA
CENTRO DE INVESTIGAÇÃO E PREVENÇÃO DE
ACIDENTES AERONÁUTICOS

FINAL REPORT
A - 132/CENIPA/2013

OCCURRENCE:	ACCIDENT
AIRCRAFT:	PR-KEX
MODEL:	G36
DATE:	19JUL2013

This is the Final Report of the 19JUL2013 accident with the G36 aircraft model, registration PR-KEX. The accident was classified as “[UNK] Unknown”.

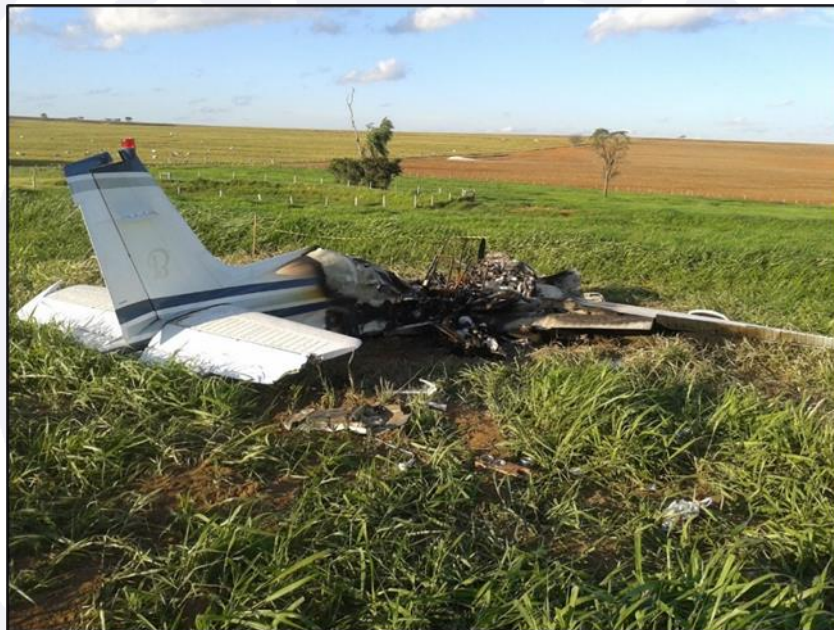
At around 1530 (UTC), the aircraft crashed into the ground and was then, partially consumed by fire.

Figure 1 - Image of the aircraft after the occurrence.

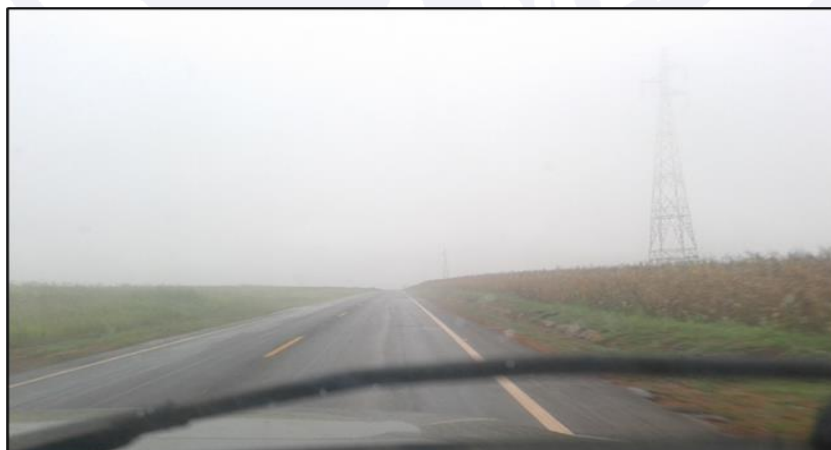
Figure 3 - Presence of fog in the region of the occurrence on 20JUL2013, at 01:00 pm (local).

As observed, the humidity recorded by the station on the day after the occurrence was identical to that of the previous day, especially concerning the RH and the differences between the minimum temperature and that of the dew point. The gradient between air and dew point temperatures was also less than 1°C. The confluence of such data with the photographic records made allows us to conclude that, in fact, there was fog when the occurrence took place.

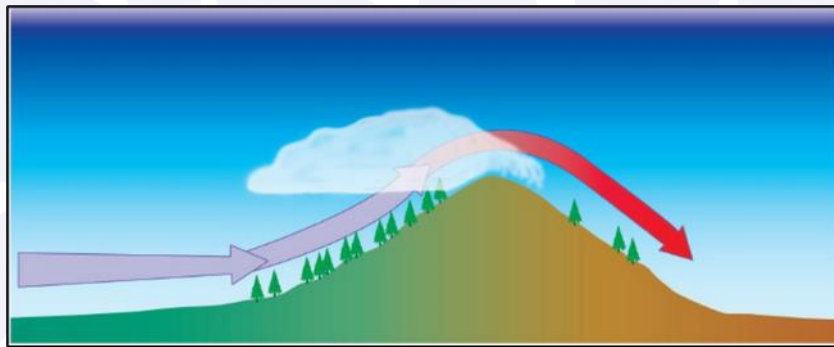
In addition to the high humidity conditions, it is worth mentioning the proximity of the place of occurrence to the *Serra da Bodoquena*, whose peaks reach about 2,500 feet in the surroundings of the route traveled by the aircraft. The presence of mountainous elevations can also favor the formation of orographic fog, through an adiabatic cooling process of air masses with high humidity, as seen in Figure 4.

Figure 4 - Orographic fog formation near mountainous regions. Source: Lester, 2013.

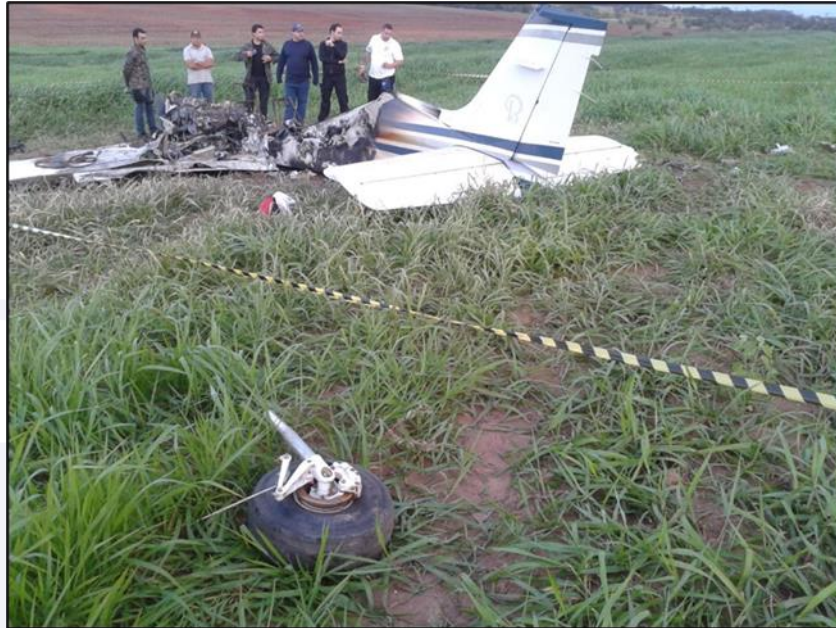
The right main landing gear, of the retractable type, was broken and located close to the rest of the wreckage, as shown in Figure 5.

Figure 5 - Broken right main landing gear.

Impact marks on the propeller blades indicated that the collision occurred with the engine at low RPM. The right main landing gear was broken during the aircraft's impact with the ground, which indicated that, possibly, the landing gears were down. The flaps were also lowered, and it was not possible to say if they were commanded intentionally or by the force of the impact with the ground.

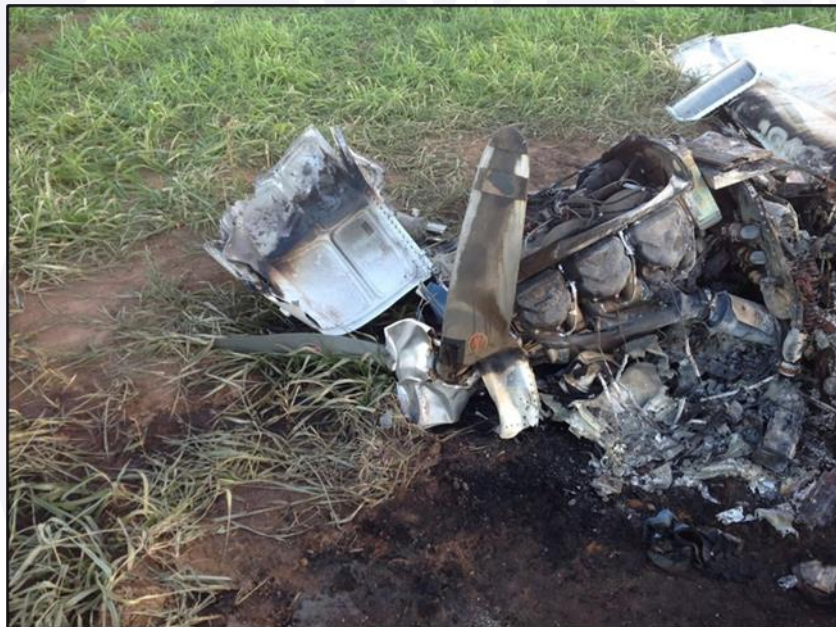
The propeller blades had characteristics of low RPM impact damage and the wings were leveled, as shown in Figures 6 and 7.

Figure 6 - Propeller damage.

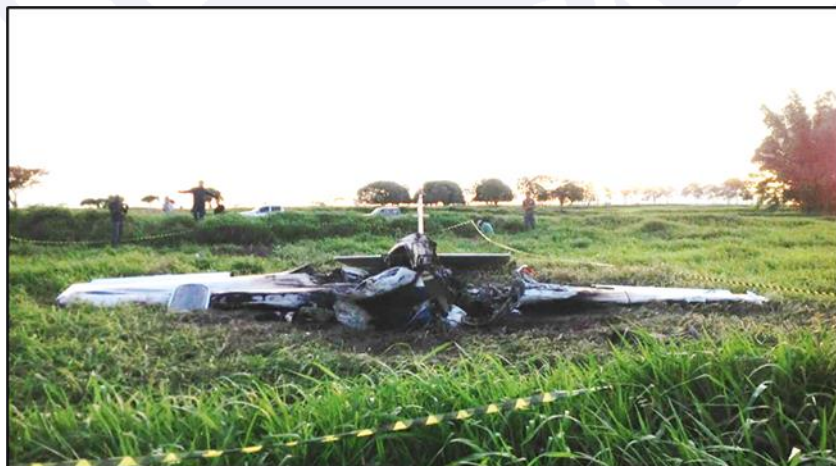
Figure 7 - Front view of the aircraft, with leveled wings.

Taking into account this information and considering the attitude of the aircraft at the moment of impact (with leveled wings), there are indications that the pilot had landing intentions. In this case, the degraded weather conditions, with fog in the area of the occurrence, may have impaired visibility to the point of causing the pilot to crash into the ground, in an attempt to make a precautionary landing.
