FINAL REPORT
A-033/CENIPA/2022

OCCURRENCE:	ACCIDENT
AIRCRAFT:	PR-LCT
MODEL:	S-76C++
DATE:	16MAR2022

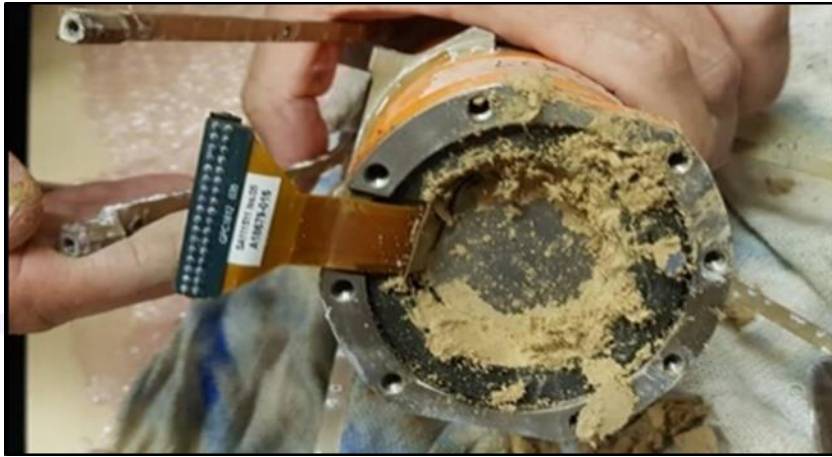
Figure 16 - View of the internal part of the MPFR at the LABDATA facilities.

During the opening process, one observed the presence of humidity in the internal part of the MPFR (Figure 16).

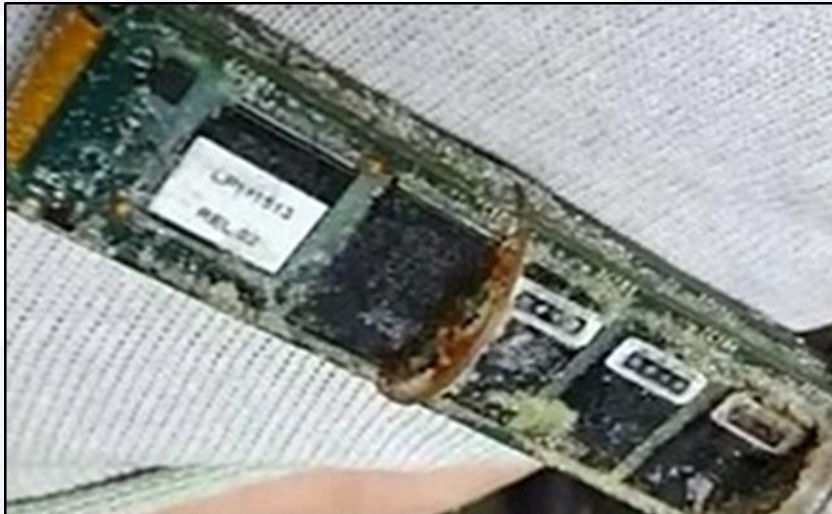
Figure 17 - MPFR memory under a process of corrosion.

The salt water, which penetrated the MPFR memory compartment, initiated a corrosion process in some of the internal components (Figure 17).

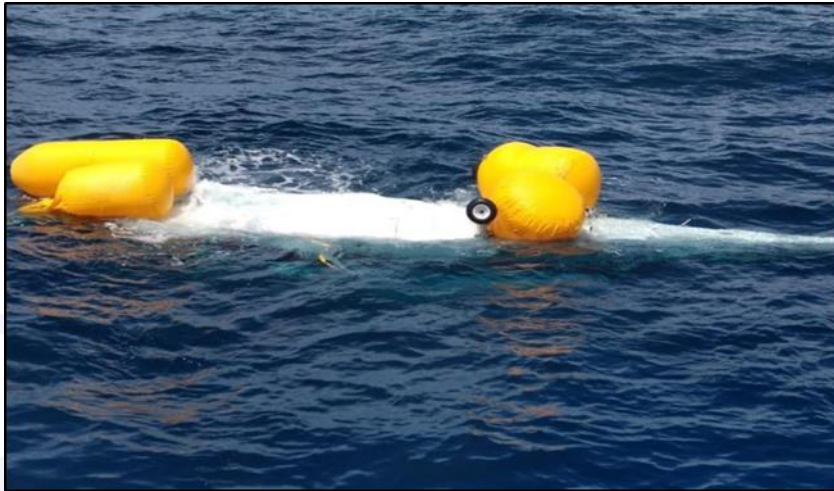
The floats of the PR-LCT deployed automatically after the crash and kept the helicopter afloat in an upside down position, with the fuselage partially submerged (Figure 22).

Figure 22 - View of the PR-LCT after the crash, showing the four inflated emergency floats, which kept the helicopter afloat just below the sea surface.

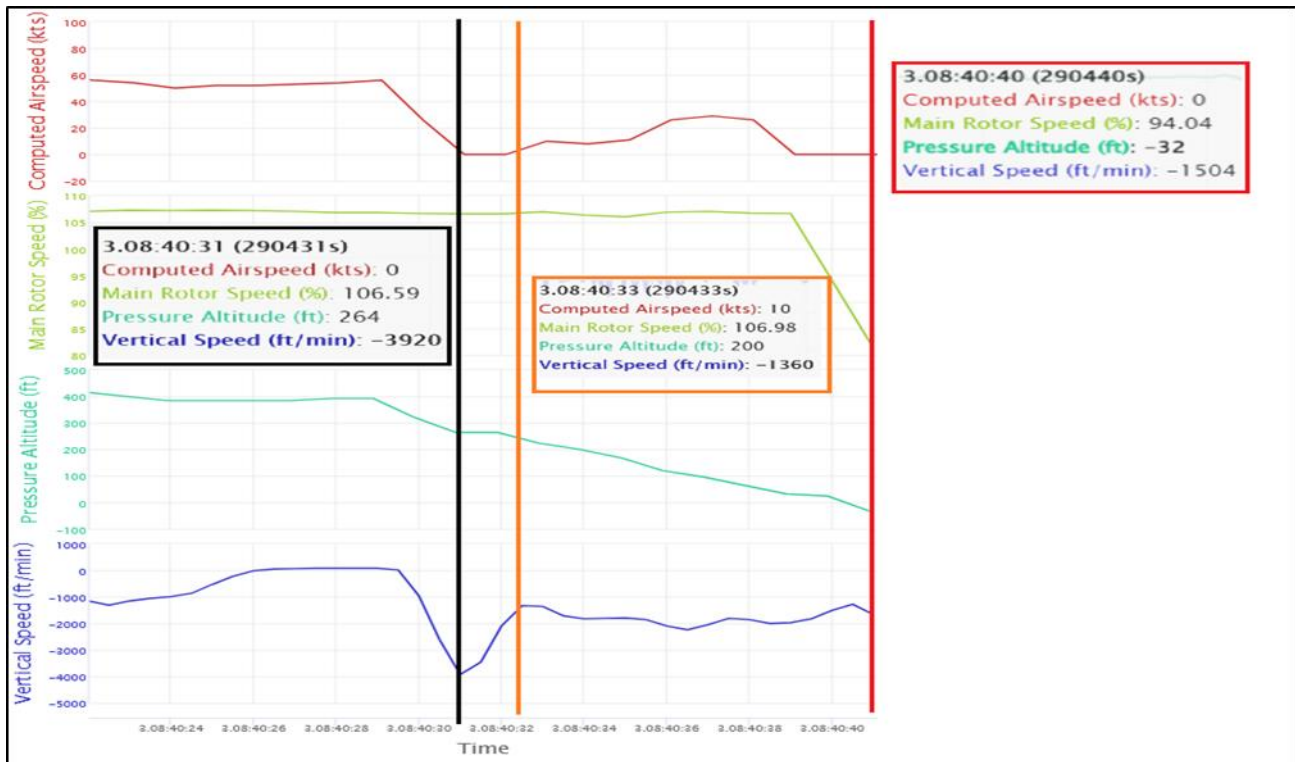
Figure 25 – Information extracted from the MPFR.

Similarly, one observed that the aircraft even experienced a vertical speed of -3,920 ft. /min, with a zero-kt horizontal speed at the altitude of 264 ft. AGL (Figure 25).

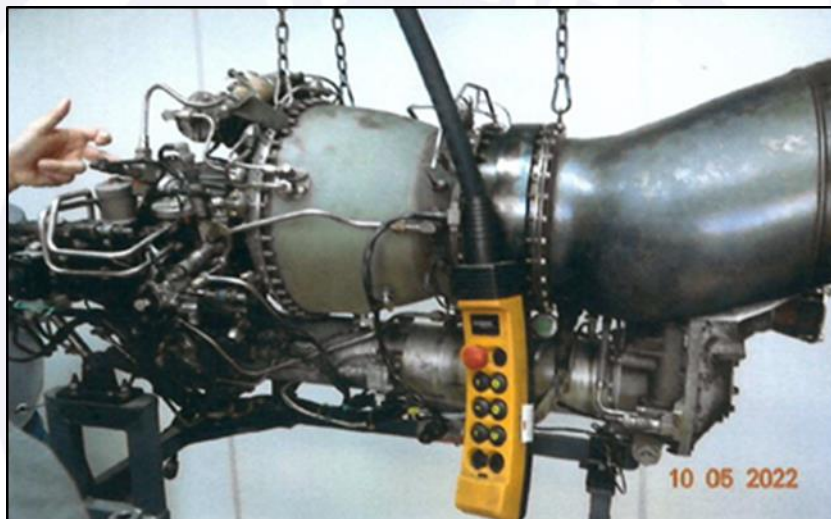
Figure 28 – Left-hand side view of the SN 42326TEC engine.

During the initial inspection of the SN 42326TEC engine, it was verified that the connections of the lubricating oil and pneumatic pipes had an appropriate torque, and no abnormal oil leaks or air leaks were identified (Figure 28).

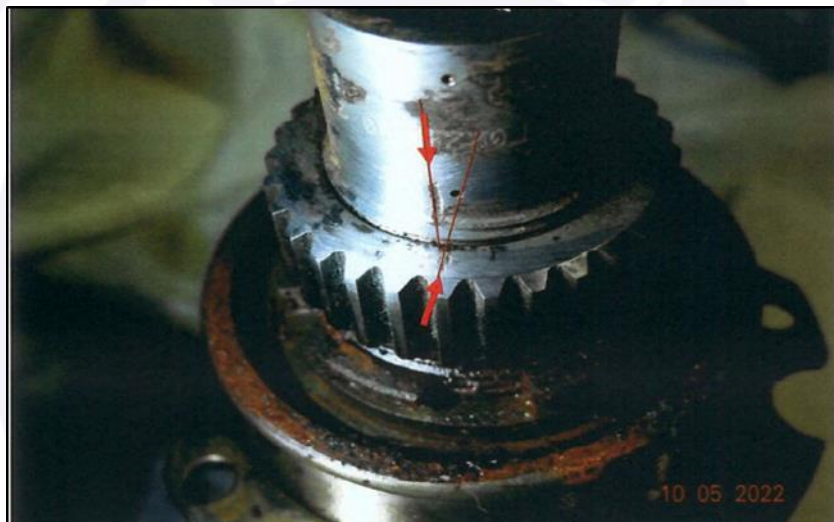
The misalignment observed in the marks on the input pinion and the splined nut of the module 05 indicated that the engine was running and that the systems in operation suffered an abrupt stop (Figure 30).

Figure 30 - View of the misalignment of the marks between the input pinion of the module 05 of the SN 42326TEC engine and the shaft.

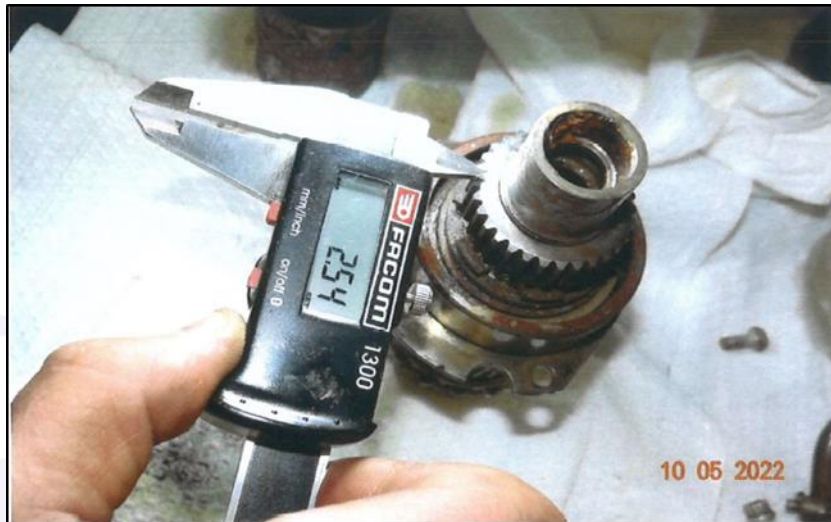
It is important to highlight that such marks only misalign during operation when the engine is functioning normally, developing power, and the assembly suffers a sudden stop. In the case of the engine in question, the misalignment was greater than 2 mm (Figure 31).

Figure 31 - Measurement of the 2.54 mm misalignment observed between marks.

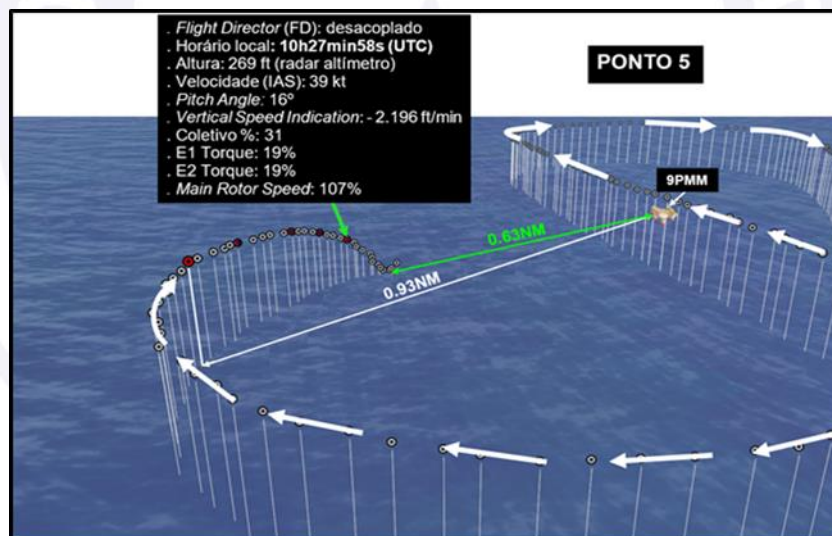
Figure 38 - PR-LCT's flight path on final approach, highlighting the parameters at point 05.

Next, the PIC alerted the SIC that the descent rate was a little high, and the SIC confirmed that it was high. The data extracted from the MPFR at this point indicated that the helicopter had the following parameters, as shown in Figure 38.
