COMANDO DA AERONÁUTICA
CENTRO DE INVESTIGAÇÃO E PREVENÇÃO DE
ACIDENTES AERONÁUTICOS

FINAL REPORT
A-136/CENIPA/2020

OCCURRENCE:	ACCIDENT
AIRCRAFT:	PR-LMP
MODEL:	EMB-500
DATE:	30OUT2020

This is the Final Report of the 30 October 2020 accident with the EMB-500 aircraft, registration marks PR-LMP. The accident received the typification of “[RE] Runway Excursion”.

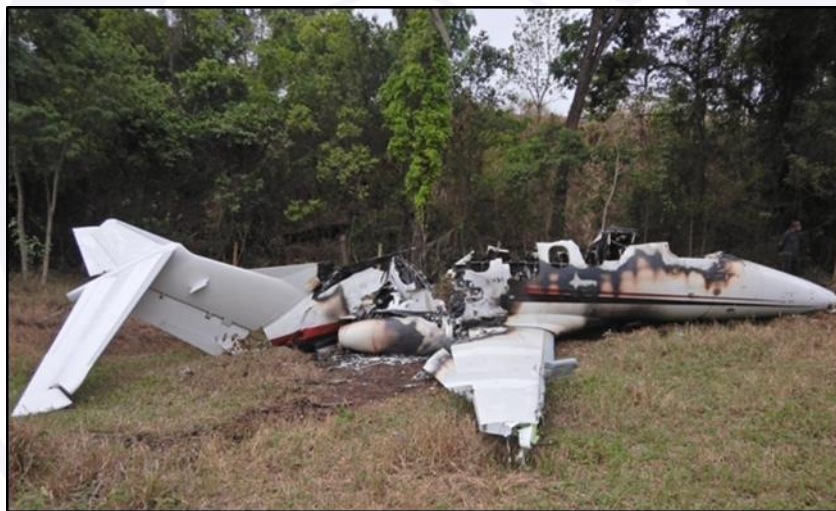
The aircraft was destroyed.

Figure 1 - Aircraft after coming to a complete stop.

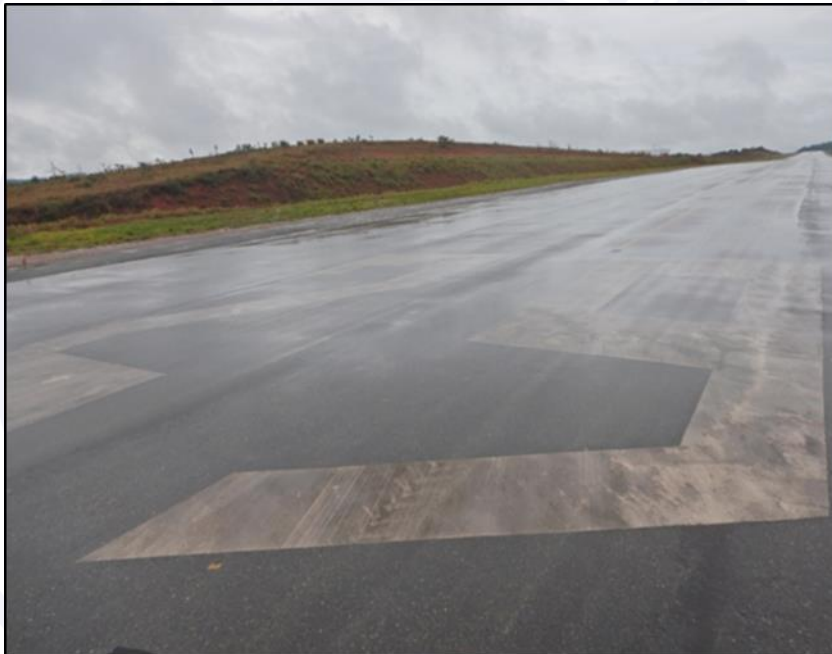
In Figure 4, depicting a photograph taken during the investigation process, it is possible to observe a mirrored condition of the runway shortly after precipitation of heavy rain.

Figure 4 –Threshold 29 of SSDK: wet and mirrored surface after rainfall.

One observed that the runway did not have transverse grooving for the drainage of water. The Investigation Commission did not identify a consistent behavior concerning the measurement of either the runway's coefficient of friction or the runway's macrotexture.

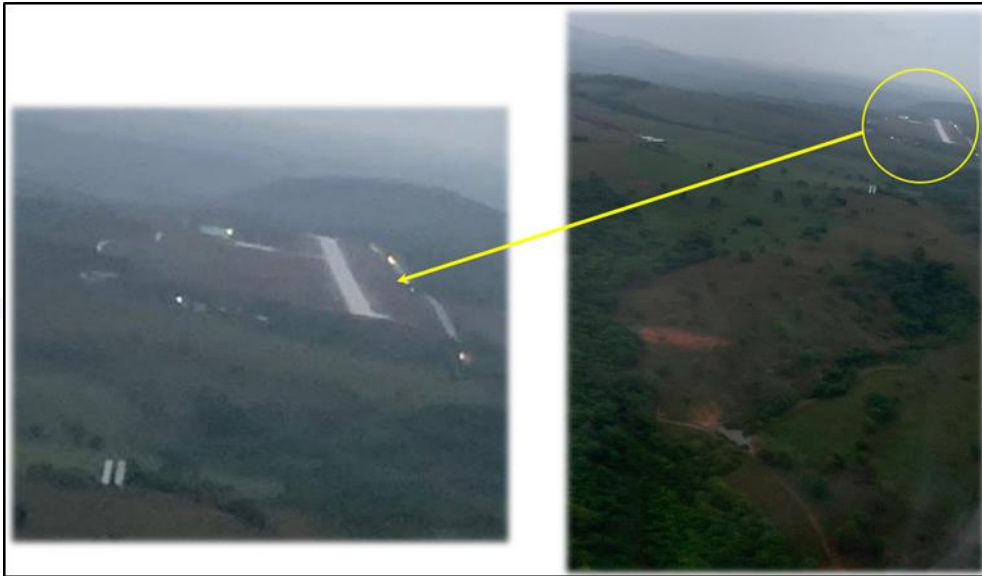
The mirrored condition observed in Figure 4 was similar to the one observed on the day of the accident, as shown in the image depicted in Figure 5 recorded by a passenger during approach for landing at the aerodrome in question on the day of the occurrence.

Figure 5 - Runway conditions on the day of the accident.

It was not possible to verify whether, besides water, there were other contaminants on the runway, which could reduce the coefficient of friction of the said runway.

Thus, one inferred that the runway was contaminated, a condition that would reduce its coefficient of friction and impair the aircraft's braking performance, making it impossible to stop within the runway limits.

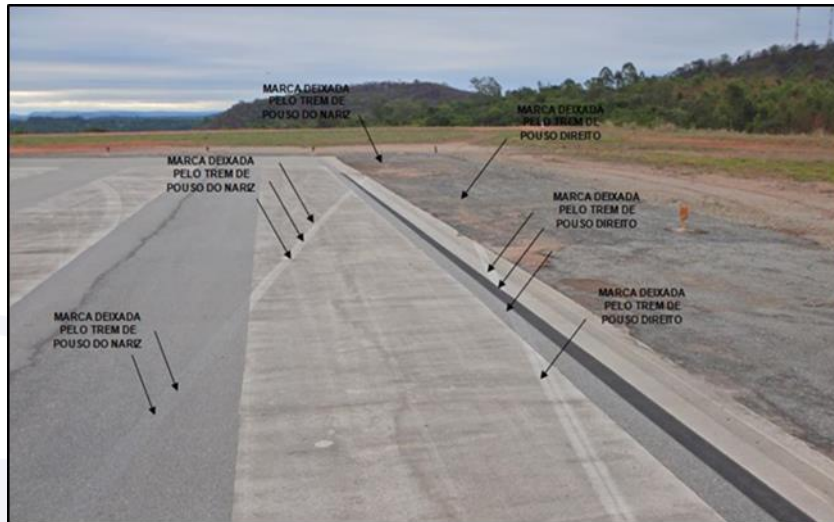
In the course of the initial investigation, the investigators identified continuous marks on the runway that ended at the point where the PR-LMP exited the runway.

The marks resulted from the "cleaning" action generated by the rubber of the aircraft tires in contact with the pavement (Figure 6).

Figure 6 - Marks with an exit profile to the right-hand side of the threshold of runway 11 in SSDK.

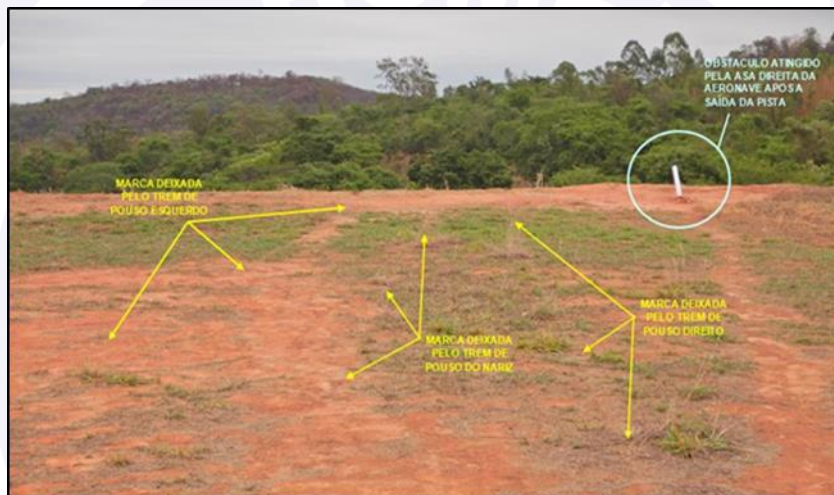
From the physical evidence found at the site, it was possible to observe that the aircraft collided with an object on the ground that was outside the runway limits. The first impact on the aircraft occurred close to the tip of the right-hand wing and caused the loss of control.

Figure 7 - Location of the first impact showing marks made by the aircraft's landing gear.

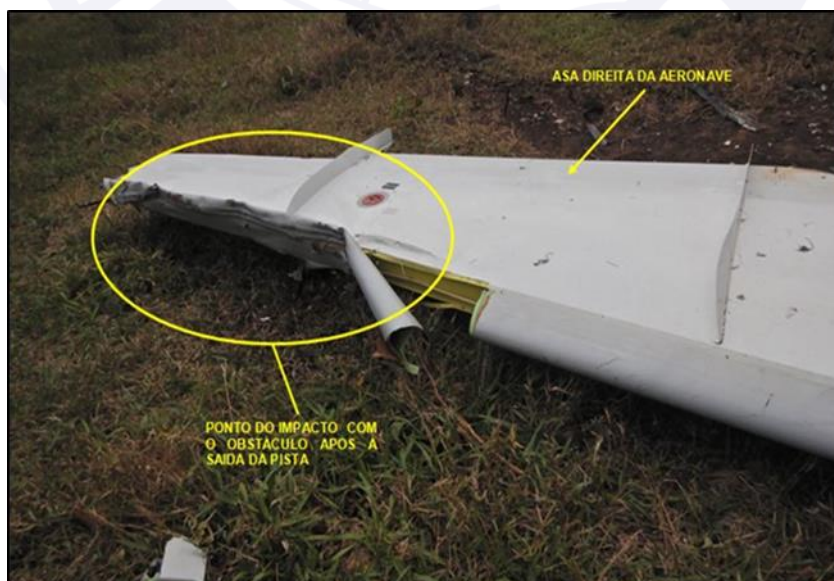
Figure 8 – Right-hand wing of the aircraft showing damage resulting from the impact with the obstacle after exiting the runway.

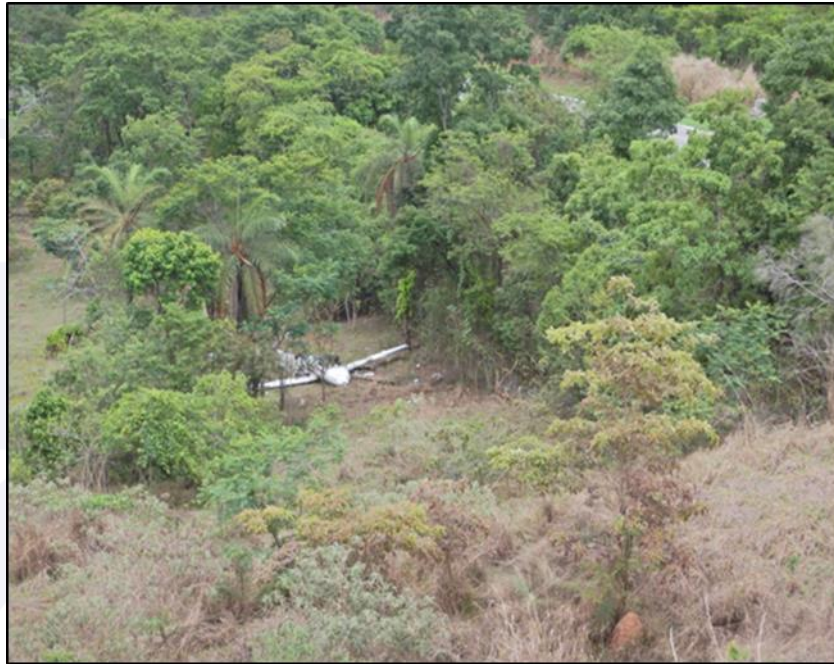
A difference of approximately 10 meters in height was observed between the threshold of the SSDK runway 11 and the spot where the aircraft came to a rest.

Figure 9 - Location of the wreckage with a view of the ravine near the threshold of runway 11 in SSDK.

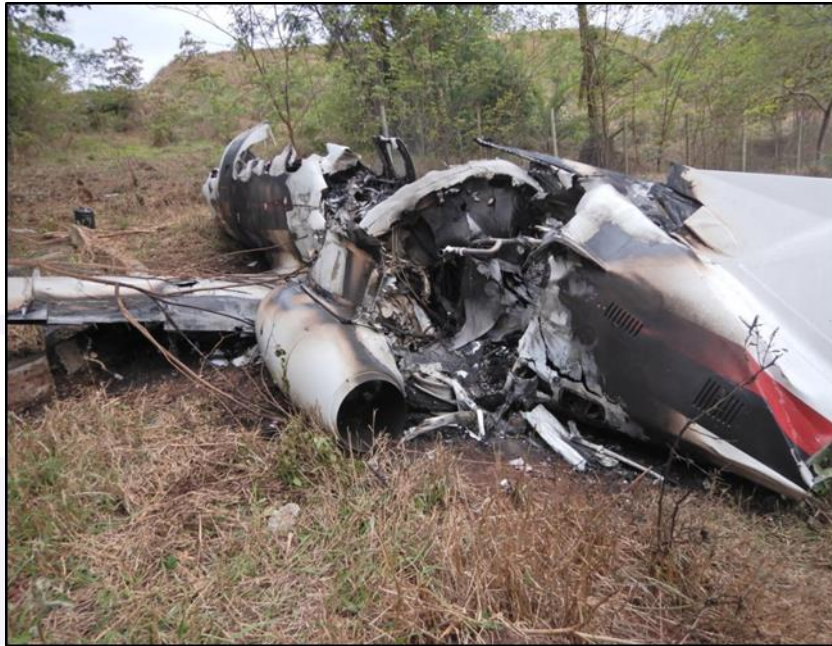
The engines continued running during the procedures for evacuation of the passengers and crew. According to reports from the ones involved, a large amount of fuel was leaking from the wings, which provided the combustion material that gave rise to the fire.

The source of ignition possibly originated from the engines that remained at high speed after the aircraft stopped and could not be turned off after the impacts.

Fig. 10 - Rear left-hand side view of the PR-LMP aircraft wreckage.

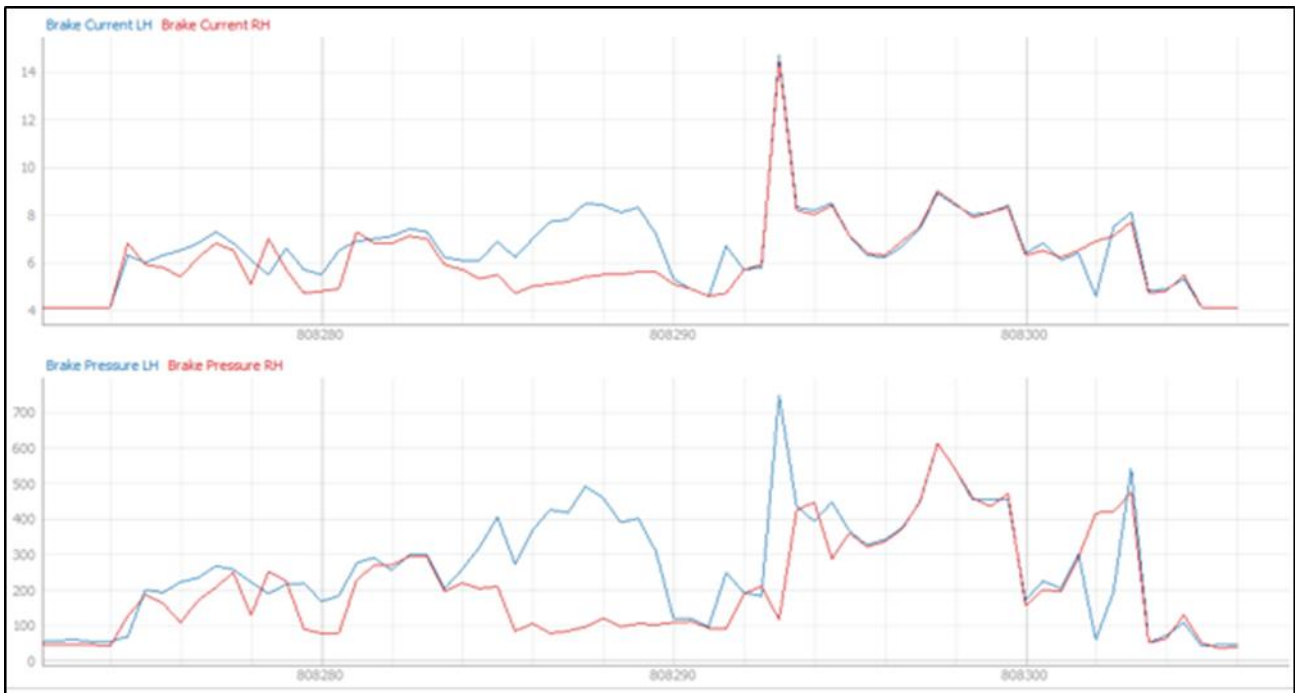
In the diagram of Figure 16, it is possible to observe a consistent correlation between the electric current of the brake valve and the pressure of the brakes. The released pressure was in line with what was expected for the level of the current, which indicated that the valve was operating properly.

Figure 16 - Data on the brake valve and brake pressure currents.

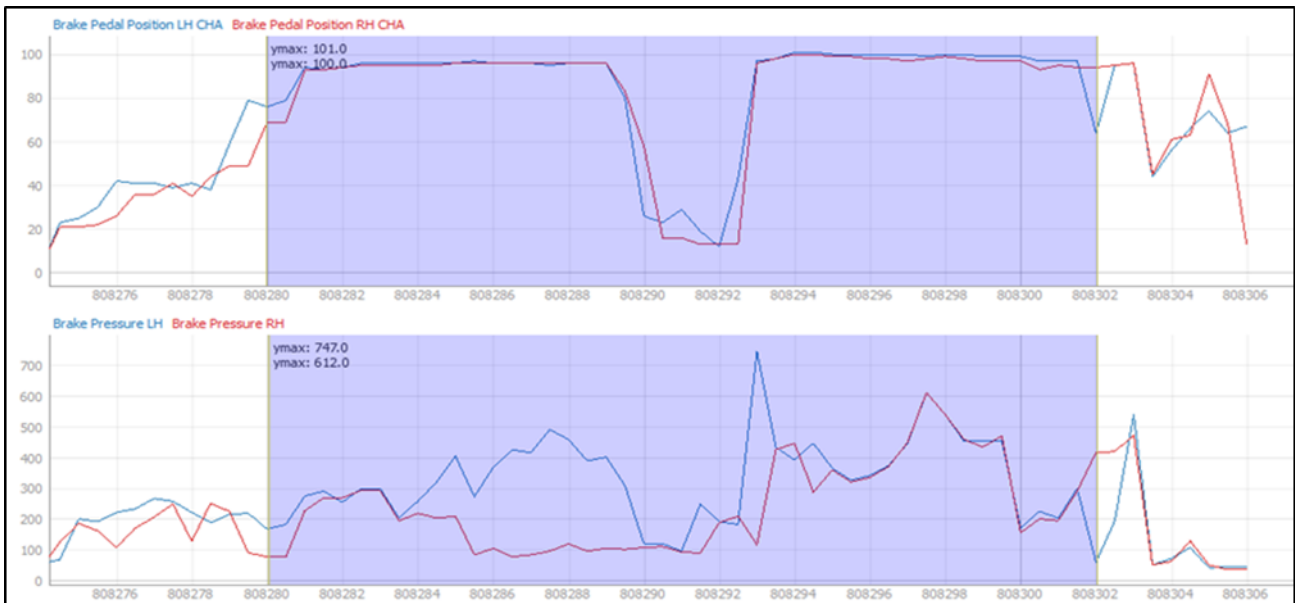
Since no failure of system components was registered, the observed pressure indicated that the antiskid system actuation limited the pressure applied by the brakes to 747 PSI, as shown in Figure 18. The limitation of the pressure value is consistent with the normal operation of the brake system, and is associated with the condition of the runway.

Figure 18 - Graphic representation of the performance of the braking system during the landing run of the PR-LMP.
