COMANDO DA AERONÁUTICA
CENTRO DE INVESTIGAÇÃO E PREVENÇÃO DE
ACIDENTES AERONÁUTICOS

FINAL REPORT
IG - 012/CENIPA/2016

OCCURRENCE:	SERIOUS INCIDENT
AIRCRAFT:	PR-MAA
MODEL:	A320-232
DATE:	18JAN2016

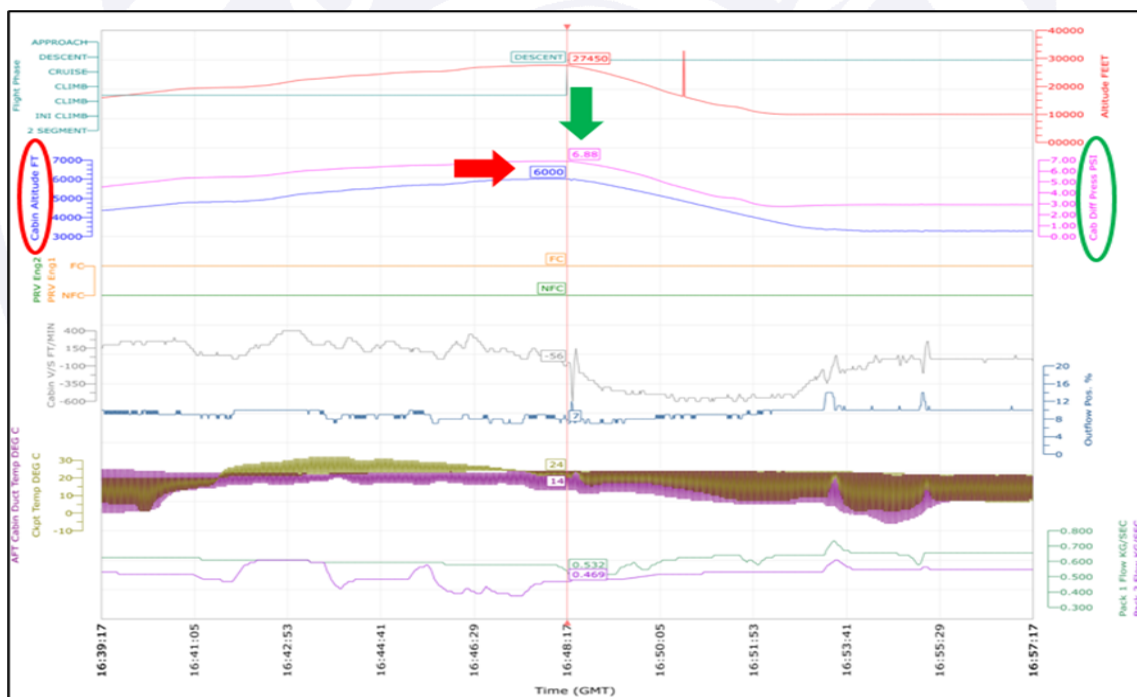
Figure 1 shows the flight data, recorded and validated by the CVDR, which had a maximum Cabin Altitude of 6,000ft and a maximum Cab Diff Press of 6.88psi.

Figure 1 - CVDR data, highlighted the Cabin Altitude 6.000ft (red arrow) and Cab Diff Press 6.88psi (green arrow).

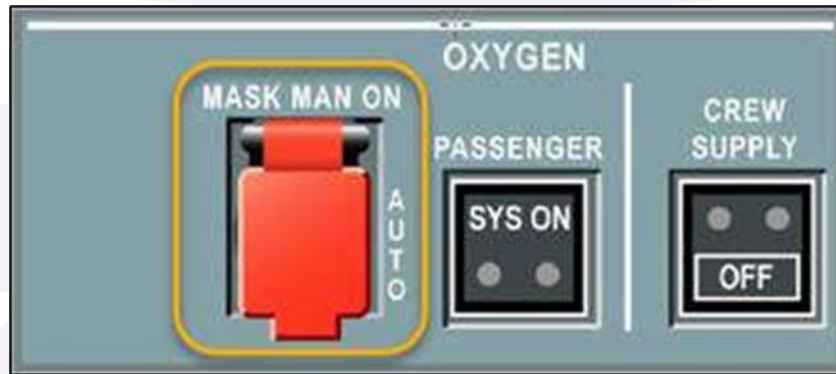
Right after the request of the chief flight attendant, the commander asked the copilot to put on the mask and commanded the masks release manually for the passengers (MASK MAN ON), on the oxygen panel (Figure 4).

Figure 4 - Oxygen panel, highlighted by the red switch MASK ON MAN.

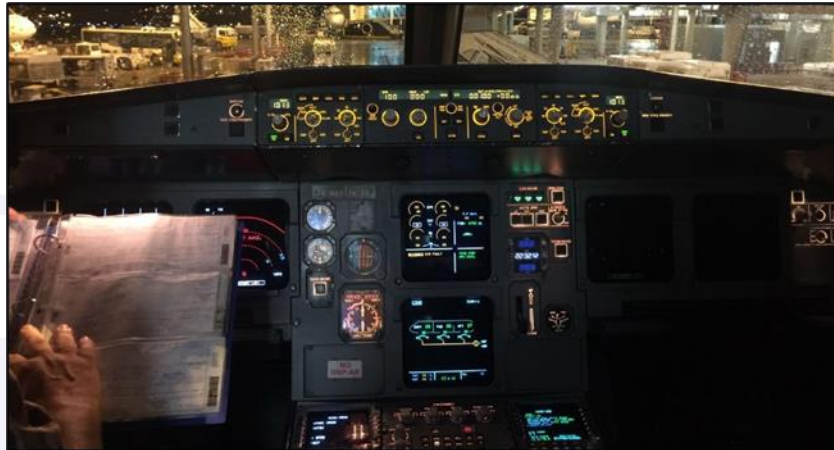
procedures on the ground. The pressurization test parameters behaved within the normal range (Figure 6).

Figure 6 - Pressurization test during the field investigation on the aircraft.

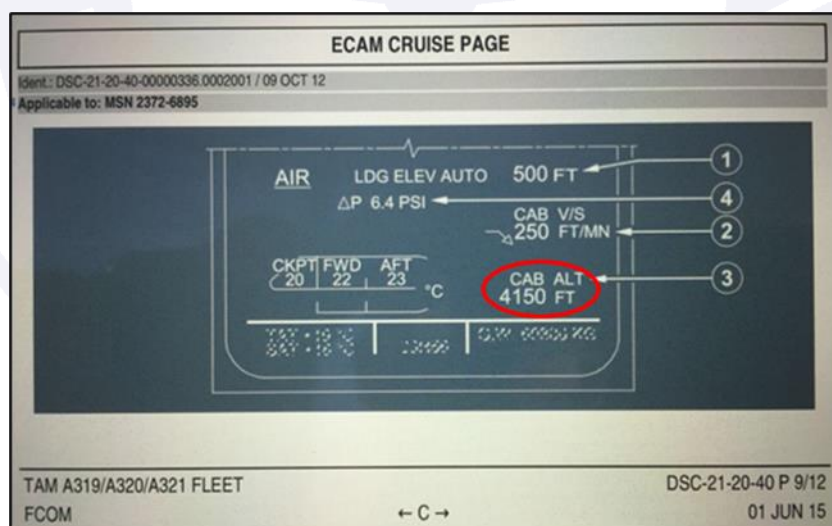
According to data extracted from the CVDR and pilots' reports, there was no alert that the parameters of CAB ALT FT, CAB V/S FT/MIN and ΔP indication were out of normal limits.

In Figures 7 and 8, according to the Flight Crew Operating Manual A319 / A320 / A321, the CAB ALT indicator pulsates if the altitude reaches 8,800ft and turns red if the cabin altitude reaches 9,550ft. The pressure differential indicator (ΔP) is amber when it is out of the normal range, when $\Delta P < -0.4$ psi or > 8.5 psi.

Figure 7 – ECAM's illustration, highlighted the CAB ALT indication.
