FINAL REPORT
A-075/CENIPA/2020

OCCURRENCE:	ACCIDENT
AIRCRAFT:	PT-MBV
MODEL:	EMB-121A
DATE:	14JUN2020

This Final Report refers to the accident with the EMB-121A aircraft, registration PT-MBV, on 14 June 2020. The accident was typified as “[LOC-I] Loss of control in flight”.

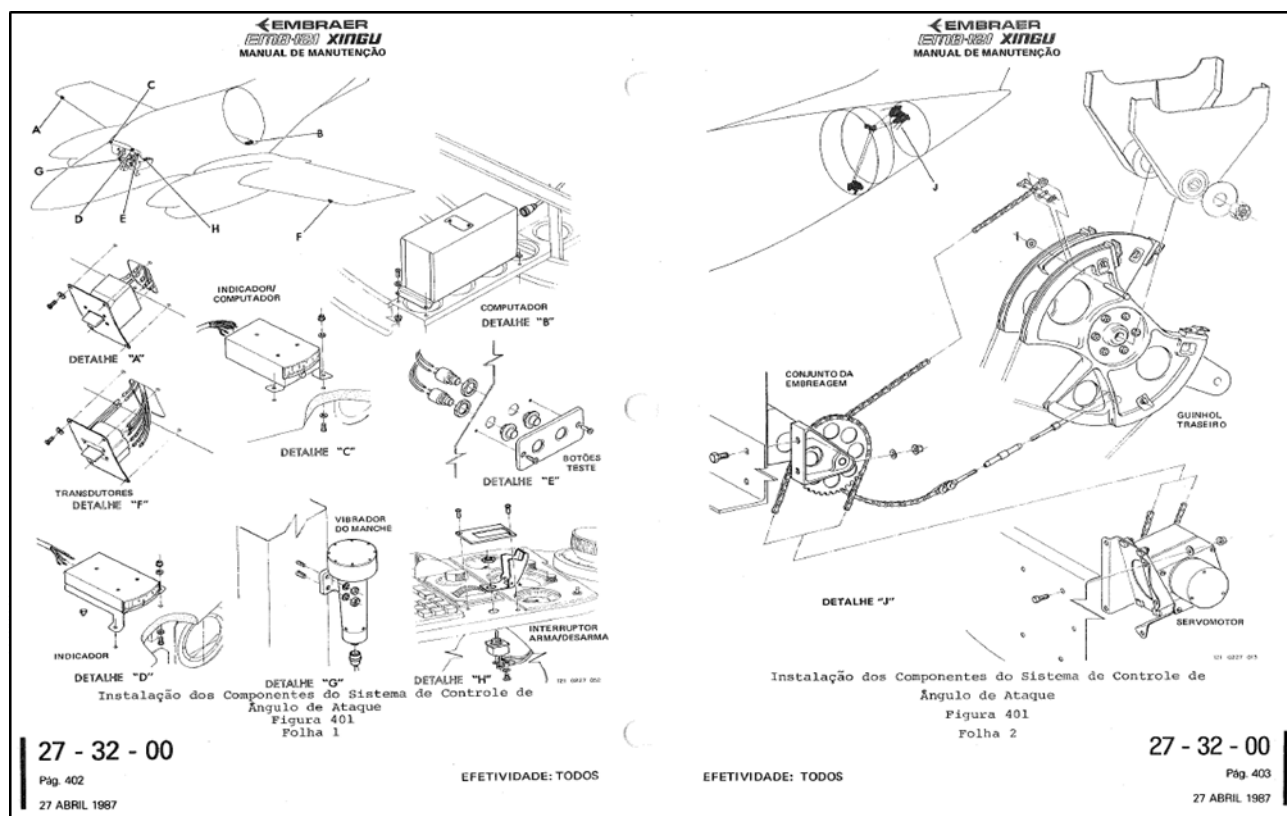
Figure 2 - Visual description of components of the angle-of-attack control system, subsystems 1 and 2.

The characteristics of the impact and the impossibility of analyzing the components of the trimming and angle-of-attack control systems led the investigators to infer that the accident in question may be related to an inadvertent activation of the control-stick pusher, due to an erroneous reading of the aircraft's angle of attack after a possible failure of a component, or failure of calibration of the angle-of-attack control system (subsystem 1).

However, it was not possible to gather sufficient elements for the endorsement of such hypothesis, since it presumes simultaneous failures of both angle-of-attack sensors, something unlikely to occur. Furthermore, in case of activation of the control-stick pusher, the pilot would be able to overcome it, applying an opposite-direction force on the control stick.

One should not rule out the hypothesis of a possible malfunction of the aircraft's angle-of-attack control system, considering that the records related to the provision of the calibration service (a necessary condition for the proper functioning of the referred system, and prescribed in the aircraft's maintenance manual) were not identified in the pertinent control documents.

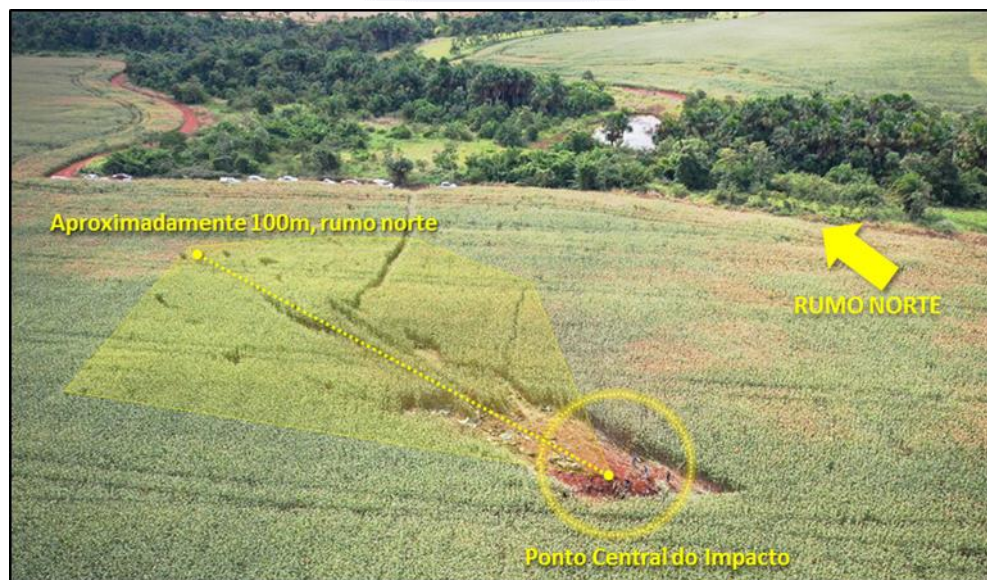
Figure 9 - Aerial view of the crash site.

The engines had penetrated the ground at a depth between 1.5 and 2 meters, with the right-hand engine buried underneath the left-hand one.

In addition, there was no sign of ground scars before the point of impact, a factor that demonstrates the high angle of impact against the ground, as shown in the aerial view in Figure 9.

Information obtained from the wreckage revealed that the engines penetrated the ground at a depth between 1.5 and 2 meters, with the right-hand engine found underneath the left-hand engine, indicating that the aircraft was in a downward turn to the right.

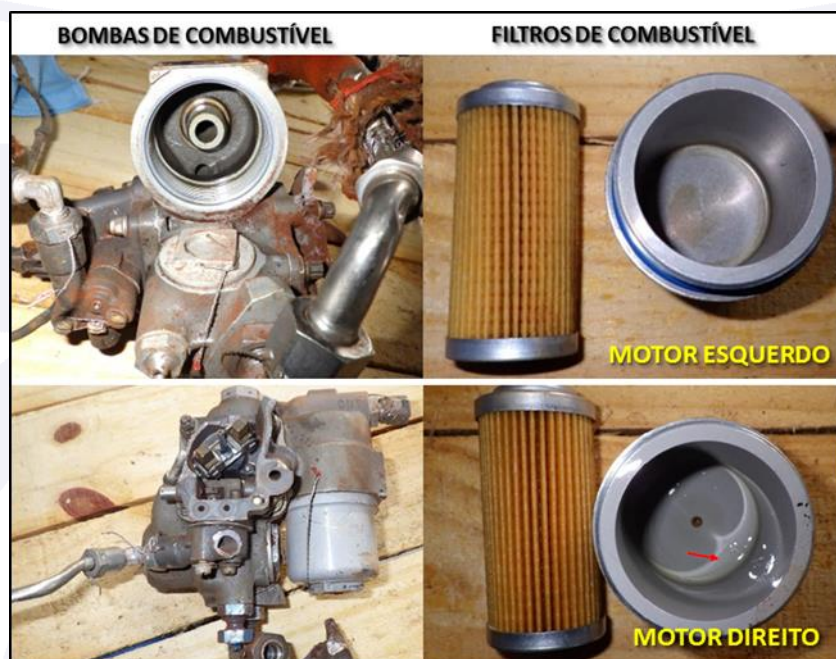
Figure 10 - General condition of the pumps, filters, and fuel.

The low-pressure fuel filters had their interiors clean, with no visible indication of contamination, but with a distinct smell of fuel, as they contained residual liquid. The fuel found was light in color, without phase separation (Figure 10).

There was no evidence that could be associated with a malfunction of the engines.
