COMANDO DA AERONÁUTICA
CENTRO DE INVESTIGAÇÃO E PREVENÇÃO DE
ACIDENTES AERONÁUTICOS

FINAL REPORT
A-160/CENIPA/2023

| AIRCRAFT: | PR-MCL |

This Final Report pertains to the December 15, 2023 accident involving the aircraft model 510 of registration marks PR-MCL. The occurrence was typified as “[RE] Runway excursion.”

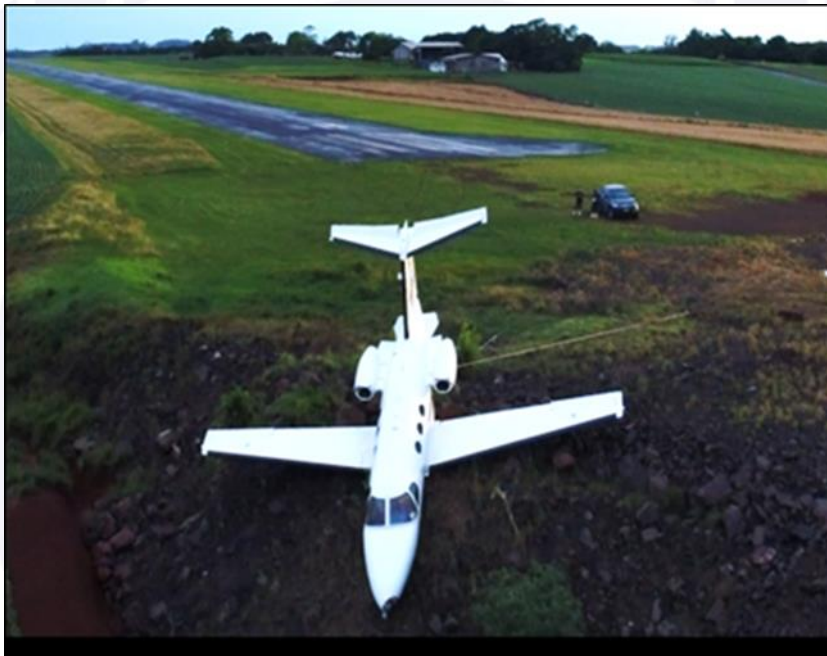
After landing at SSIJ, the aircraft overran the departure end of the runway, veered to the right, and came to a stop on a sloped area.

Figure 1 – View of the aircraft after coming to a complete stop.

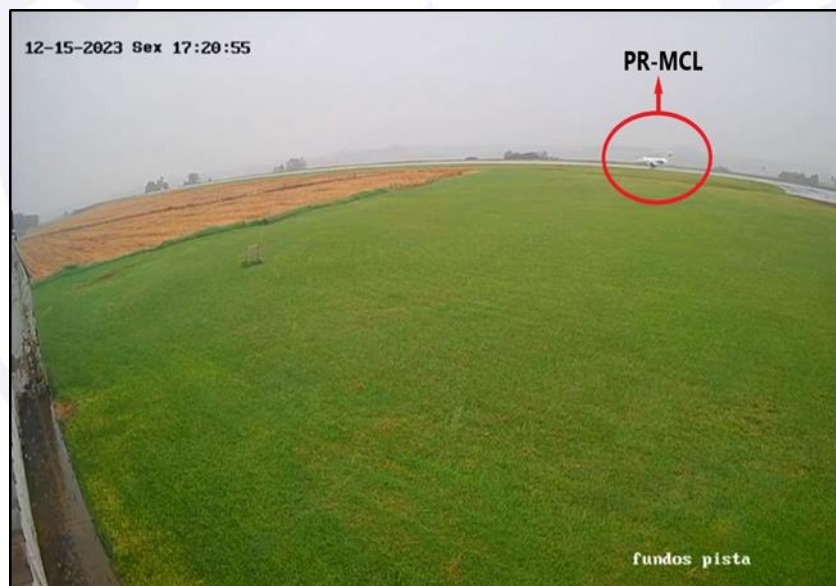
Security camera footage from the aerodrome showed it was raining and the runway was wet at the time of the landing that culminated in the accident. The footage also showed a layer of low clouds and limited horizontal and vertical visibility. Figure 5 shows the overcast and rainy conditions at *Ijuí* Aerodrome during the landing of PR-MCL that resulted in the accident.

Figure 5 – Weather conditions at *Ijuí* Aerodrome at the time of landing.
Source: security camera footage from the aerodrome.

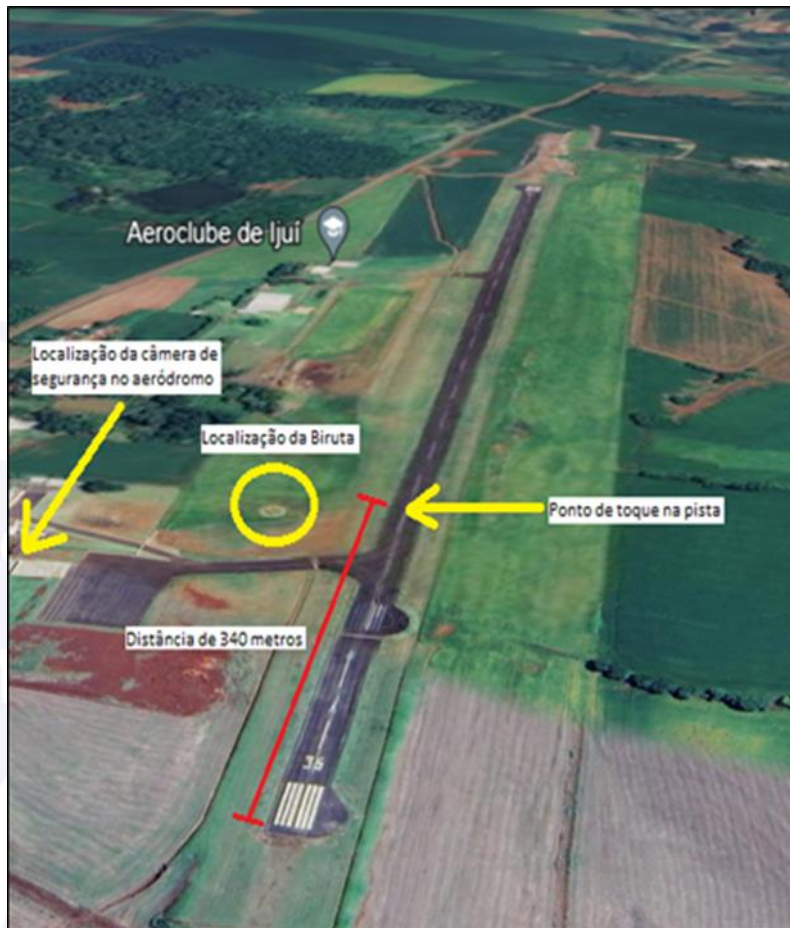
The landing took place in the direction of runway 36. The aircraft's touchdown point was approximately 340 m after the 36 threshold, which was also consistent with the tire marks found on the runway.

Figure 6 - General view of *Ijuí* Aerodrome.
Source: adapted from GoogleEarth.

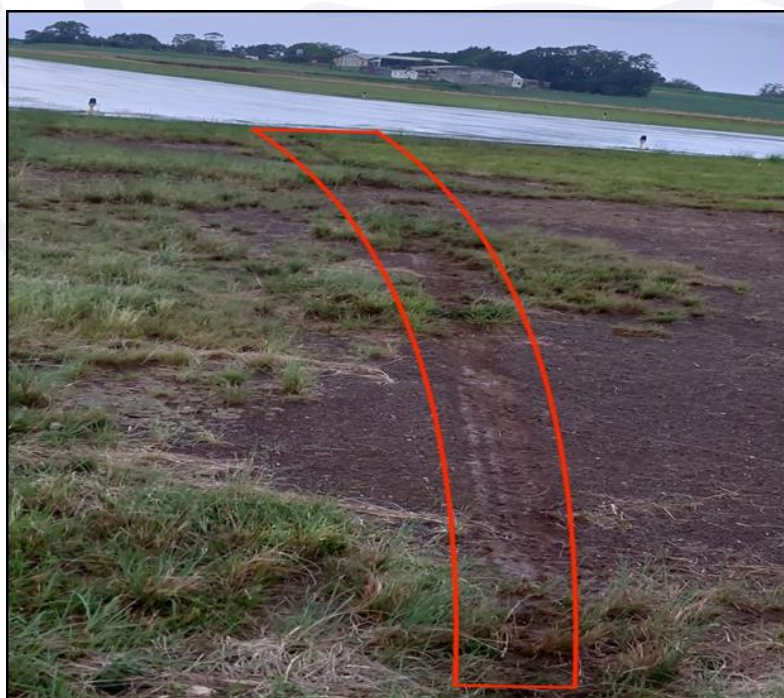
After the runway excursion through the departure end of runway 36, the aircraft traveled 90 m across open land and about 20 m on sloped terrain until coming to a complete stop. The aircraft's final stop occurred in a nose-down attitude (approximately 35°) after its front impacted stones on the ground.

Figure 7 - Aircraft trajectory after runway excursion past the departure end of SSIJ RWY 36.

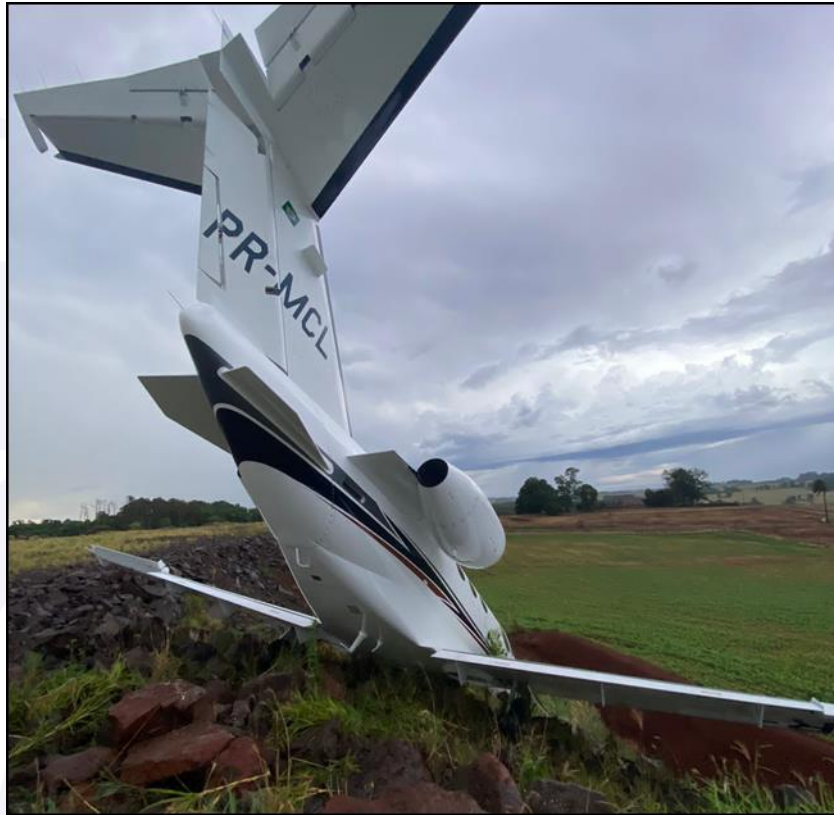
There was damage to the hydraulic system, main landing gear, as well as the collapse of the auxiliary landing gear. The lower fuselage suffered dents in its structure.

The central and rear sections of the fuselage remained intact, as did the tail cone and its components.

Figure 8 - View of the aircraft damage after its full stop.
